Municipality: 7. Brčko

7.1 Bijela Mosque

Neighborhood:	Kolobara
Town:	Brčko
GPS:	44°52'47.6"N 18°48'13.9" E
Construction:	19 th century (1881, rest. 1893)
Historical period:	Austro-Hungarian
Official status:	listed monument
Building use:	religious
Building type:	Mosque
Building setting:	city
Building condition:	completely destroyed under reconstruction

Damage description: Mosque completely destroyed, ruins razed, building materials removed.

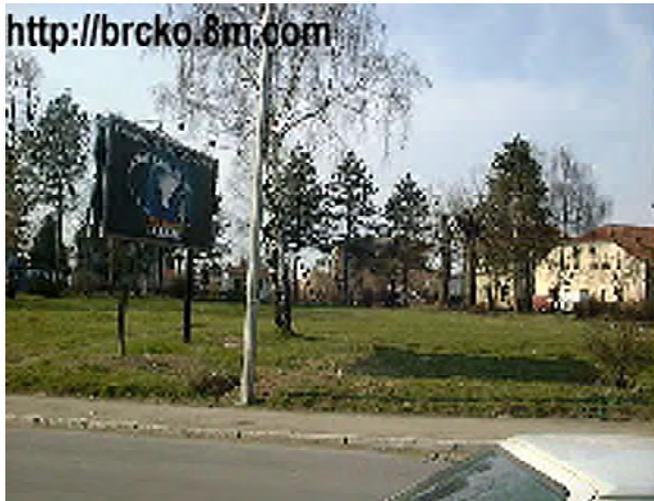
7.1 Bijela Mosque in Brčko – photo 1

Empty site of the razed Bijela Mosque (White Mosque) in Kolobara, Brčko.
Photo from: Medžlis of the Islamic Community of Brčko (1998) .

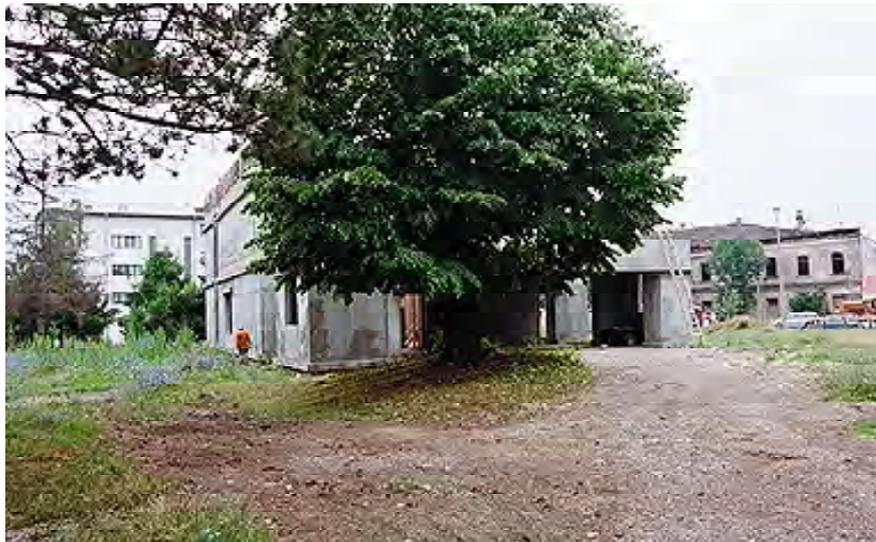
7.1 Bijela Mosque in Brčko – photo 2

Site of destroyed Bijela Mosque, facing former entrance; new mosque under construction in rear. The large, old tree next to the entrance of the mosque also appears on the pre-war photos.
Photo: András Riedlmayer (July 2002).

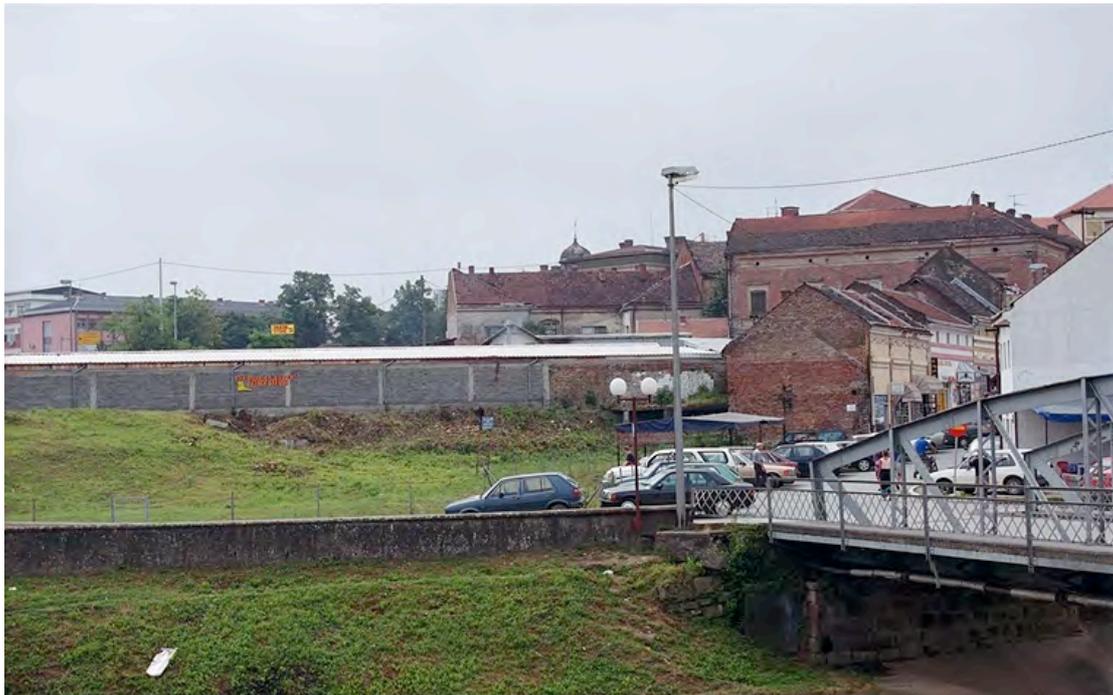
**7.2 Sava mosque in Brčko – photo 1**

Damage description: Mosque completely destroyed, ruins razed, site levelled, foundations excavated; mosque rubble reportedly dumped atop mass grave site outside Brčko.

Empty site of the razed Sava Mosque (Atik džamija) in Brčko. Note iron bridge at right, also seen in prewar photo of mosque. photo by: András Riedlmayer (07/2002)

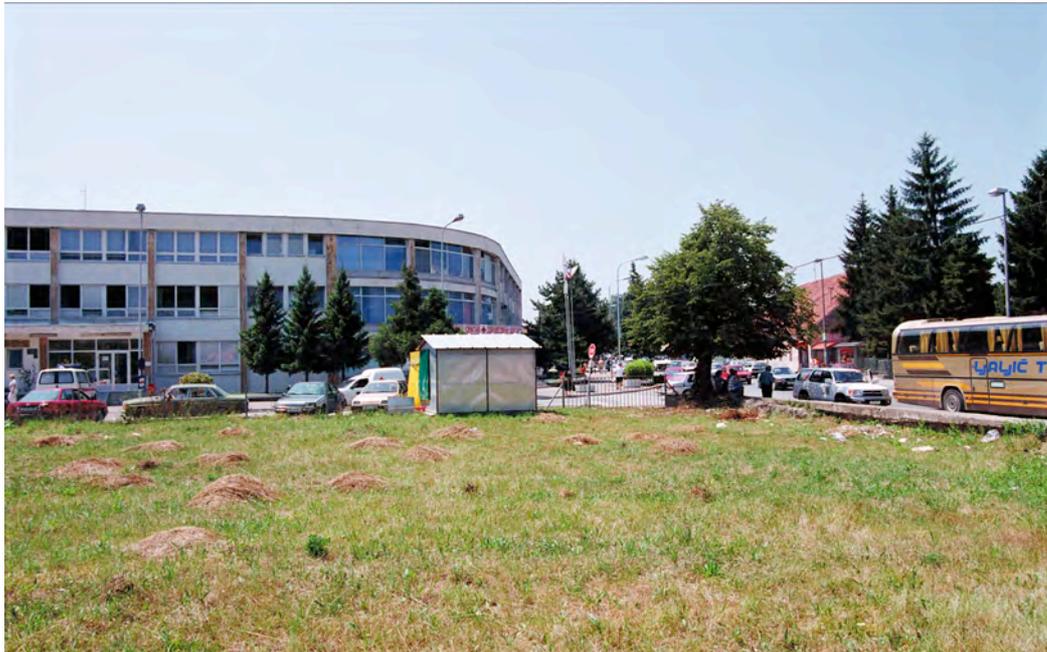
7.3 Old Hadži Paša Mosque – photo 1

Damage description: Old Mosque with a traditional wooden minaret, completely destroyed, site levelled, building materials and foundations excavated and removed. The site is overgrown with grass, uneven, rutted ground but no trace of foundations.

Empty site of razed mosque with the Health Centre at rear; note linden tree at the corner of the lot, where the mosque entrance used to be.

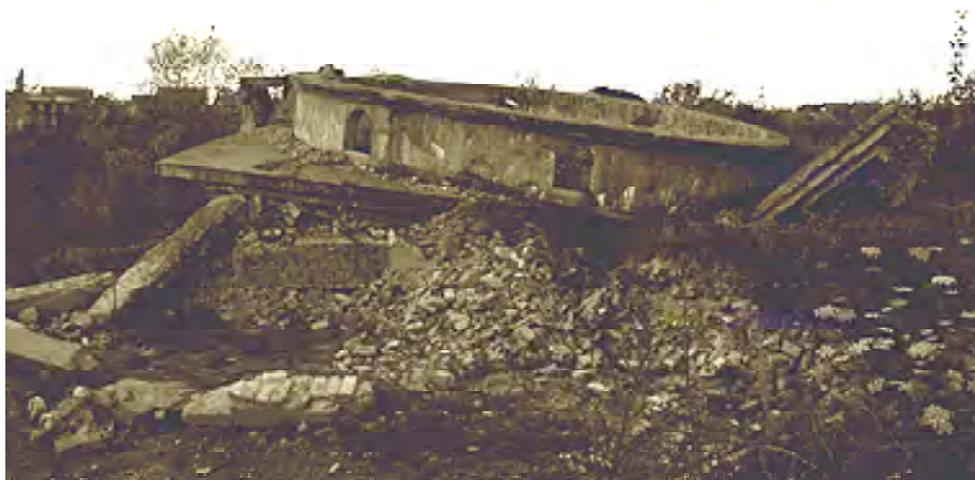
7.4 Dizdaruša Mosque – photo 1

Damage description: New domed mosque destroyed by mining, structure almost completely demolished; only the concrete drum of the dome resting atop a pile of rubble remains.

Ruins of the new mosque at Dizdaruša after the end of the war.

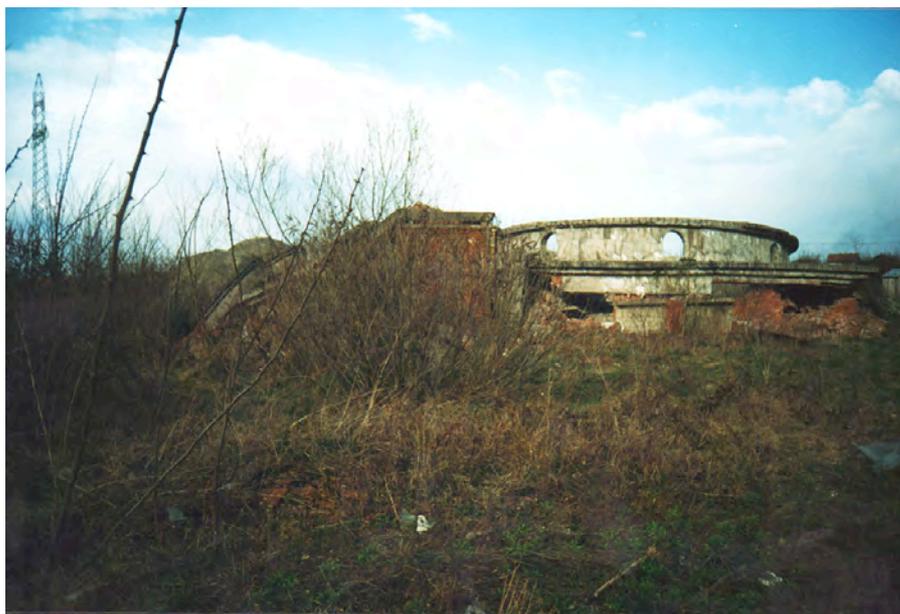
7.4 Dizdaruša Mosque – photo 2

Ruins of the new mosque at Dizdaruša after the end of the war.

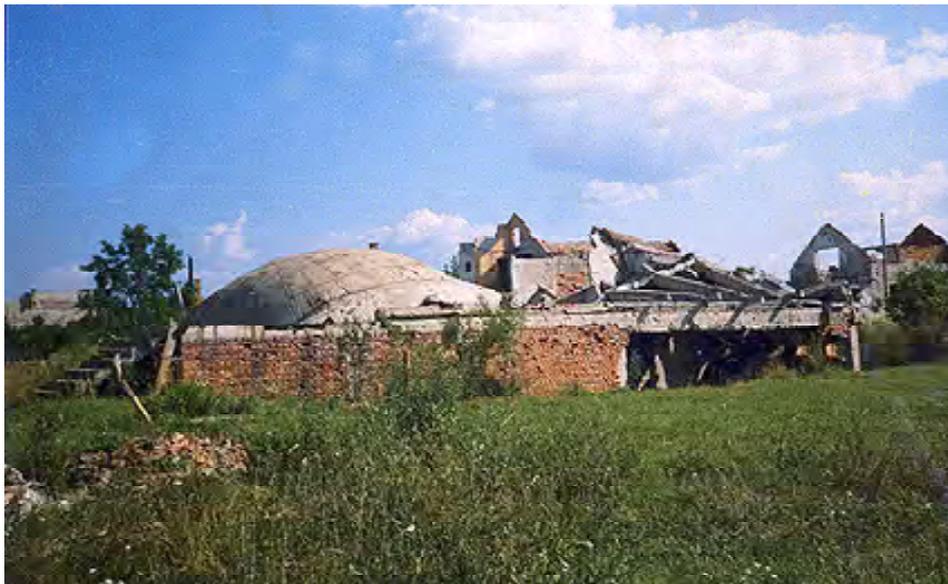
7.5 Rijeka Mosque – photo 1

Damage description: New domed mosque destroyed with explosives in 1992, only the foundations remained at the end of the war, according to photos and information supplied by the Medžlis of the Islamic Community of Brčko.

Remains of the destroyed new mosque at Rijeke at the end of the war.
Source: Medžlis of the Islamic Community of Brčko.

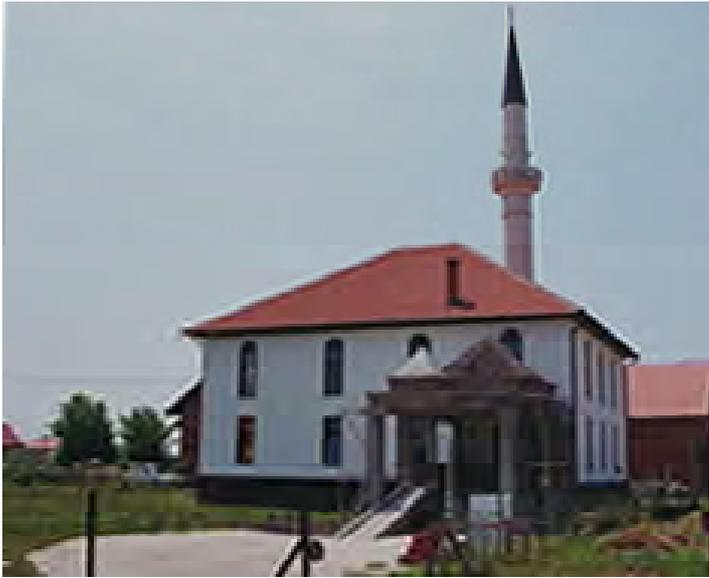
7.5 Rijeka mosque – photo 3

Newly reconstructed mosque at Rijeke, at site of the mosque that was destroyed in the war

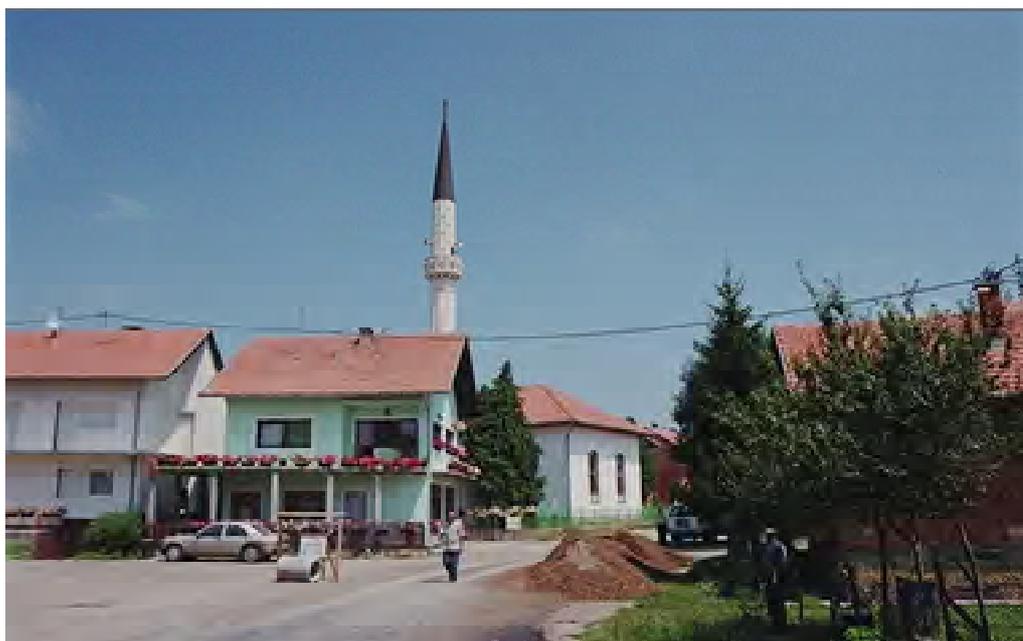
7.6 Omerbegova Mosque – photo 1

View of mosque and surrounding buildings after post-war reconstruction.

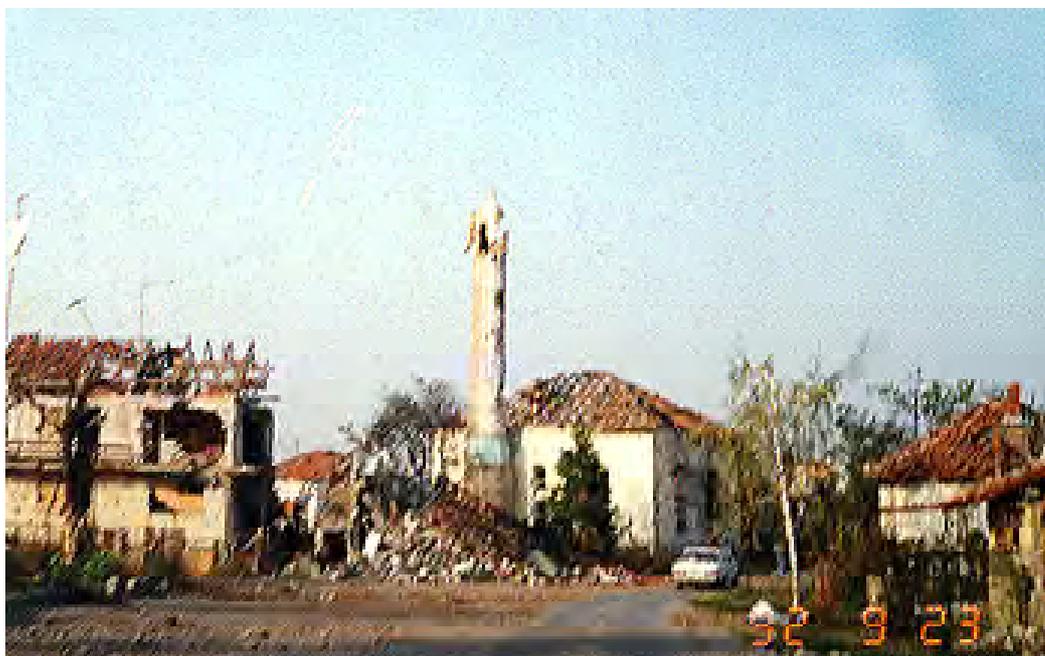
7.6 Omerbegova Mosque – photo 2

Damage description: Mosque severely damaged by shelling in 1992, minaret decapitated, roof and interior of mosque destroyed, multiple projectile impacts. Photos taken at the time document the destruction.

Same view as above, taken during early months of the war (date-stamped 23/09/1992)

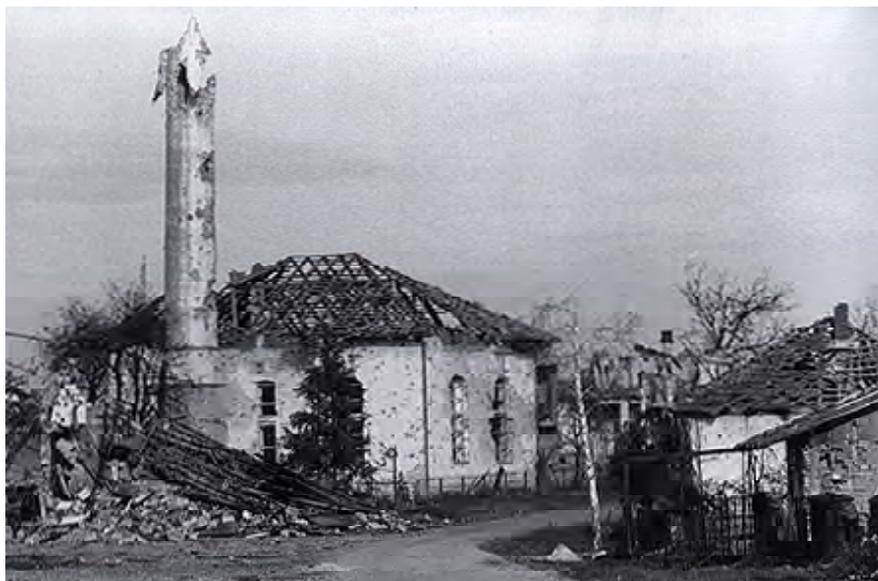
7.6 Omerbegova Mosque – photo 3

View of the damaged mosque during the war.

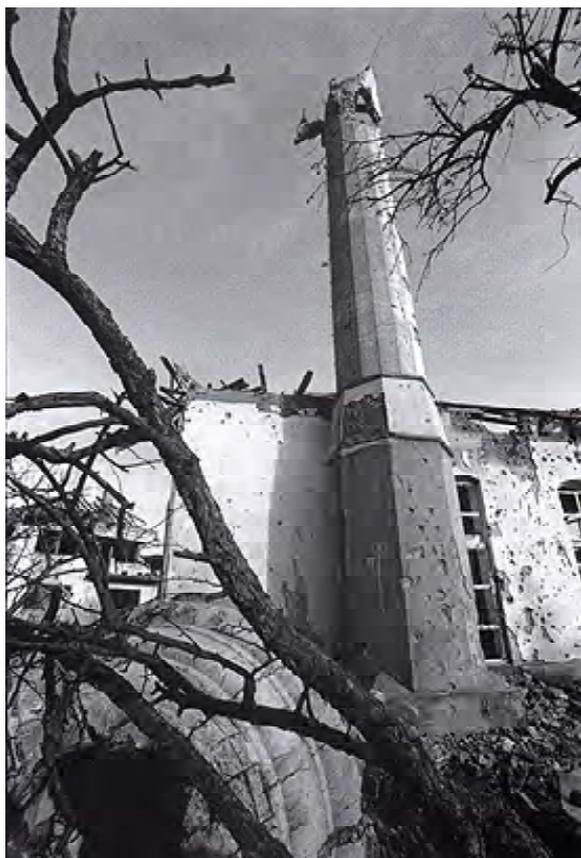
7.6 Omerbegova Mosque – photo 4

Close-up view of the Omerbegova mosque and of its decapitated minaret, its toppled *šeref* (muezzin's balcony) lying on the ground next to mosque.

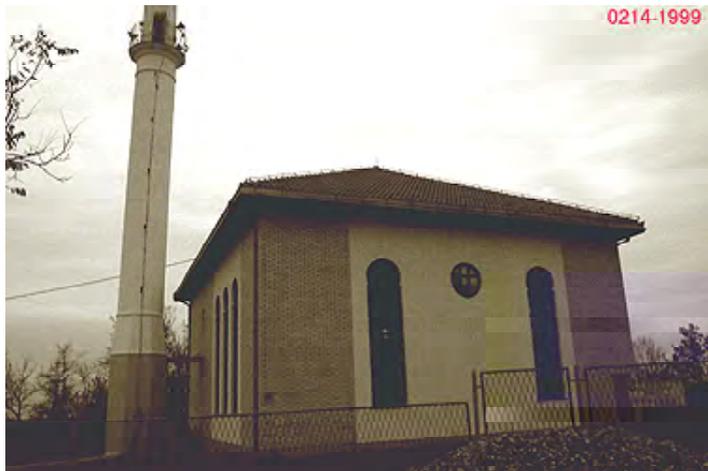
7.7 Palanka Mosque – photo 1

Damage description: Mosque roof and walls damaged by shelling, according to informant statement; mosque recently repaired. Qur'an school (mekteb), located next to the mosque, heavily damaged by shelling.

The new mosque at Palanka following postwar reconstruction (2002).

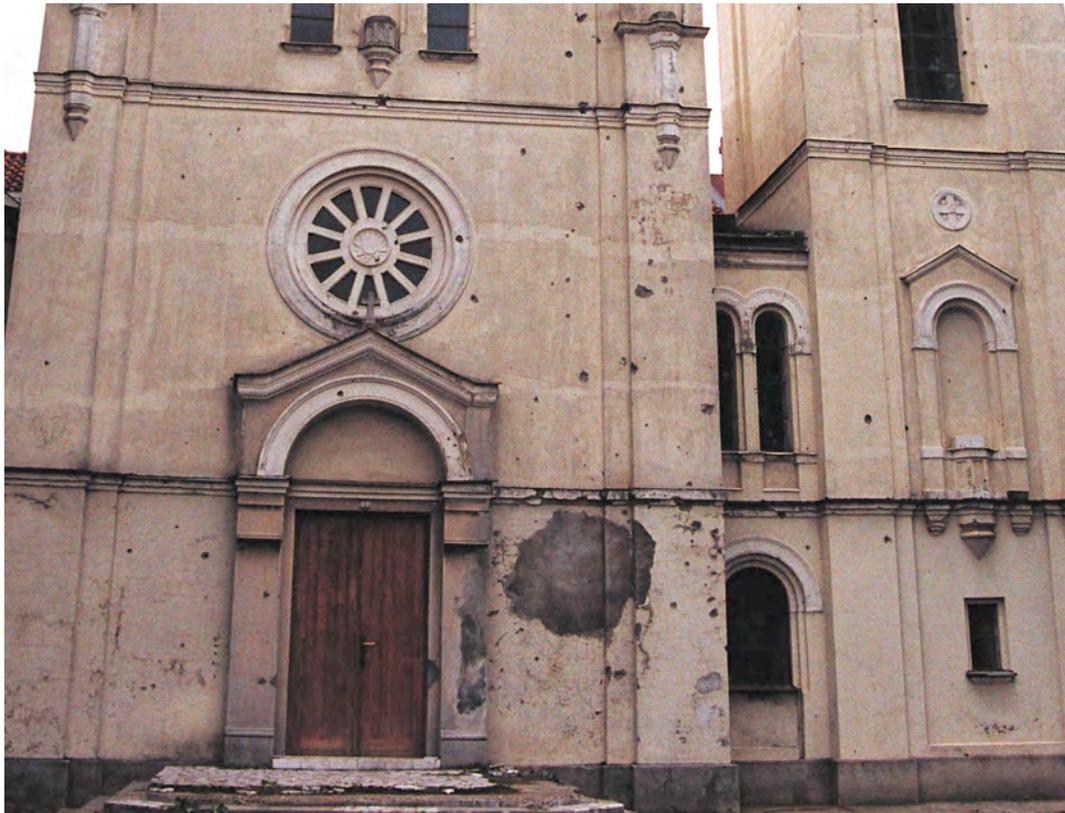
7.8 Catholic church in Brčko – photo 1

Damage description: Signs of damage to church roof and front facade (projectile impacts), front facade of church peppered with bullet holes. The church's interior was vandalised, reportedly used as a toilet by Serbs during war. The hands of all the saints' statues inside the church had been broken off, as could still be seen at time of author's visit (07/2002).

Church building in need of repairs, but appears to have suffered no structural damage.

Projectile impact crater, bullet holes in front facade of Roman Catholic church
Photo: András Riedlmayer (07/2002).

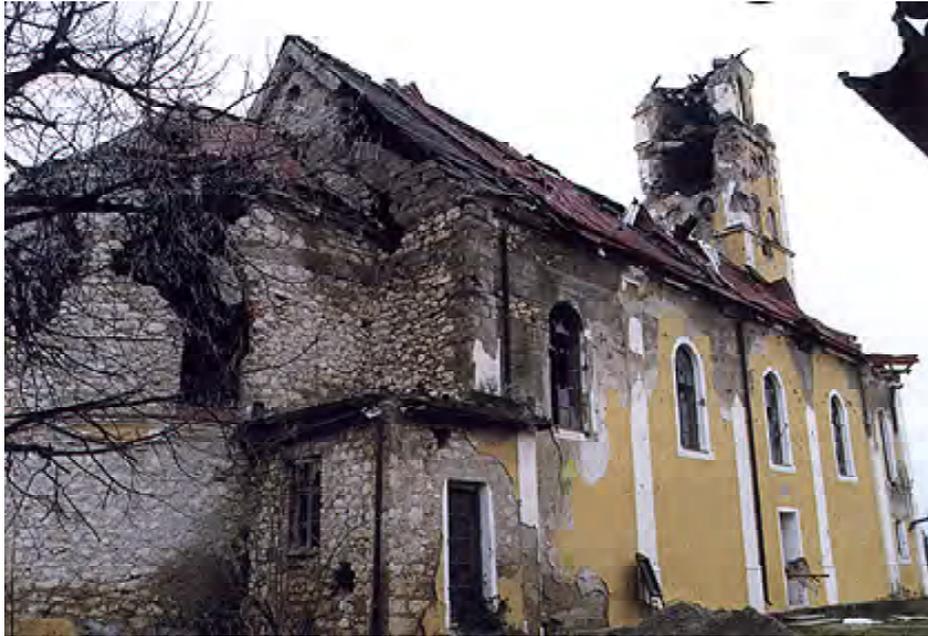
7.9 Catholic church in Dubrave – photo 1

View of church from apse side, showing damage from projectile impacts.
Photo from: Roman Catholic Ordinariate of Vrhbosna (1996).

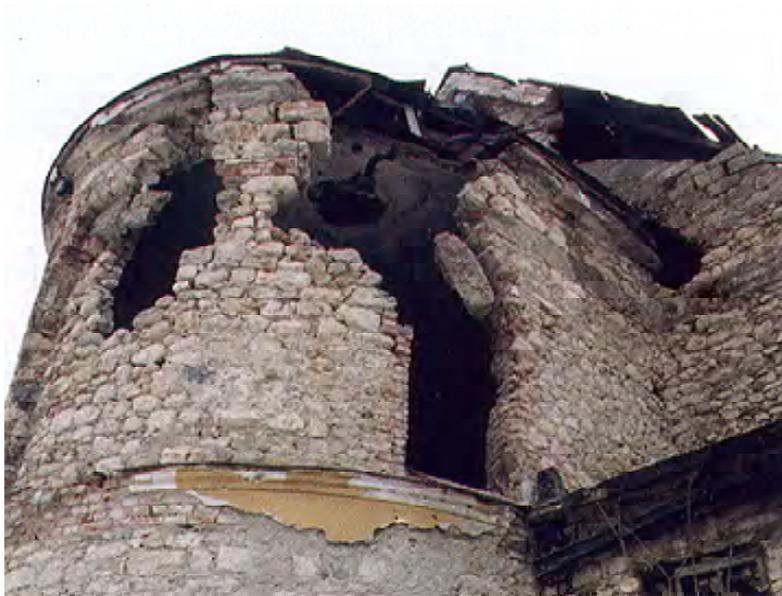
7.9 Catholic church in Dubrave – photo 2

Detail of damage to apse.
Photo from: Roman Catholic Ordinariate of Vrhbosna (1996).

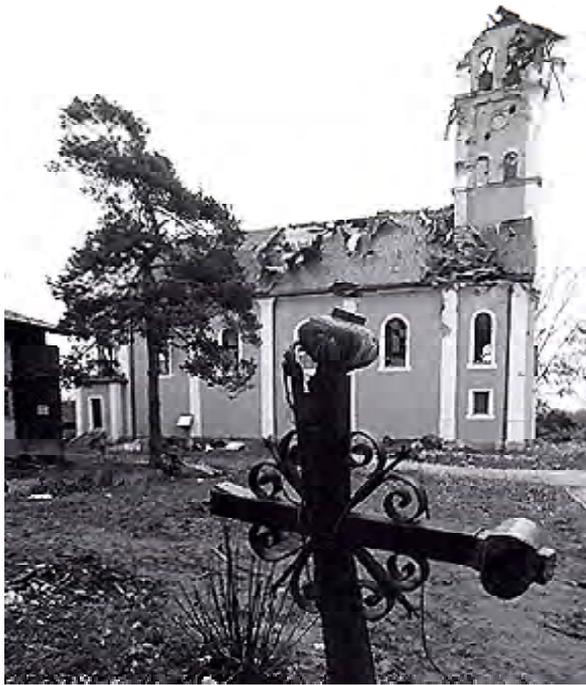
7.9 Catholic church in Dubrave – photo 3

View of church from the side, showing impacts on roof and steeple.

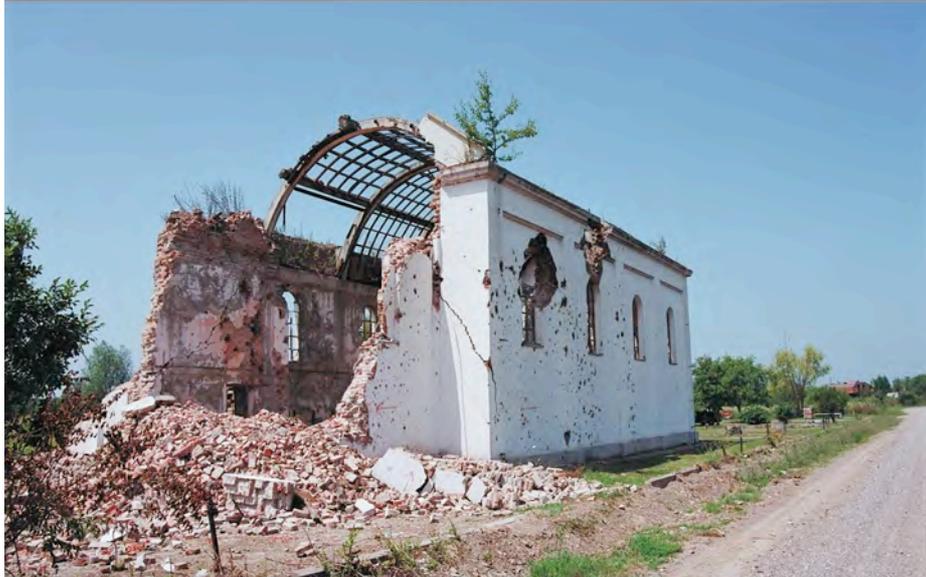
7.10 Catholic church in Gorice – photo 1

View of church from rear (altar wall), showing destruction of steeple, roof and apse.
Photo: András Riedlmayer (07/2002).

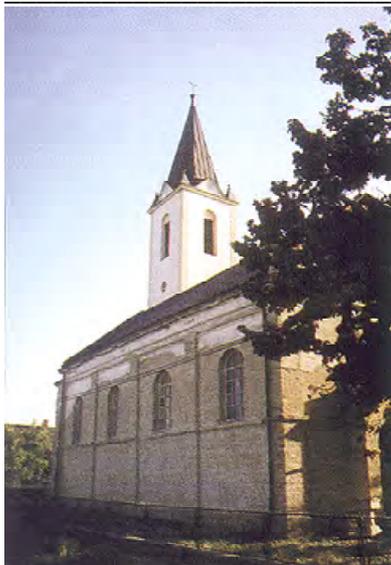
7.10 Catholic church in Gorice – photo 2

Pre-war photo of Catholic church, viewed from entrance side.
Photo from: Živković, *Raspeta crkva u Bosni i Hercegovini*

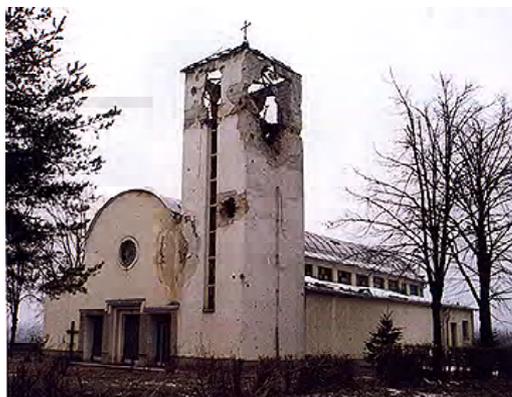
7. 11 Catholic church in Poljaci – photo 1

Damage description: Church steeple, main facade of church building, and roof damaged by multiple projectile impacts. It has been reconstructed since the war with a pitched roof (instead of the original barrel vault roof) and a pointed steeple.

Damaged Catholic church at the end of the war.

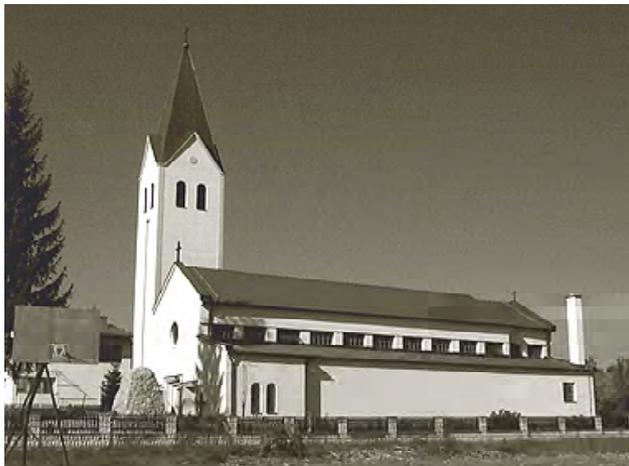
7. 11 Catholic church in Poljaci – photo 3

Catholic church at Poljaci reconstructed after the war, with new steeple and pitched roof.

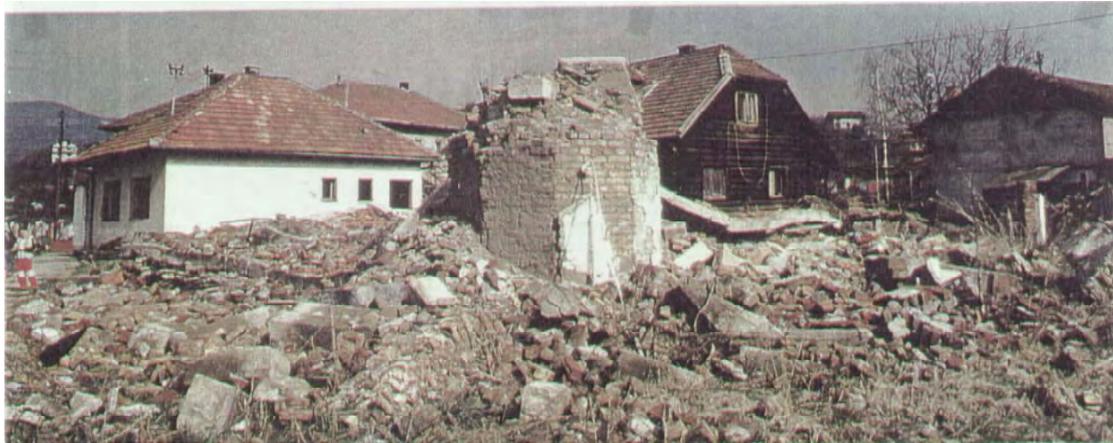
11.1 Town mosque in Stari Ilijaš – photo 1

Damage description: Mosque destroyed by explosives, site covered with large mound of rubble, only identifiable part left standing is the massive stump of the base of the destroyed minaret.

Remains of the old Town Mosque in Ilijaš at end of war

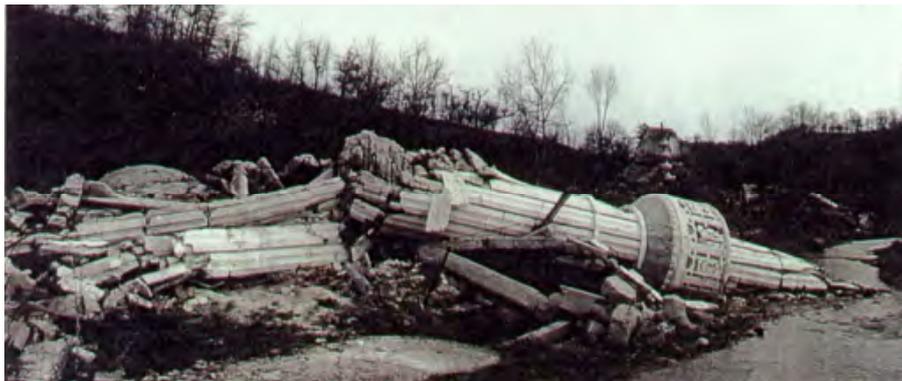
11.3 DonjaMisoča Mosque – photo 2

Ruins of the Donja Misoča Mosque at end of war (1996).
photo from: Islamic Community of Bosnia and Herzegovina.

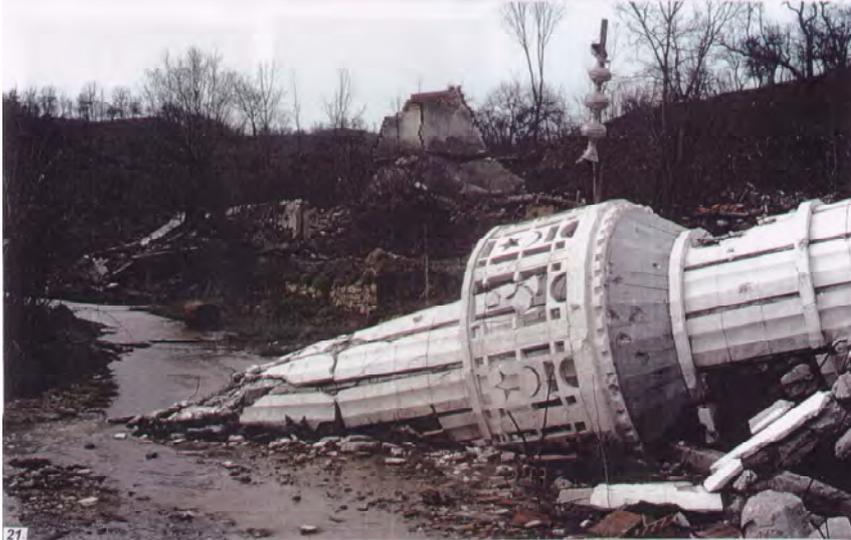
11.3 Donja Misoča Mosque – photo 3

Ruins of the Donja Misoča Mosque at end of war (1996).
Photo from: Islamic Community of Bosnia and Herzegovina.

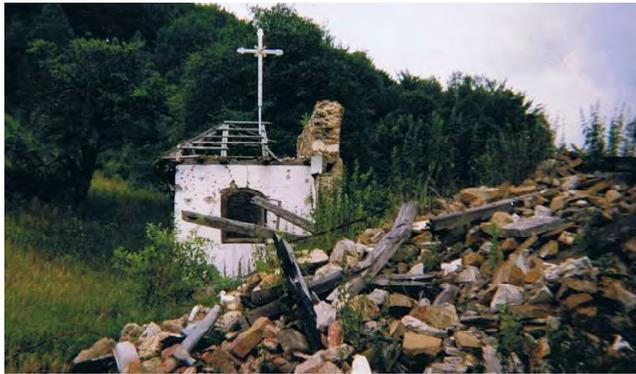
11. 5 Catholic Church at Taračin Do – photo 2

Remains of church at end of war, with top of church steeple on its side next to rubble.
Photo (1996): Roman Catholic Ordinariate of Vrhbosna.

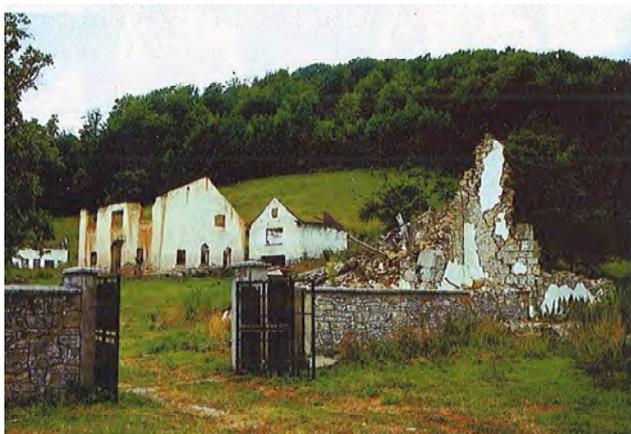
11. 5 Catholic Church at Taračin Do – photo 3

Ruins of church at end of war, viewed from the front, destroyed parish house at left.
Photo (1996): Roman Catholic Ordinariate of Vrhbosna.

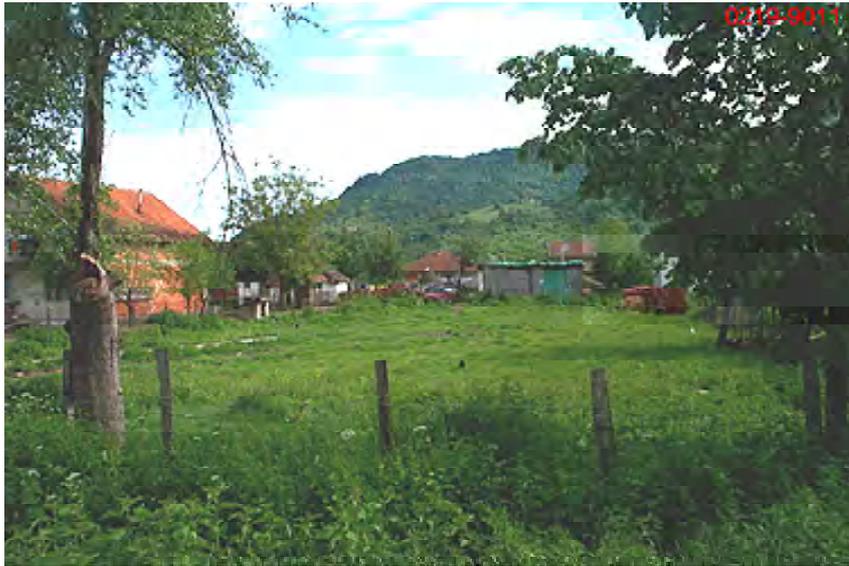
22.1. Đulići mosque – photo 1

Site of razed Đulići mosque . Note line of hills in rear of site.
Photo (05/2002): ICTY OTP 0219-9011

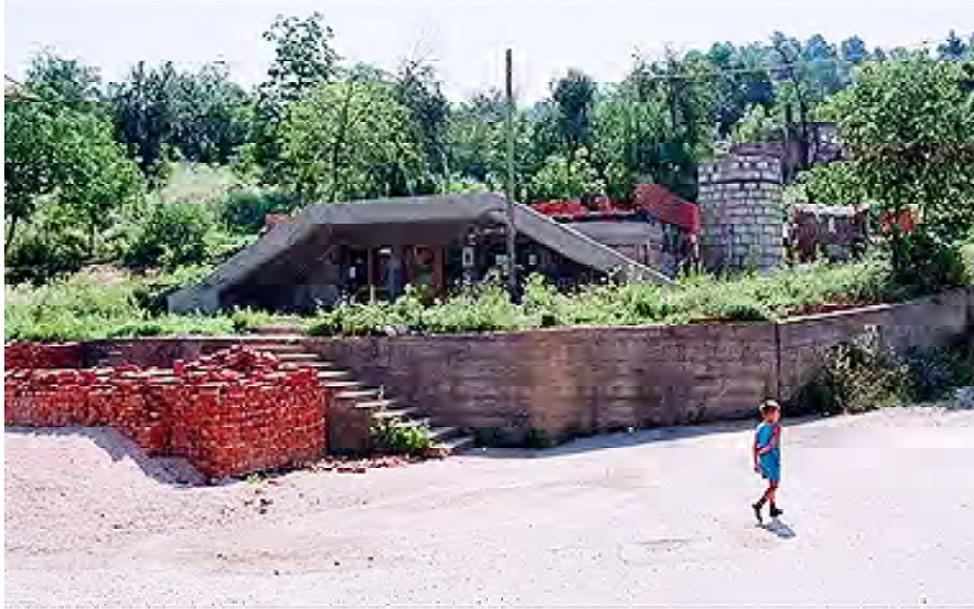
22.2. Kula Grad mosque – photo 1

Foundations of Kula Grad mosque, stump of toppled minaret at right.
Photo by: András Riedlmayer (07/2002)

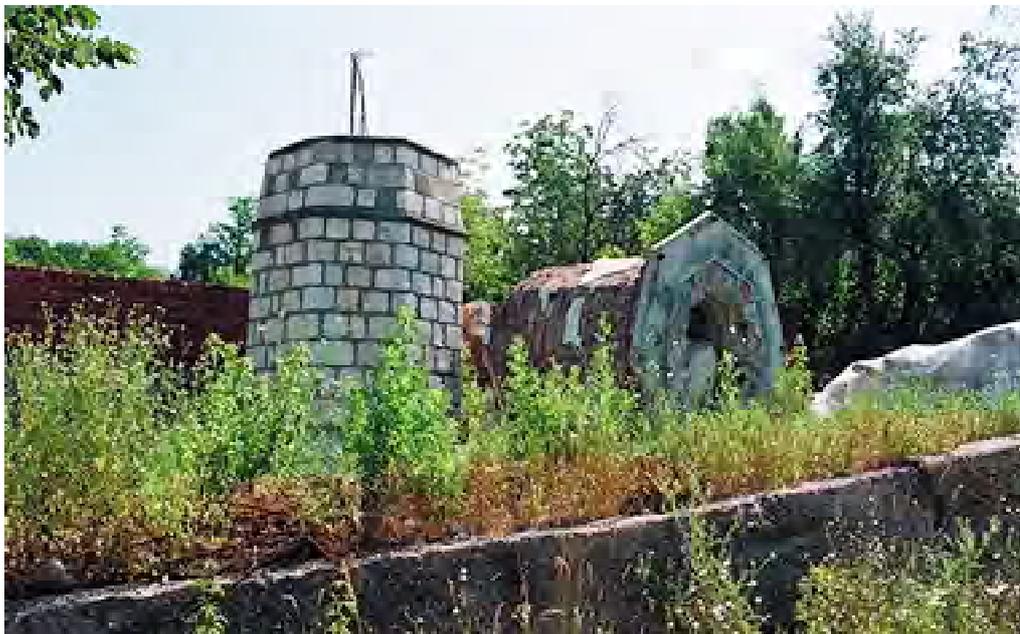
22.2. Kula Grad mosque – photo 2

Stump and part of toppled shaft of minaret.
Photo by: András Riedlmayer (07/2002)

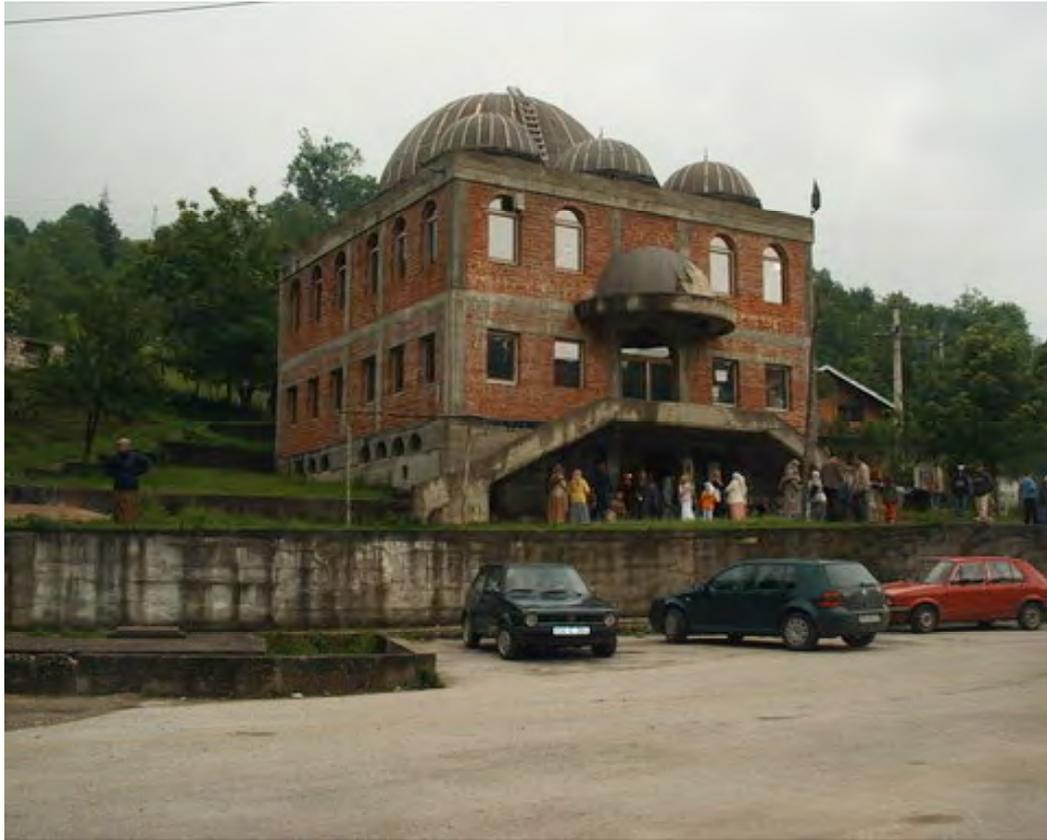
22.2. Kula Grad mosque – photo 3

The Kula Grad mosque under reconstruction.

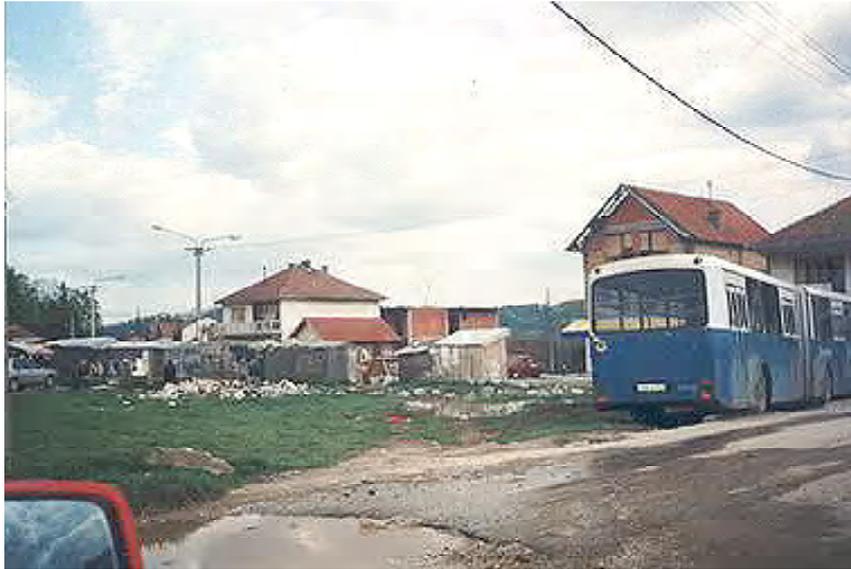
22.3. Kozluk mosque – photo 1

Site of razed Kozluk mosque, with rubbish containers and parked buses.
Photo (2001): Medžlis of the Islamic Community of Zvornik.

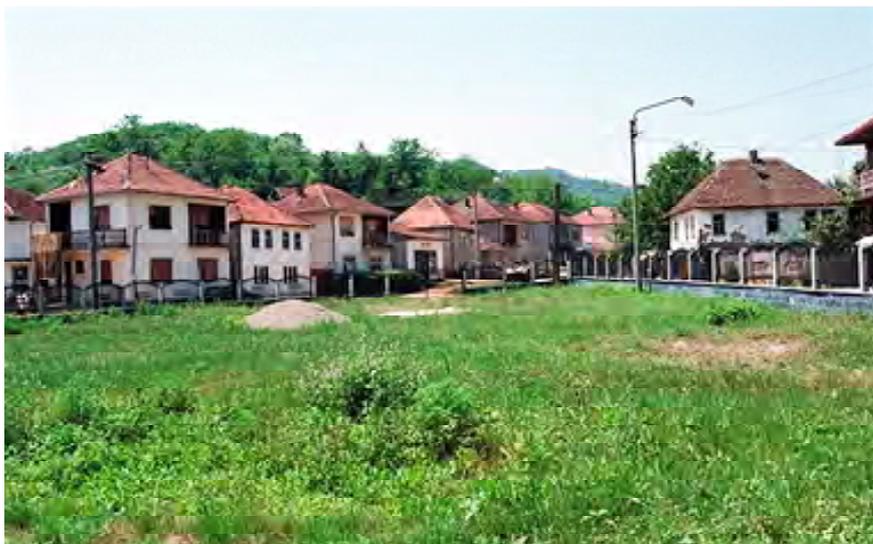
22.3. Kozluk mosque – photo 2

Site of razed Kozluk mosque, rubbish bins removed and site newly fenced in.
Photo (07/2002): András Riedlmayer

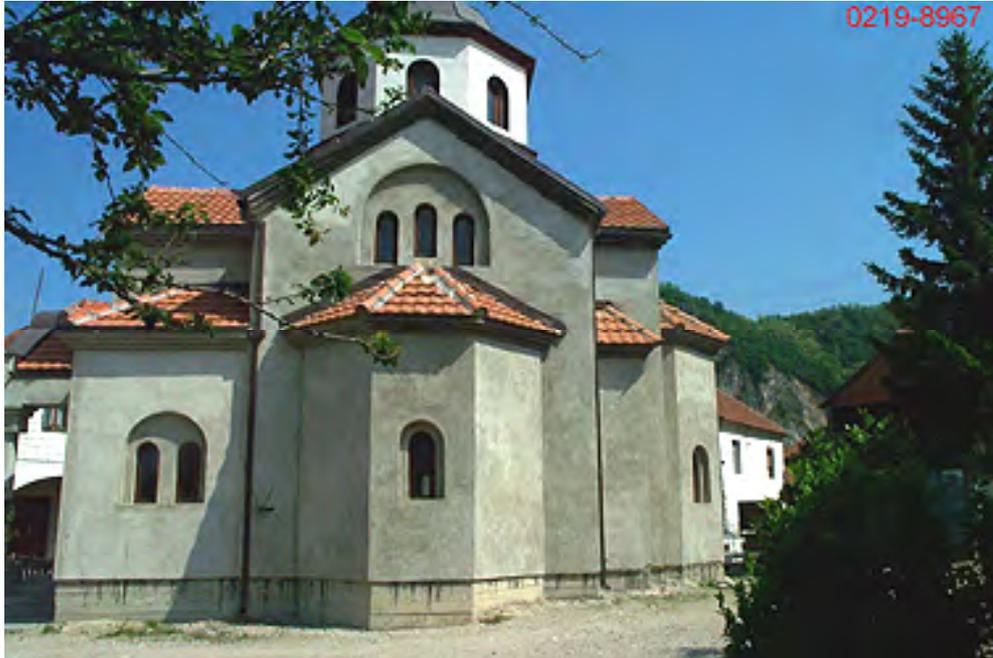
22.4. Divič mosque – photo 1

New Serb Orthodox Church built on site of razed Divič mosque.
Photo (05/2002): ICTY OTP 0219-8967

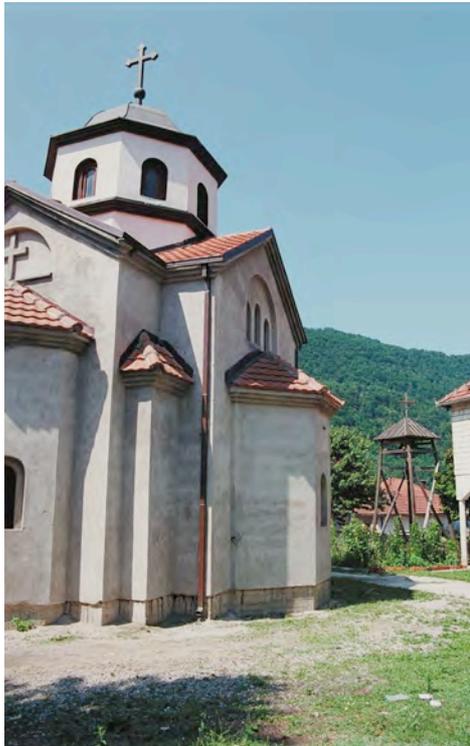
22.4. Divič mosque – photo 4

New Serb Orthodox church built on site of the destroyed Divič mosque.
Photo by: András Riedlmayer (07/2002)

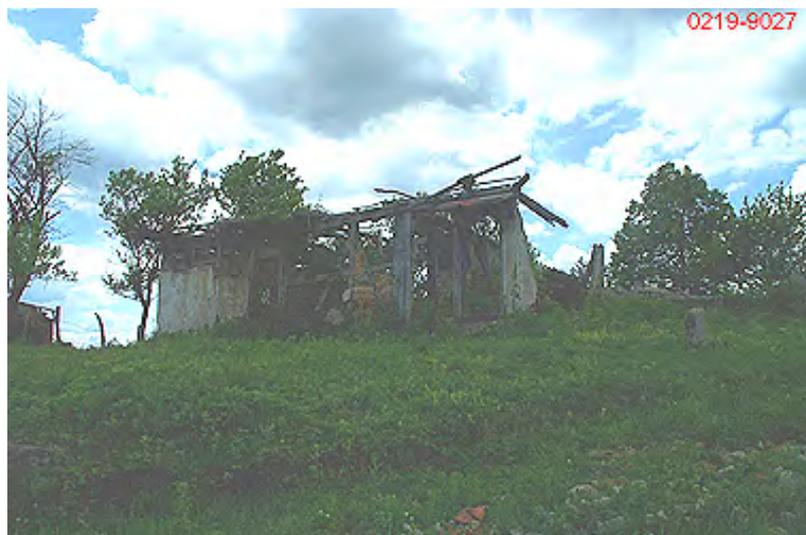
**22.5. Snagovo mosque – photo 1**

Remains of the destroyed old mosque at Snagovo–Gornja Glumina.
 Photo (05/2002): ICTY OTP 0219-9027

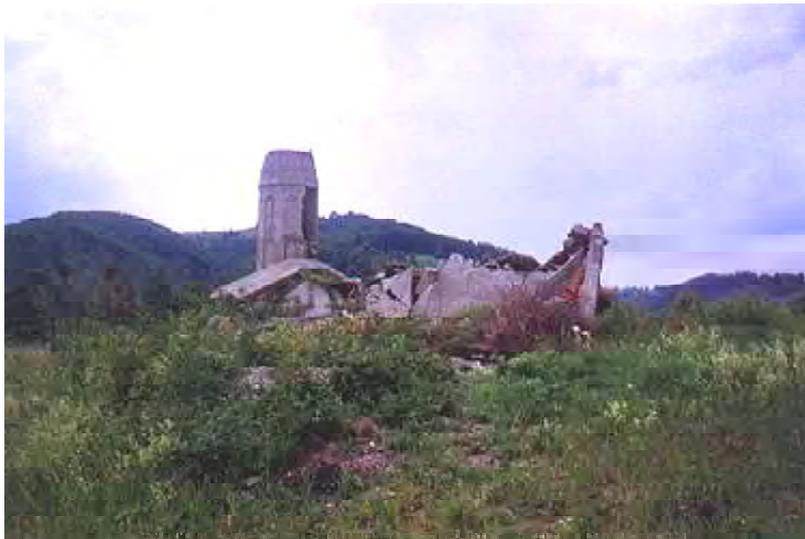
22.6. Novo Selo mosque – photo 1

Remains of the Novo Selo mosque after the war, stump of minaret at center left. Photo (2001): Medžlis of the Islamic Community of Zvornik.

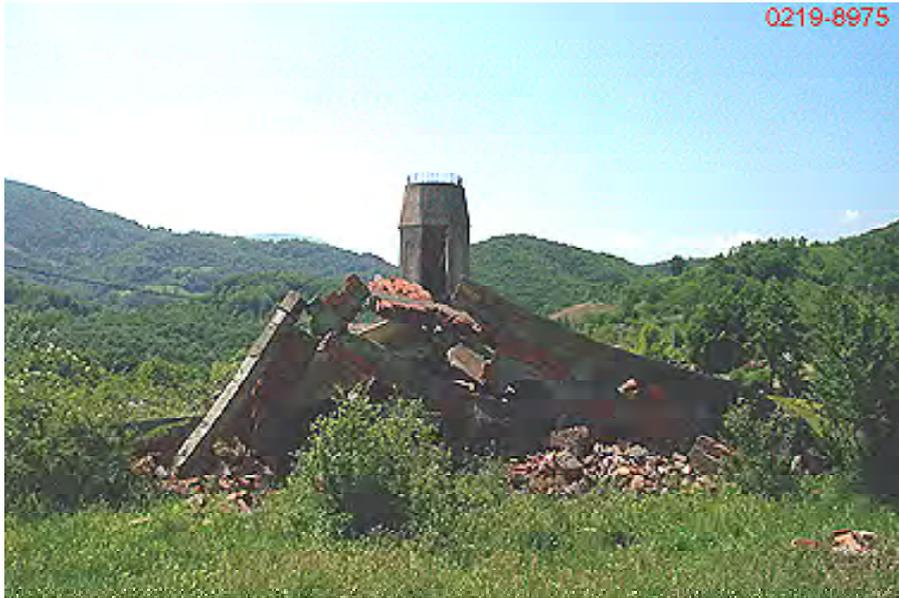
22.6. Novo Selo mosque – photo 2

Remains of the Novo Selo mosque, stump of minaret at center.

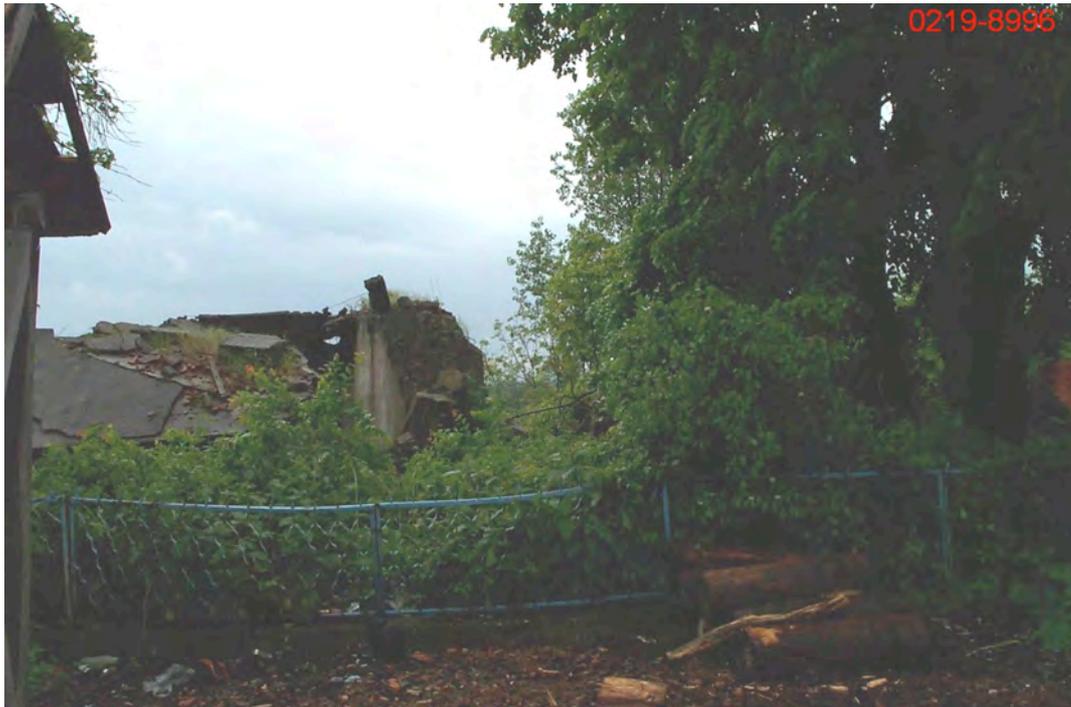
Damage description: Mosque destroyed by blast, most of building collapsed, only stump and rubble of toppled minaret and broken fragments of perimeter walls remain.

22.7. Skočić mosque – photo 1
Ruins of Skočić mosque after the war
Photo (05/2002): ICTY OTP 0219-8996

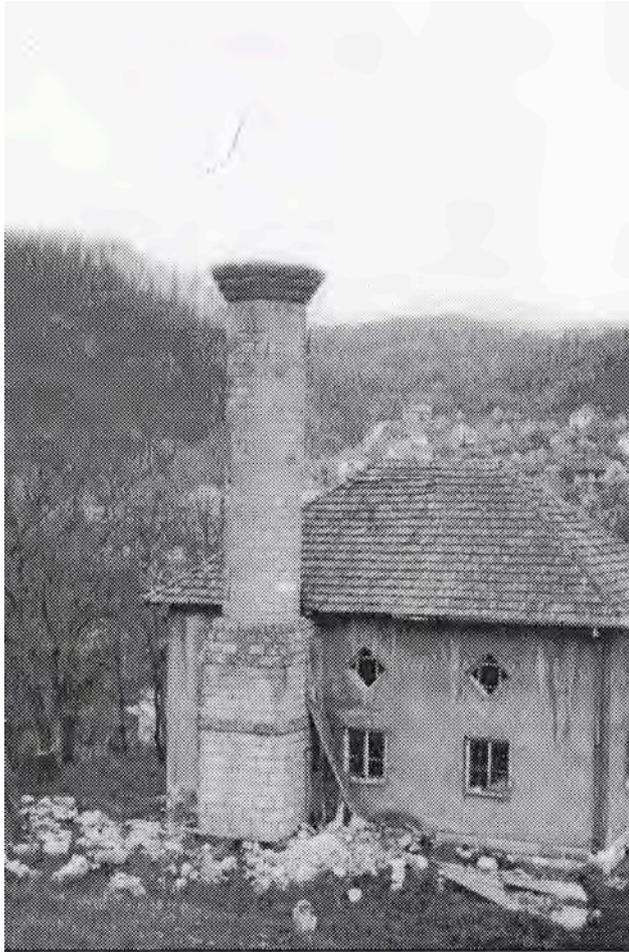
22.8. Svrake mosque – photo 1
Photo published in: M.Tokača (1995).

Damage description: Minaret decapitated by projectile impact, the mosque's windows shot out, rubble of minaret lying on the ground next to the mosque.

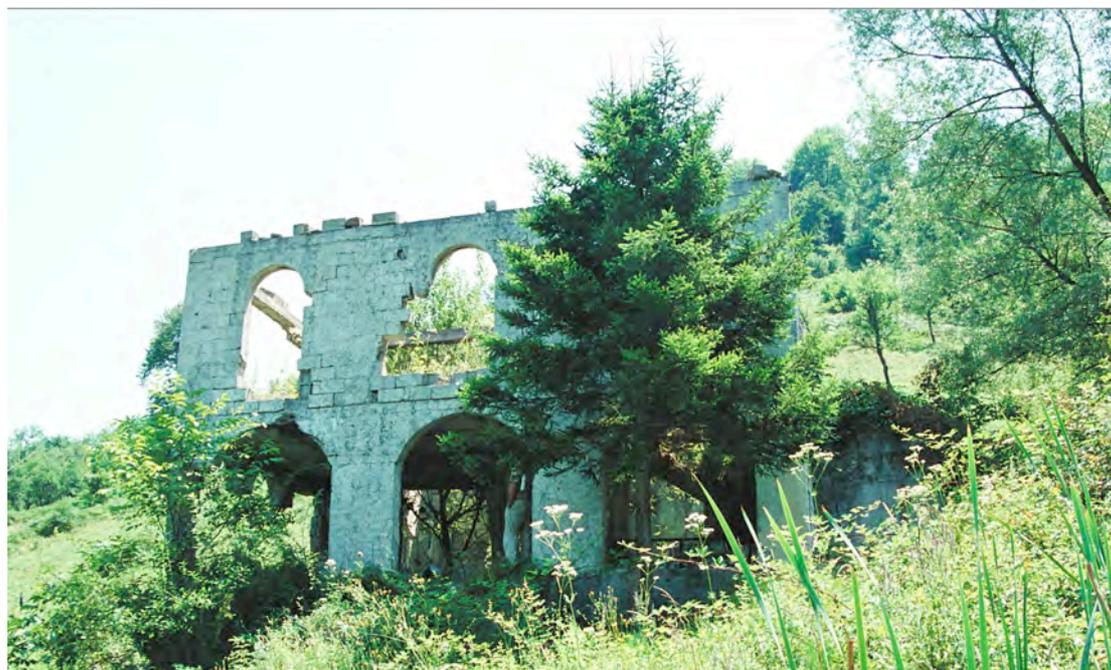
**22.9. Drinjača mosque**

Damage description: Mosque heavily damaged by blast, only a stump of the minaret remains, roof destroyed, interior gutted, perimeter walls partly destroyed by blast but some sections remain standing to roofline. The mosque's interior is open to the sky and full of rubble, with tree saplings and other vegetation growing in it.

Entrance façade of the Drinjača, viewed from the north, stump of the minaret at right. Photo by: András Riedlmayer (07/2002).
