Municipality: 7. Brčko

7.1 Bijela Mosque

Neighborhood:	Kolobara
Town:	Brčko
GPS:	44°52'47.6"N 18°48'13.9" E
Construction:	19 th century (1881, rest. 1893)
Historical period:	Austro-Hungarian
Official status:	listed monument
Building use:	religious
Building type:	Mosque
Building setting:	city
Building condition:	completely destroyed under reconstruction

Damage description: Mosque completely destroyed, ruins razed, building materials removed.

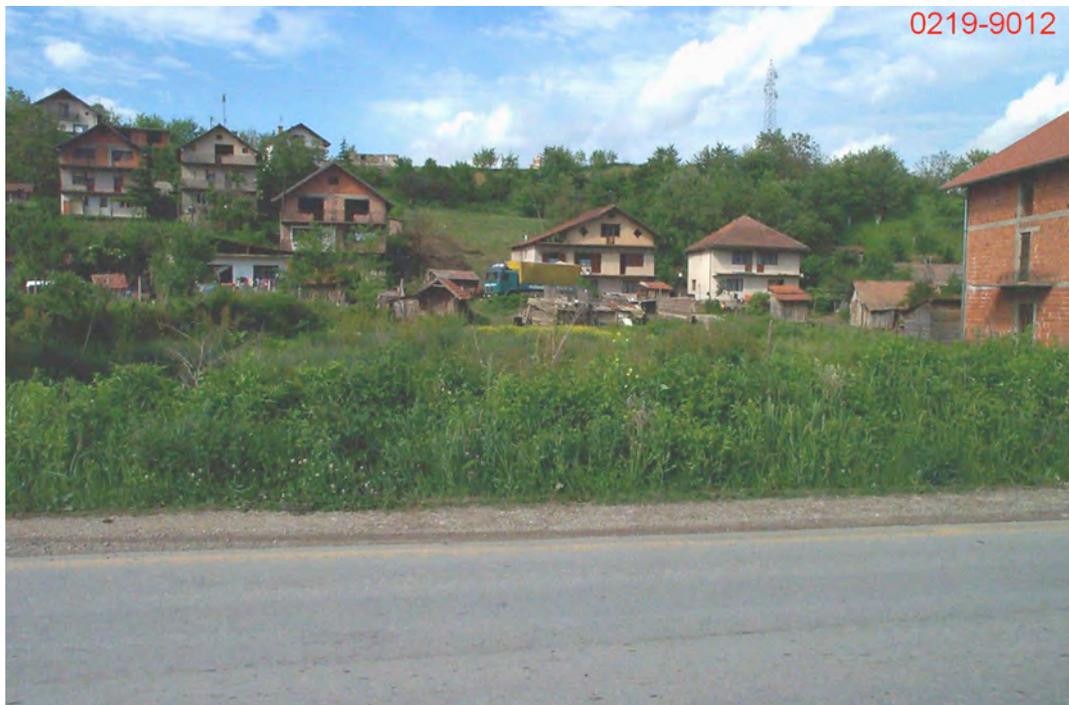
22.10. Glumina mosque

Damage description: Mosque completely destroyed, site cleared, only a mound overgrown with vegetation remained after end of war.

Empty site of the Glumina mosque after the war.

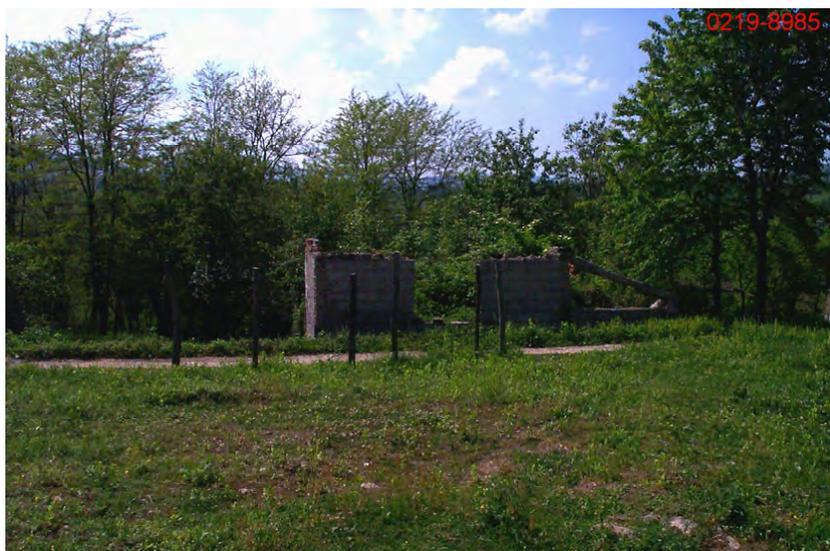
22.11. Donja Kamenica mosque

Damage description: The small mosque is almost destroyed, its roof gone, interior gutted, only parts of the perimeter walls remain in photo taken after the war.

Ruins of the Donja Kamenica mosque after the war.

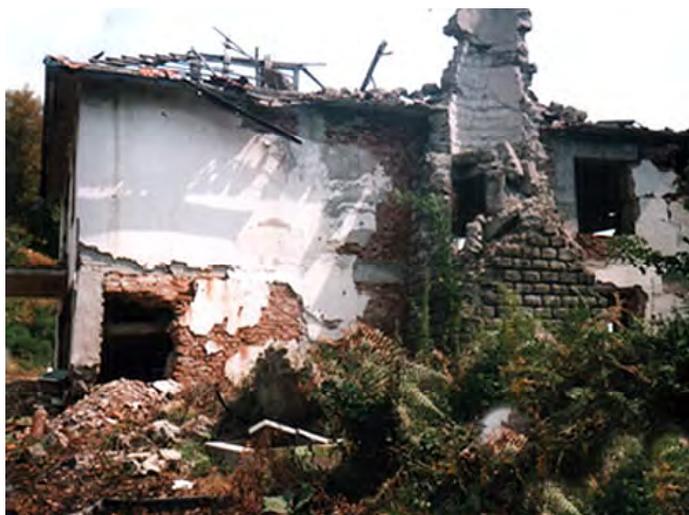
22.12. Gornja Kamenica mosque

In this photo, the old mosque appears heavily damaged by multiple projectile impacts, the stone minaret shattered above its base, the mosque's roof caved in and the interior gutted, the perimeter walls damaged but still standing to the roofline.

Old mosque at Kamenica Gornja after the end of the war.

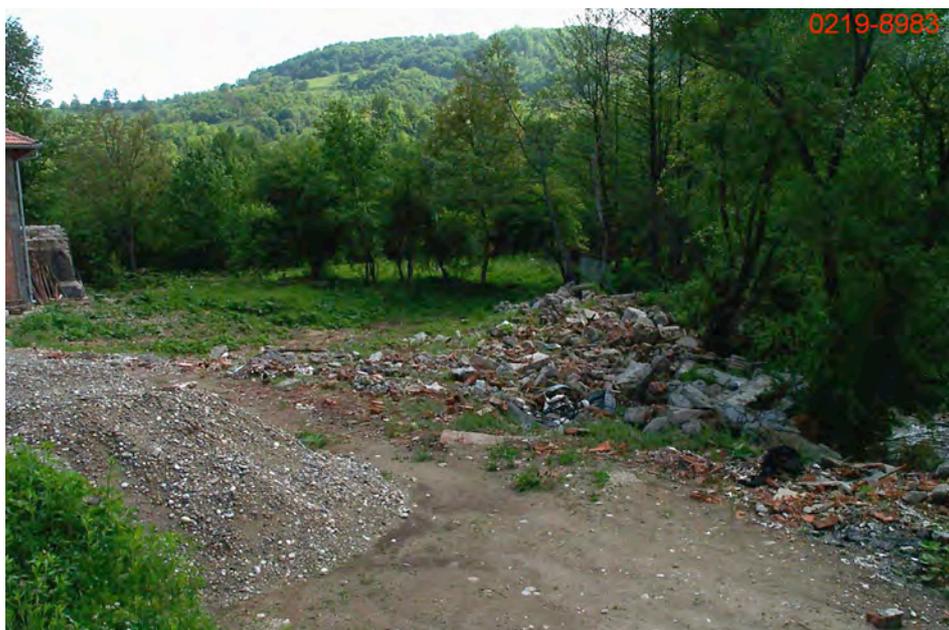
22.12. Gornja Kamenica mosque – photo 1

Damage description: In a photo taken by ICTY OTP investigators in May 2002, a new mosque was under reconstruction next to the site of the old mosque in Kamenica Gornja; the remains of the old mosque had been cleared and only a pile of rubble was to be seen at the edge of the site.

Remains of old Gornja Kamenica mosque , new mosque under construction at left

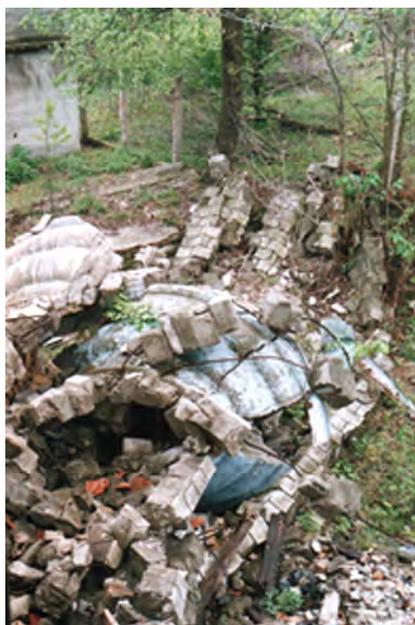
**22.13. Klisa mosque – photo 1**

Damage description: The mosque was damaged in May 1992, its roof and minaret and the interior destroyed, the walls badly damaged, according to information from the Medžlis of the Islamic Community of Zvornik. A photo taken in 2000 shows the destroyed minaret in pieces, lying on the ground.

Remains of the destroyed minaret of the Klisa mosque after the end of the war.

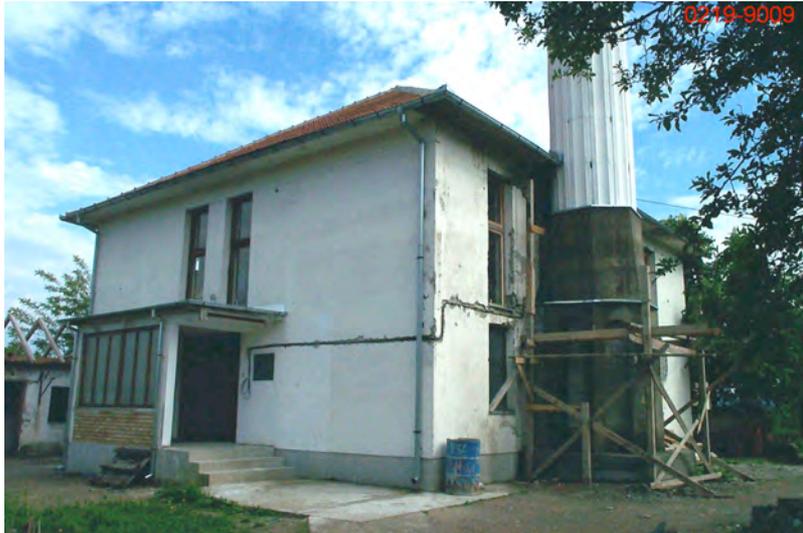
22.13. Klisa mosque – photo 2

Klisa mosque undergoing reconstruction, scaffolding around newly rebuilt minaret.
photo (05/2002): ICTY OTP 0219-9009

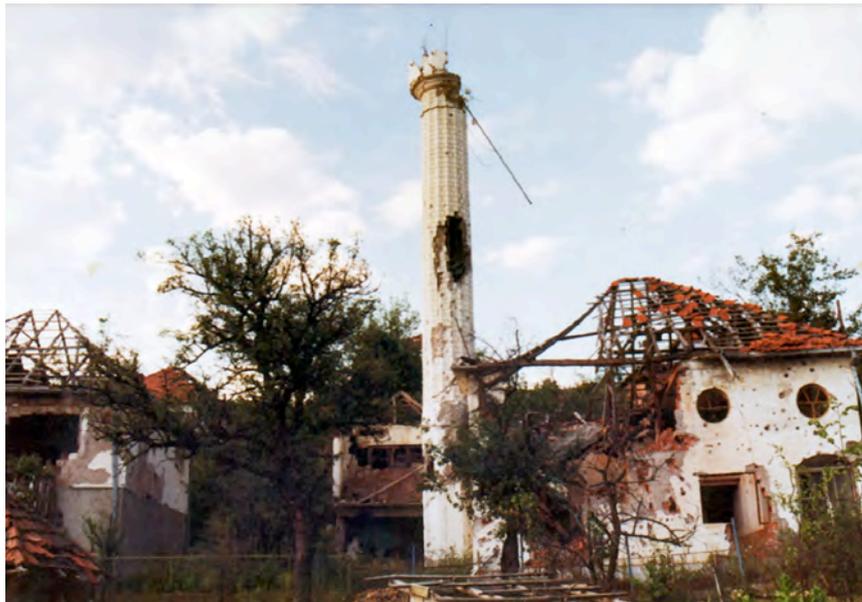
22.14. Kovačevići mosque – photo 1

View of mosque showing damage from projectile impacts.

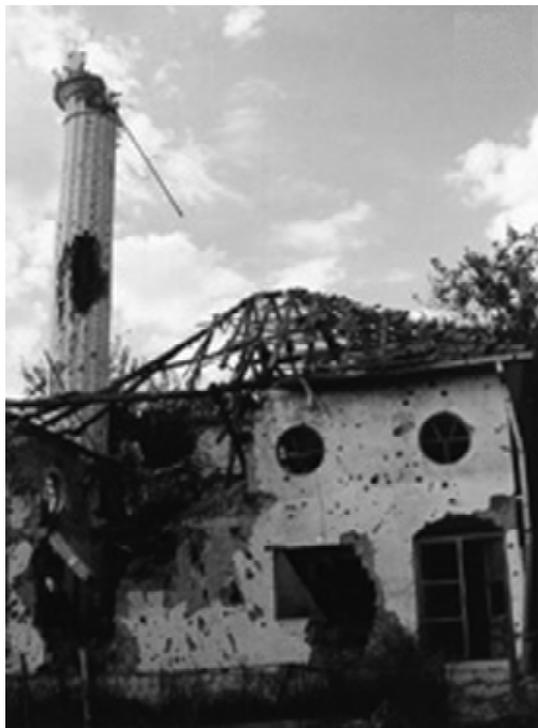
22.14. Kovačevići mosque – photo 2

Damage description: Mosque burned out, roof destroyed, interior gutted, minaret decapitated above its balcony, large projectile impact hole in lower half of minaret, extensive damage to perimeter walls.

Close-up view, showing damage from projectile impacts.

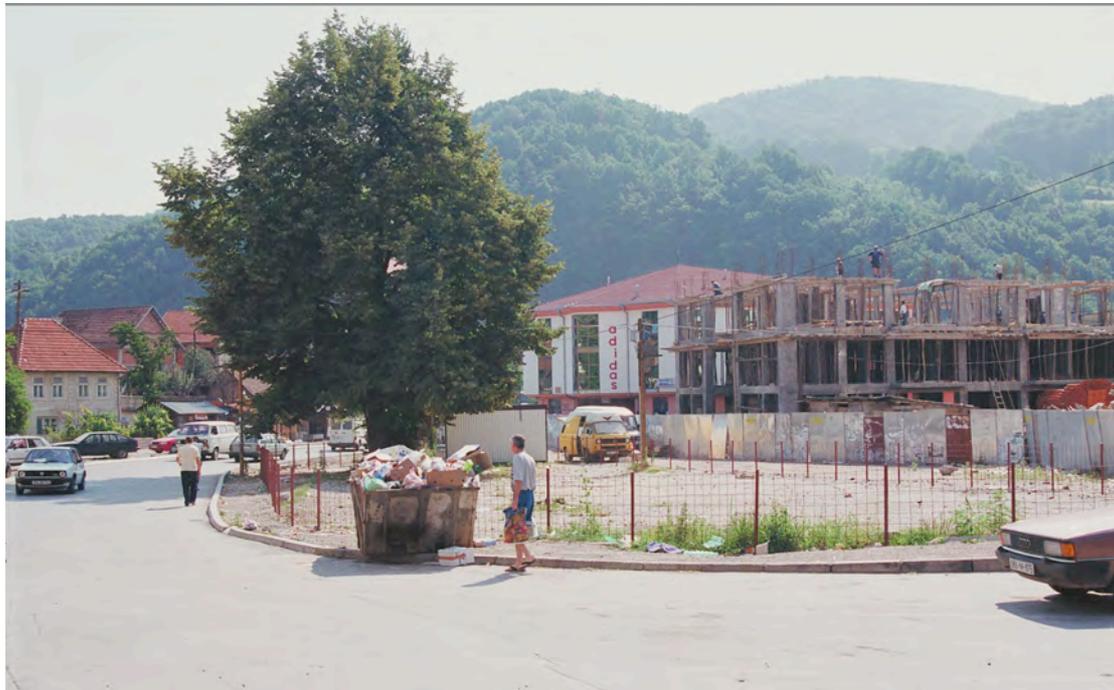
22.15. Rijeka mosque – photo 1

Damage description: Mosque completely destroyed, ruins razed, site levelled and surfaced with gravel. Only an old lime tree (linden), of the sort traditionally planted next to mosque entrances, still remains.

Site of razed Rijeka mosque, view looking east, with rubbish bin in front of linden tree at former mosque entrance, new construction at right encroaching on the site. Photo (07/2002) by András Riedlmayer

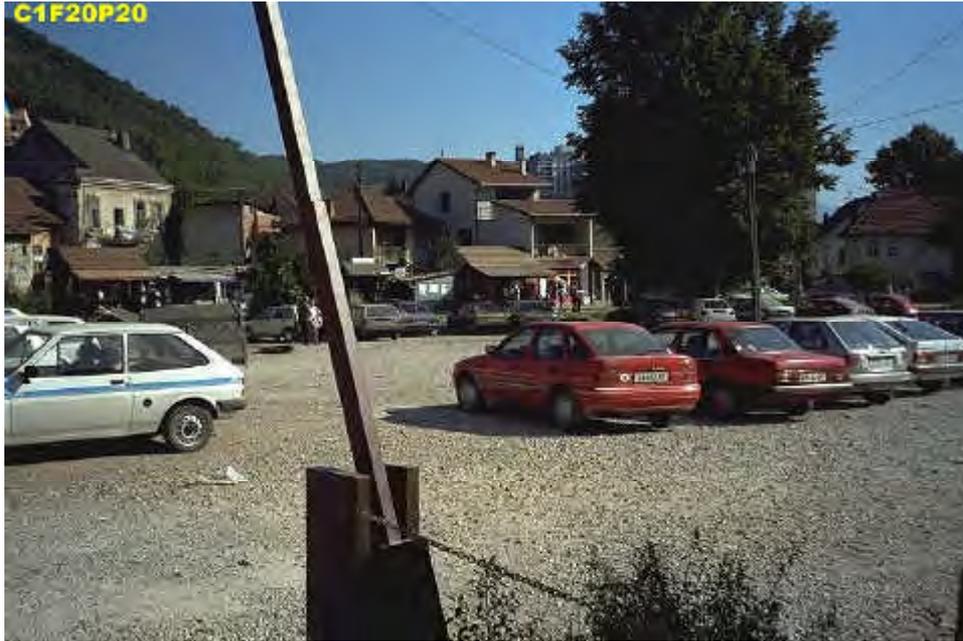
22.15. Rijeka mosque – photo 2

Site of razed Rijeka mosque being used as parking lot. View looking to the west from eastern end of the site, towards linden tree at the former mosque entrance. Photo (1998): Council of Europe - Cultural Heritage Division.

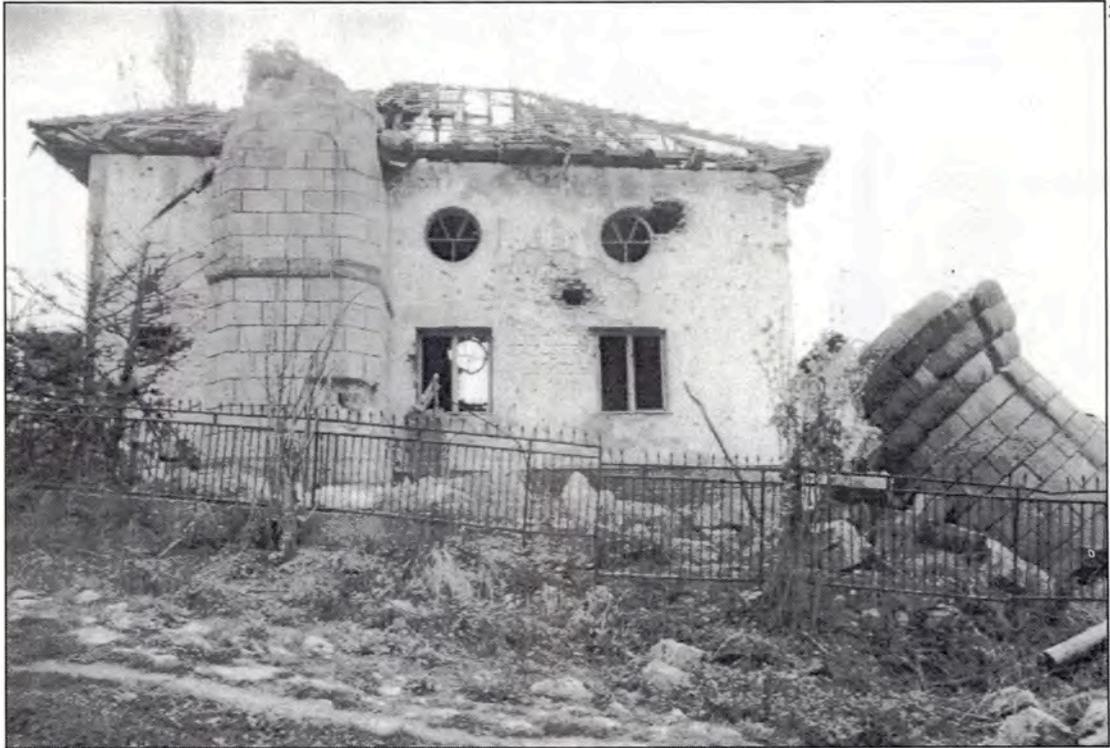
22.16. Selimovići mosque – photo 1

View of the damaged mosque. Note piece of the toppled minaret at right.

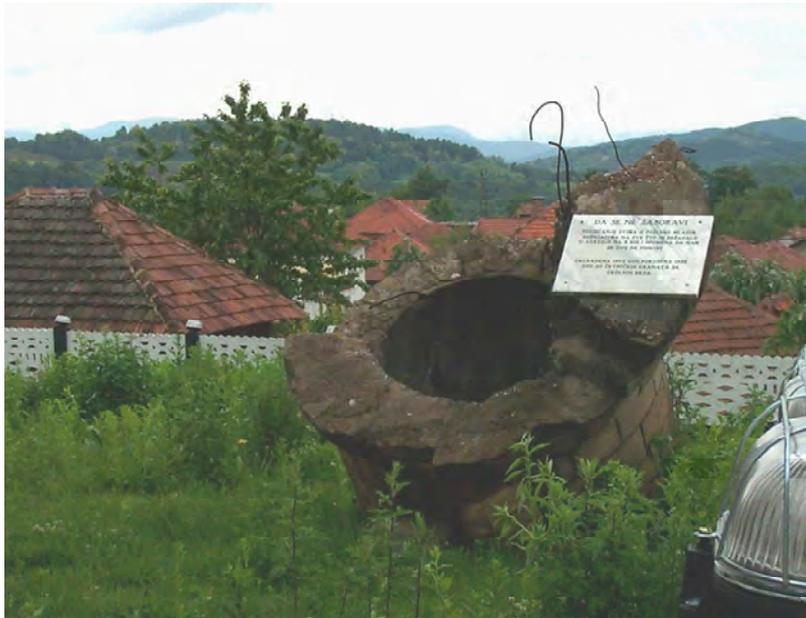
22.16. Selimovići mosque – photo 2

Piece of the toppled minaret, with memorial plaque

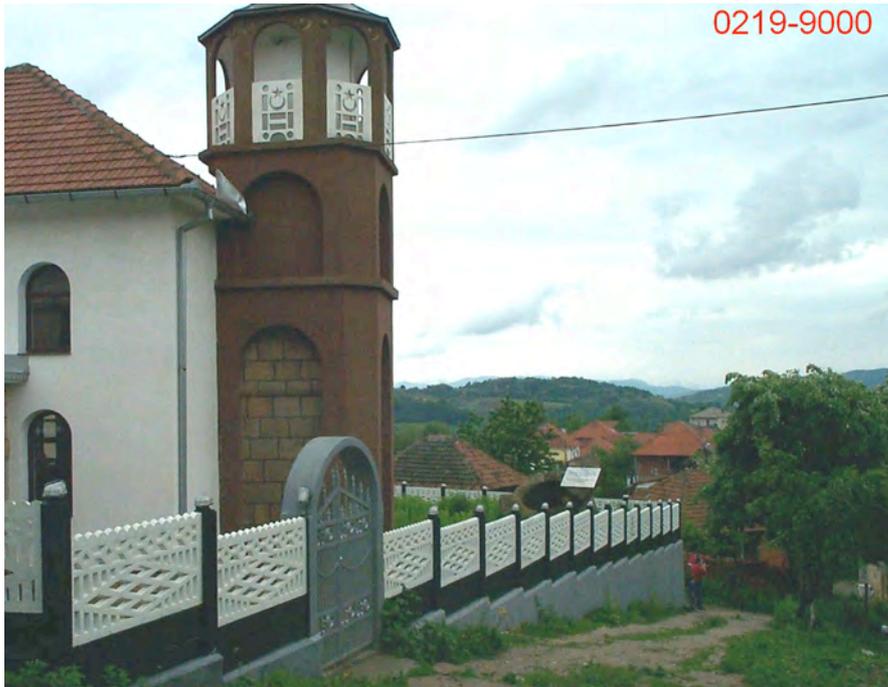
22.16. Selimovići mosque – photo 3

Rebuilt mosque; fallen minaret and plaque can be seen at right, inside fence.
Photo (05/2002): ICTY OTP 0219-9000

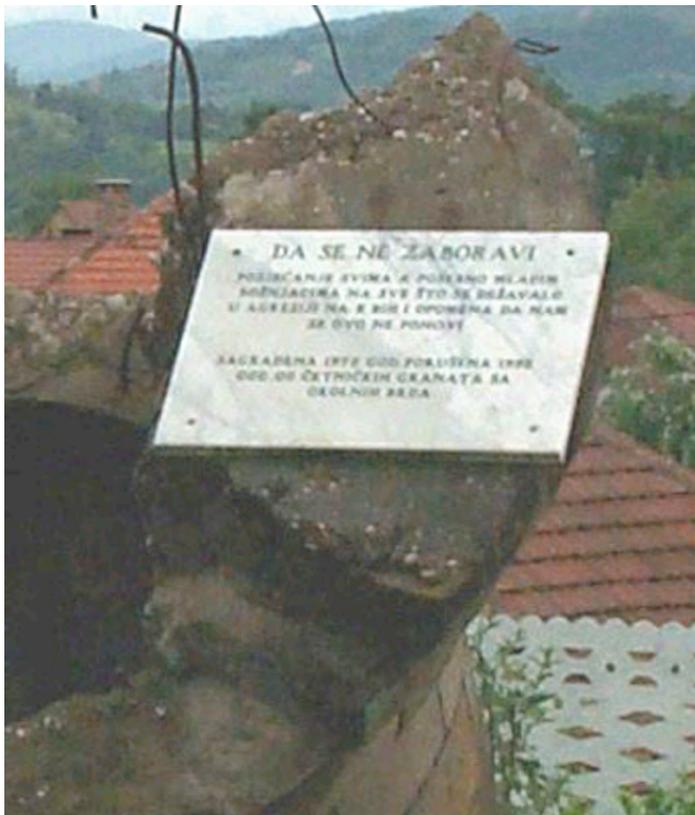
22.16. Selimovići mosque – photo 4

Plaque with memorial inscription on preserved piece of the fallen minaret.
Photo (05/2002): ICTY OTP 0219-9001 (detail)

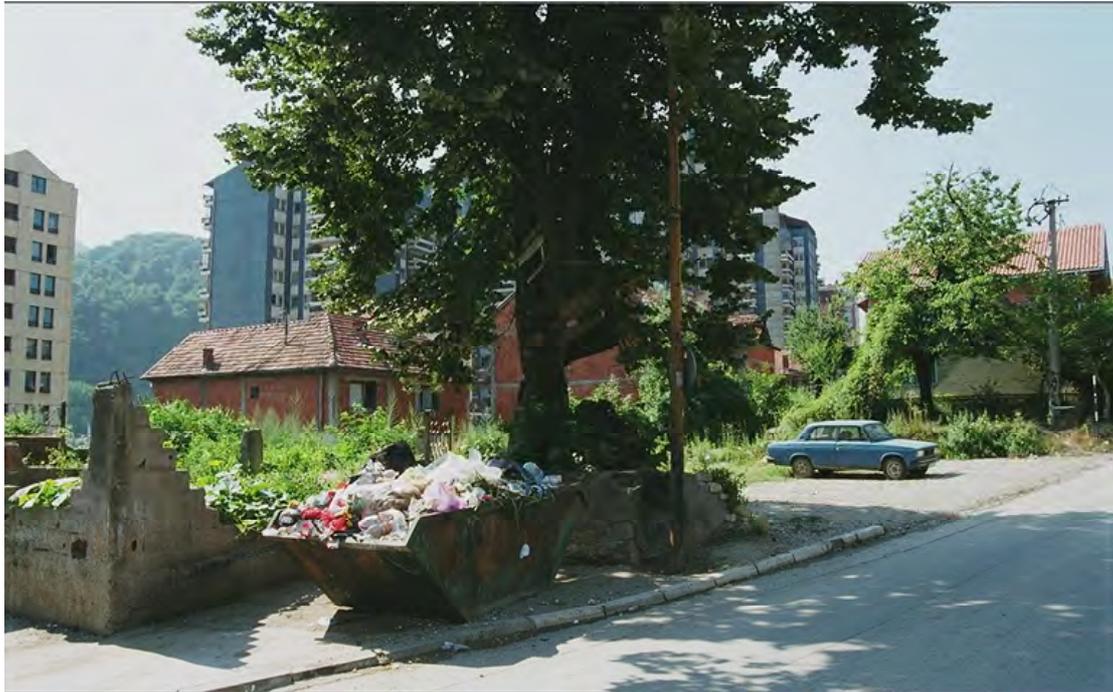
22.17. Beksuja mosque – photo 1

Damage description: Mosque completely destroyed, the ruins razed; only fragments of its foundations and a lime tree (linden) of the kind traditionally planted next to the entrances Bosnian mosques, remained on the site at time of the author's 2002 visit.

Site of razed Beksuja mosque, with rubbish bin in front of linden tree at former mosque entrance.

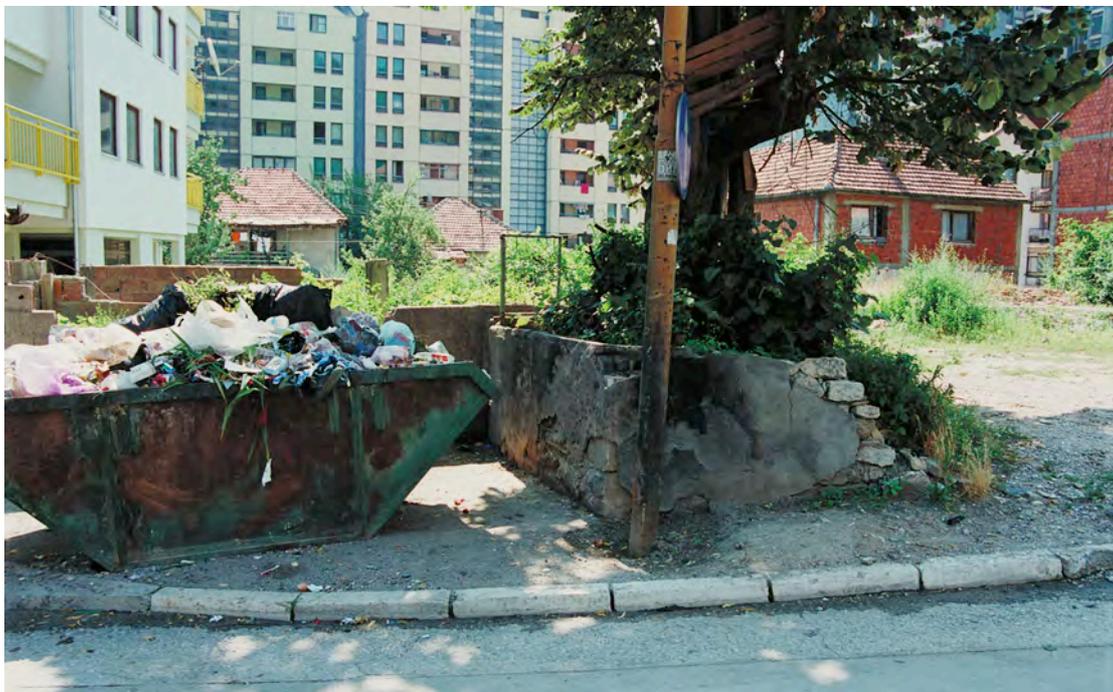
22.17. Beksuja mosque – photo 2

The turbe (shrine - Muslim saint's tomb) that stood next to the Beksuja mosque is also gone. The outlines of its foundations can still be seen at the rear of the site.

Former mosque entrance, with rubbish bins. Site of razed Beksuja Turbe at right rear.

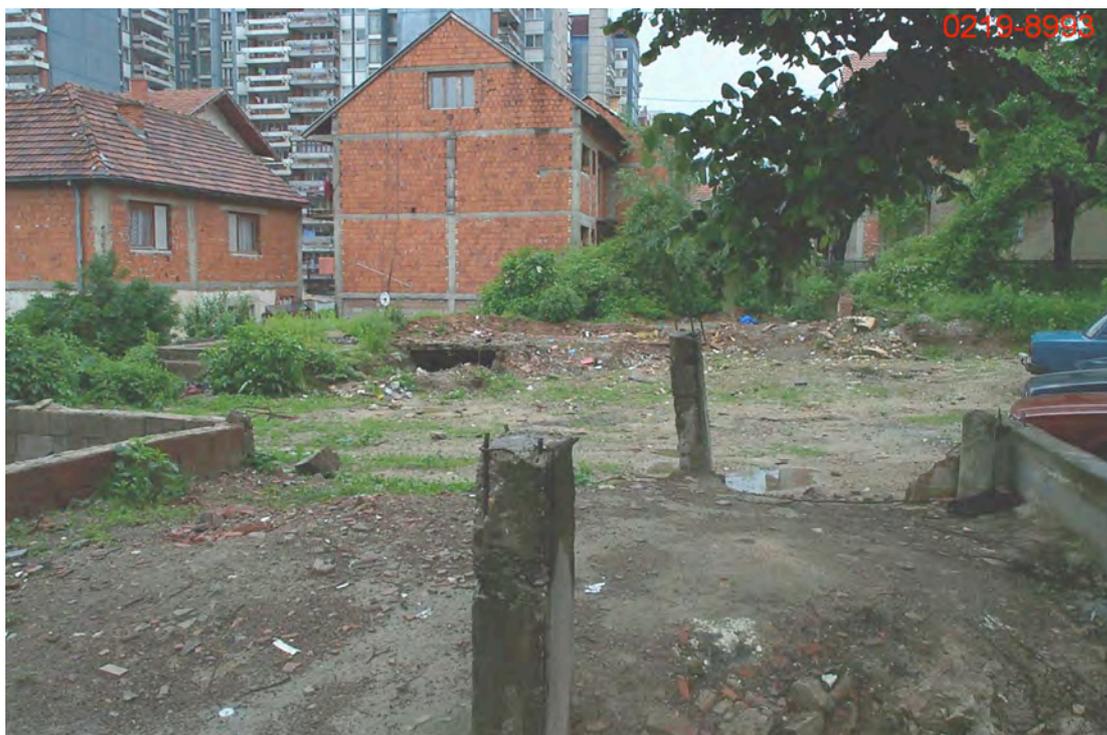
22.17. Beksuja mosque – photo 3

Foundations of razed Turbe in rear, site of destroyed Beksuja mosque in foreground, site in use as a parking lot.

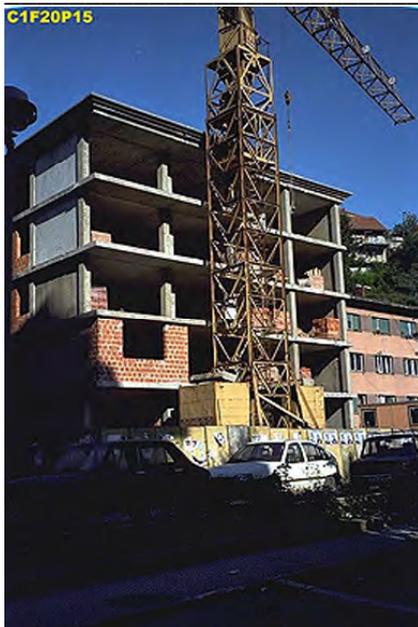
22.18. Zamlaz mosque – photo 2

Damage description: Mosque completely destroyed, ruins levelled, all traces removed. A new building now occupies the site of the razed mosque, but the neighbouring buildings are the same as the ones that can be seen next to the mosque in pre-war photographs. Some old Muslim gravestones from the mosque cemetery can still be seen in the back of the new building that now occupies the mosque's site.

New block of flats being built on site of razed Zamlaz mosque; note building at right, which can also be seen in the pre-war photo, to the right of the mosque. Photo (Aug. 1998): Council of Europe - Cultural Heritage Division.

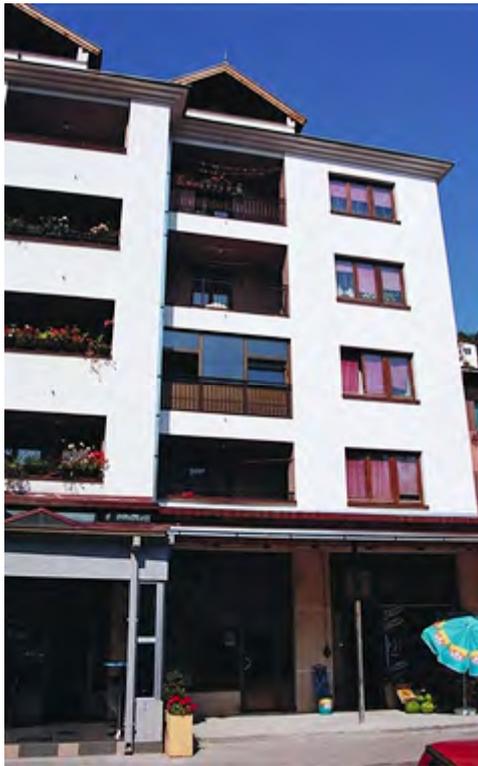
22.18. Zamlaz mosque – photo 3

New block of flats and shops occupying the site of the razed Zamlaz Mosque.
Photo by: András Riedlmayer (07/2002).

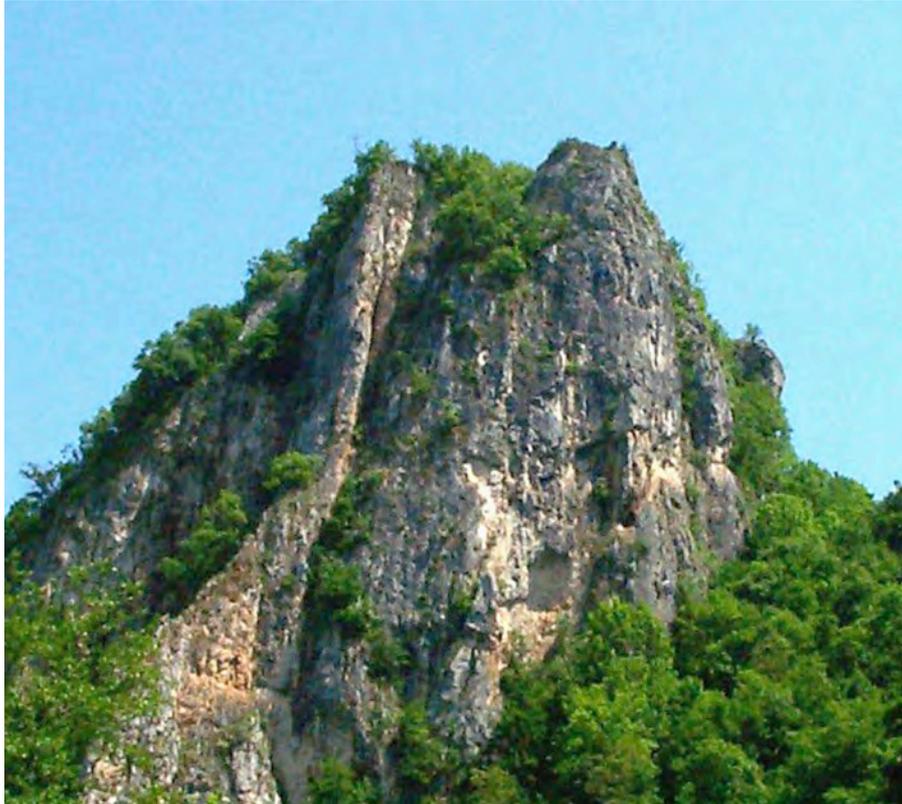
22.19. Kušlat mosque – photo 5

Post-war view of site of Kušlat mosque, on left-hand ridge on top of cliff.
Photo (05/2002) ICTY OTP 0219-8972

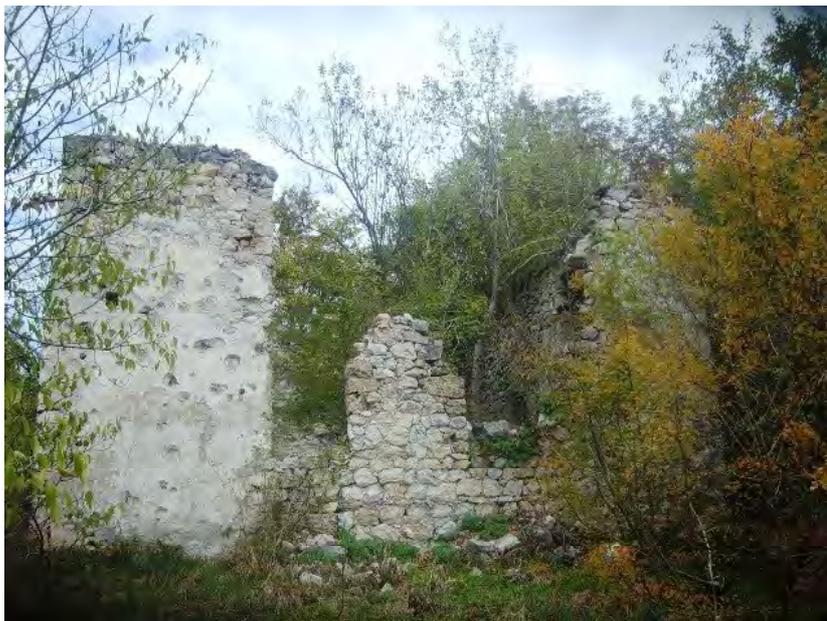
22.19. Kušlat mosque – photo 6

Ruins of the Kušlat mosque.
Photo (2008): Mensura Mustafić.

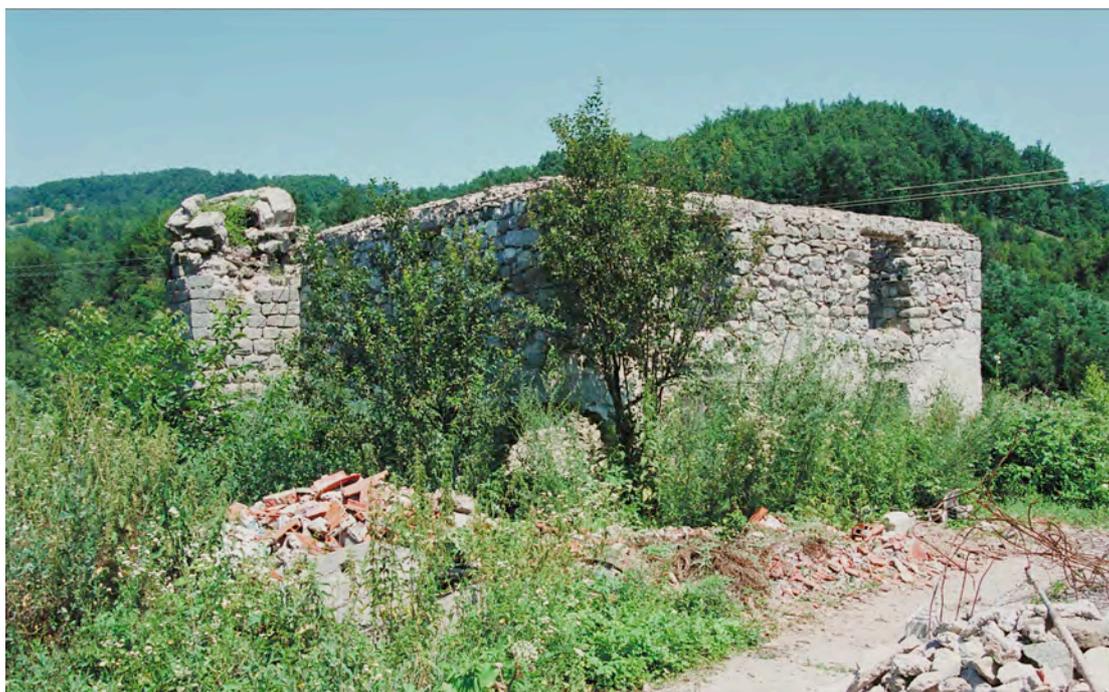
22.20. Donja Kamenica-Redžići mosque – photo 1

Ruins of mosque, viewed from south, stump of minaret at left.

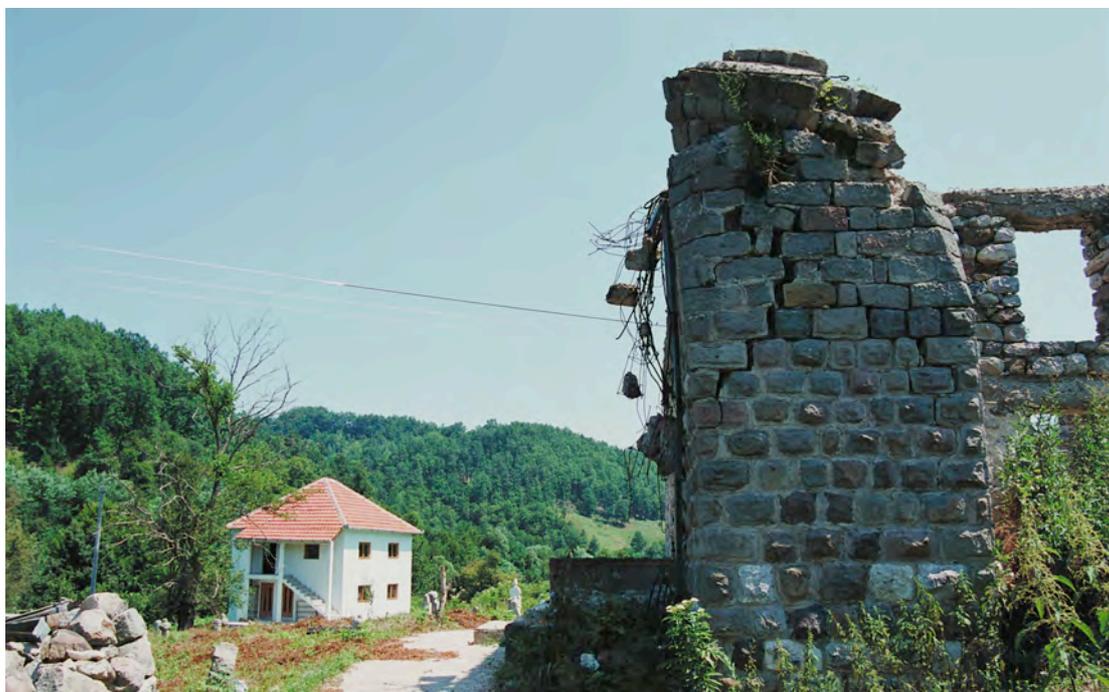
22.20. Donja Kamenica-Redžići mosque – photo 2

Ruins of mosque, stump of minaret at right centre, rebuilt Qur'an school at left.

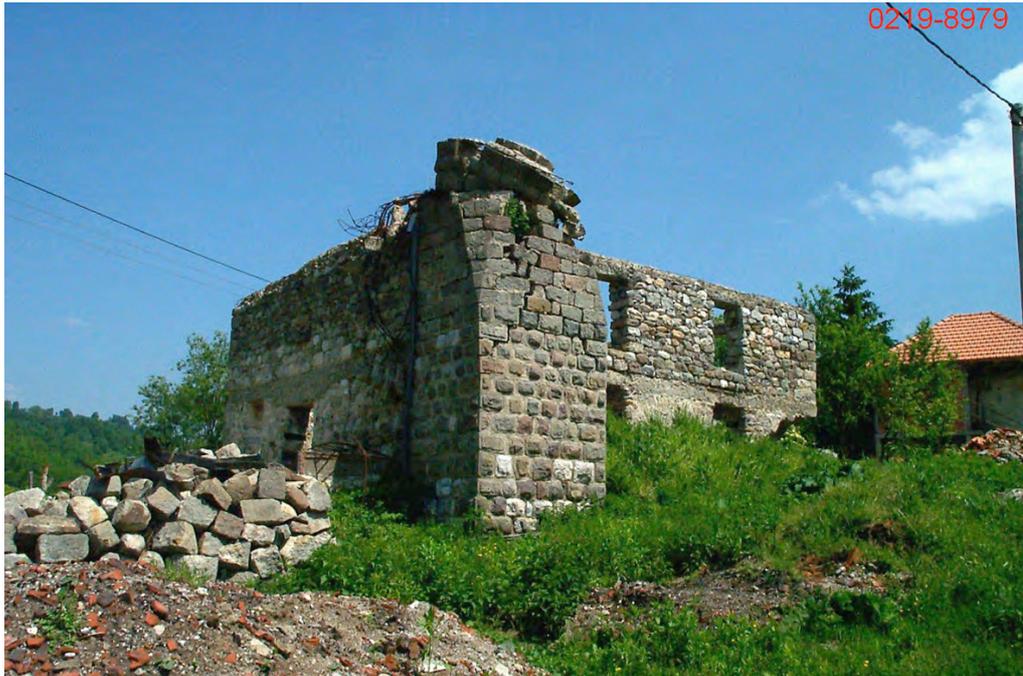
22.20. Donja Kamenica-Redžići mosque – photo 3

View of mosque from west, stump of minaret at centre, site of entrance portico at left.

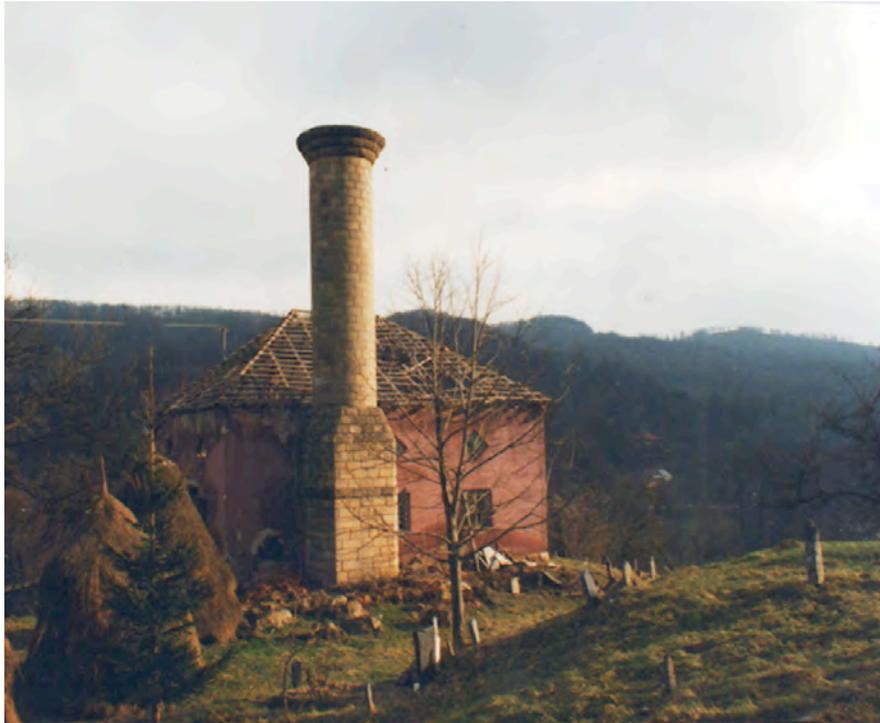
22.21. Gornja Sapna mosque – photo 1

Exterior view of the mosque, showing damage to roof and decapitated minaret.
Photo (1995): Kemal Zukic, Islamic Community of Bosnia and Herzegovina.

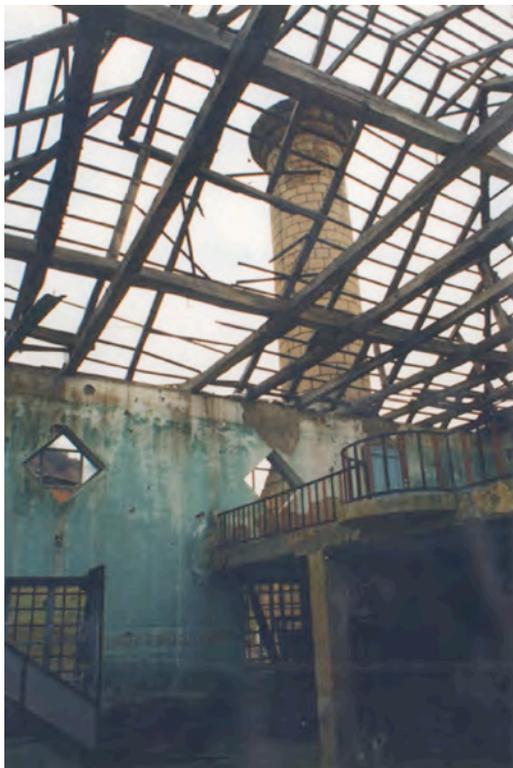
22.21. Gornja Sapna mosque – photo 2

Damaged interior of the Gornja Sapna mosque at the end of the war.
Photo published in K,Zukić (2000)

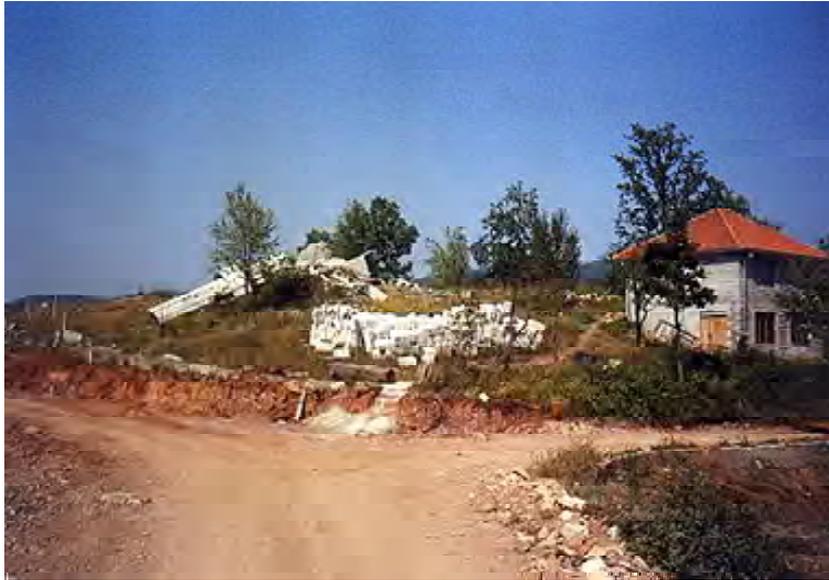
22.22. Jošanica mosque – photo 1

Rubble of the mosque with toppled minaret at left, behind tree.
Photo (2001): Islamic Community of Bosnia and Herzegovina.

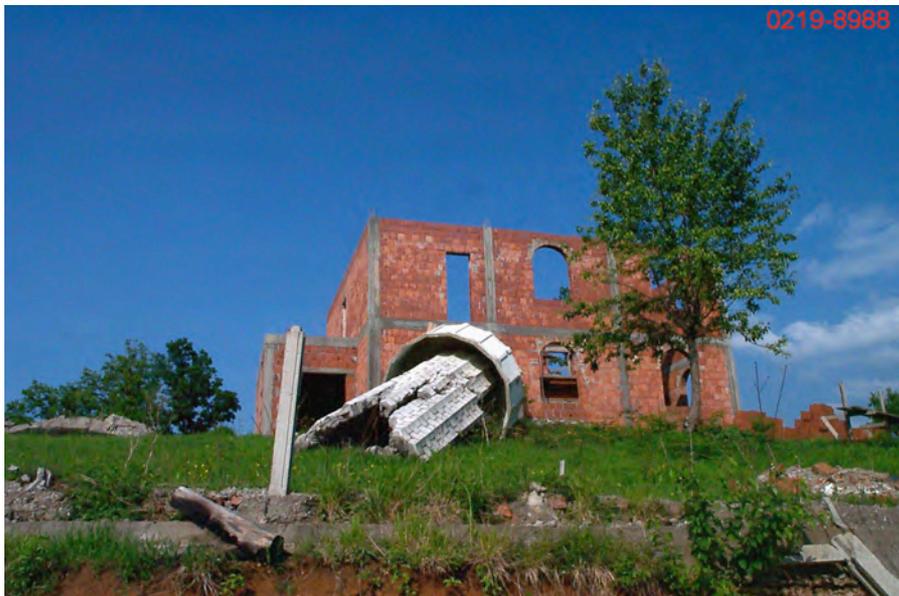
22.22. Jošanica mosque – photo 2

Mosque undergoing postwar reconstruction, toppled minaret in foreground.
Photo (05/2002) - ICTY OTP 0219-8988

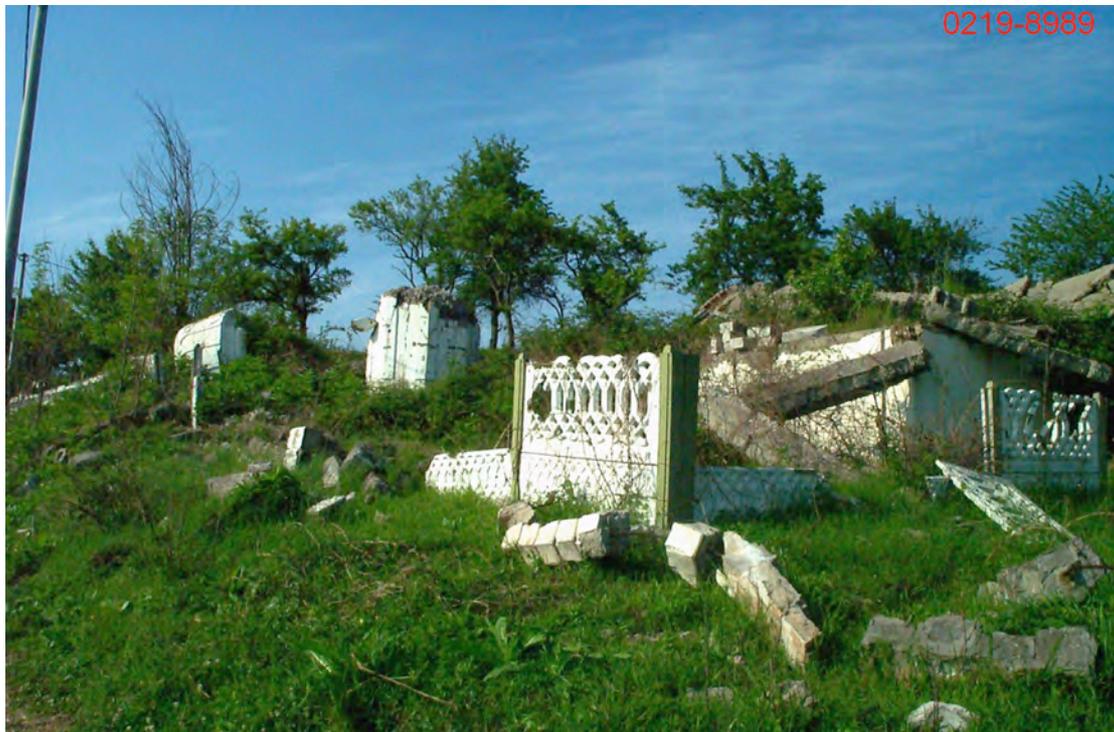
22.23. Hasići mosque – photo 1

Remains of Hasići mosque, stump of minaret at left rear, rubble of mosque at right.
Photo (05/2002): ICTY OTP 0219-8989

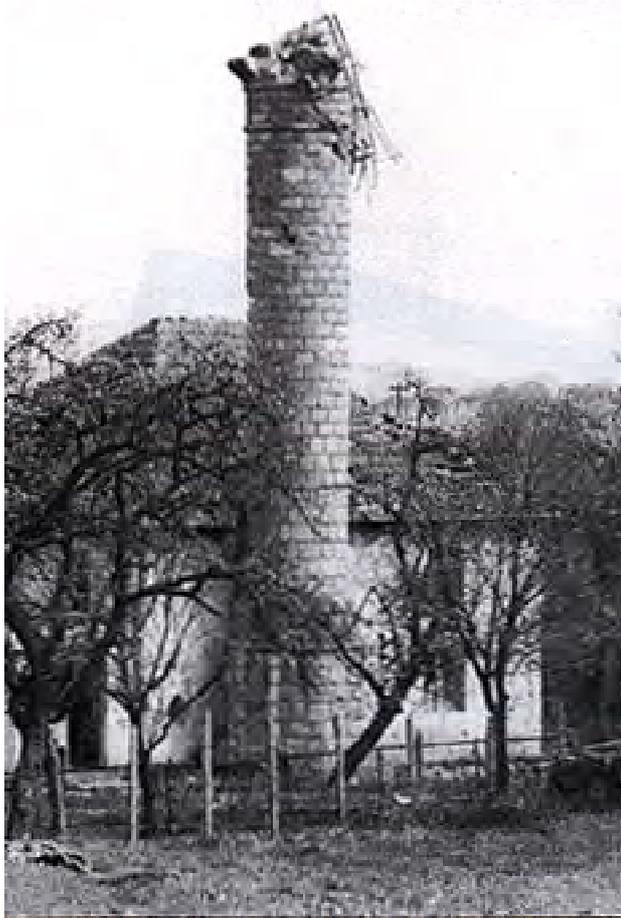
22.24. Vitinica mosque – photo 1

Vitinica mosque, viewed from the north, showing damage to roof and minaret.
Photo published in: M.Tokača (1995)

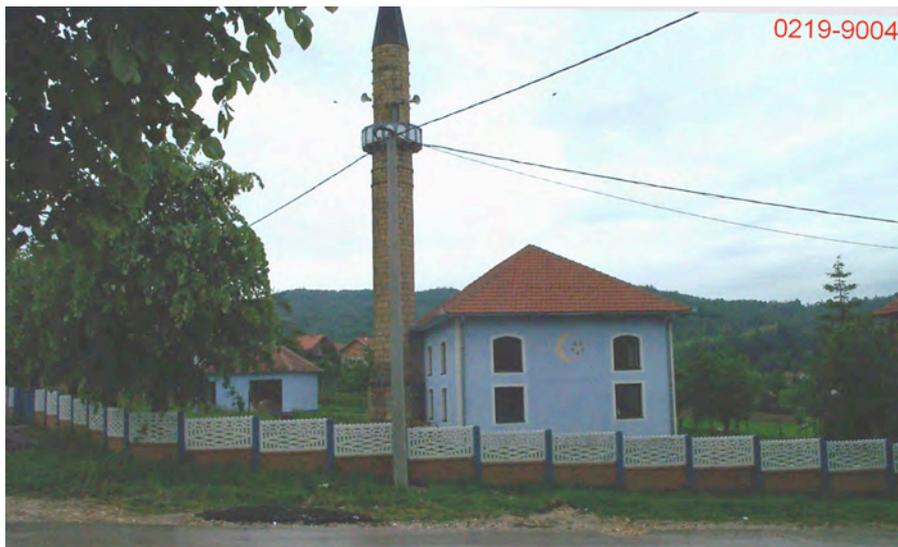
22.24. Vitinica mosque – photo 2

Vitinica mosque, after post-war reconstruction of minaret and roof.
Photo (05/2002): ICTY OTP TP 0219-9004

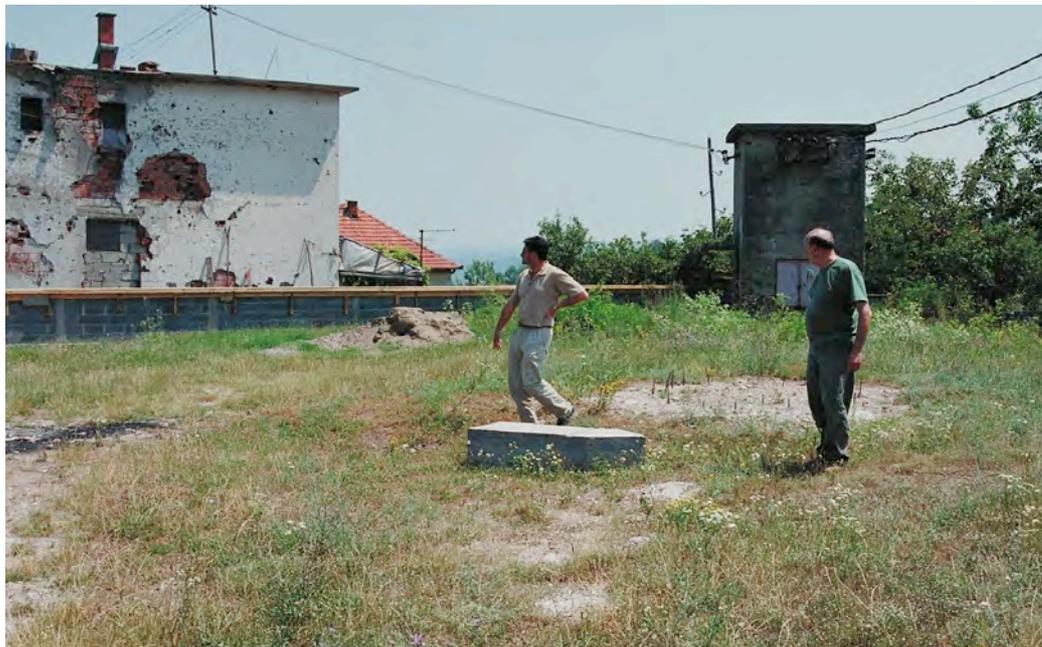
22.25. Gornji Šepak mosque – photo 1

Empty site of the destroyed mosque in Gornji Šepak.

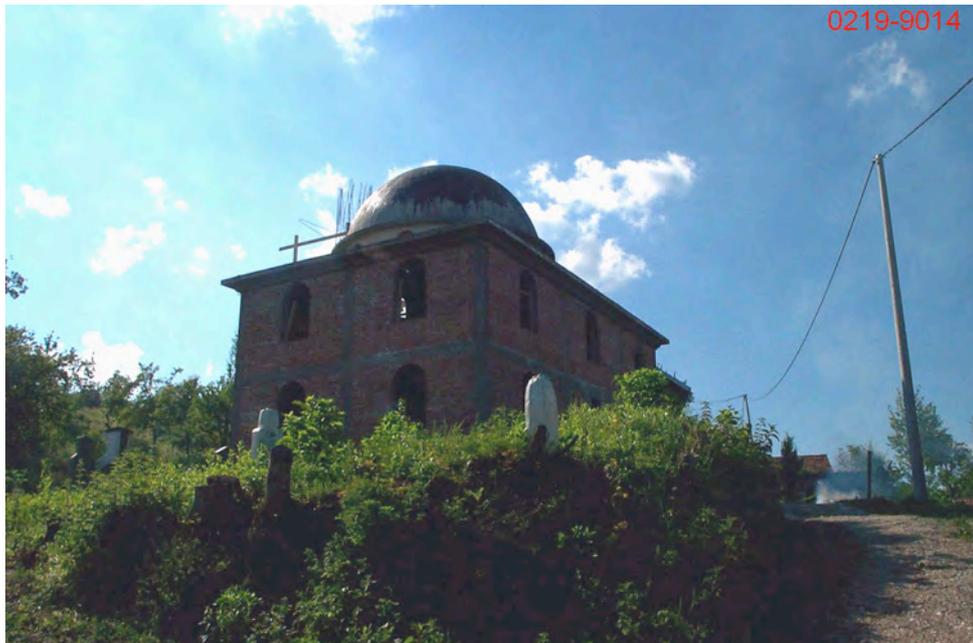
**22.26. Donji Križevići mosque – photo 1**

New mosque in Donji Križevići, iron reinforcing bars for the new minaret, as yet unbuilt, can be seen projecting behind the dome at left.

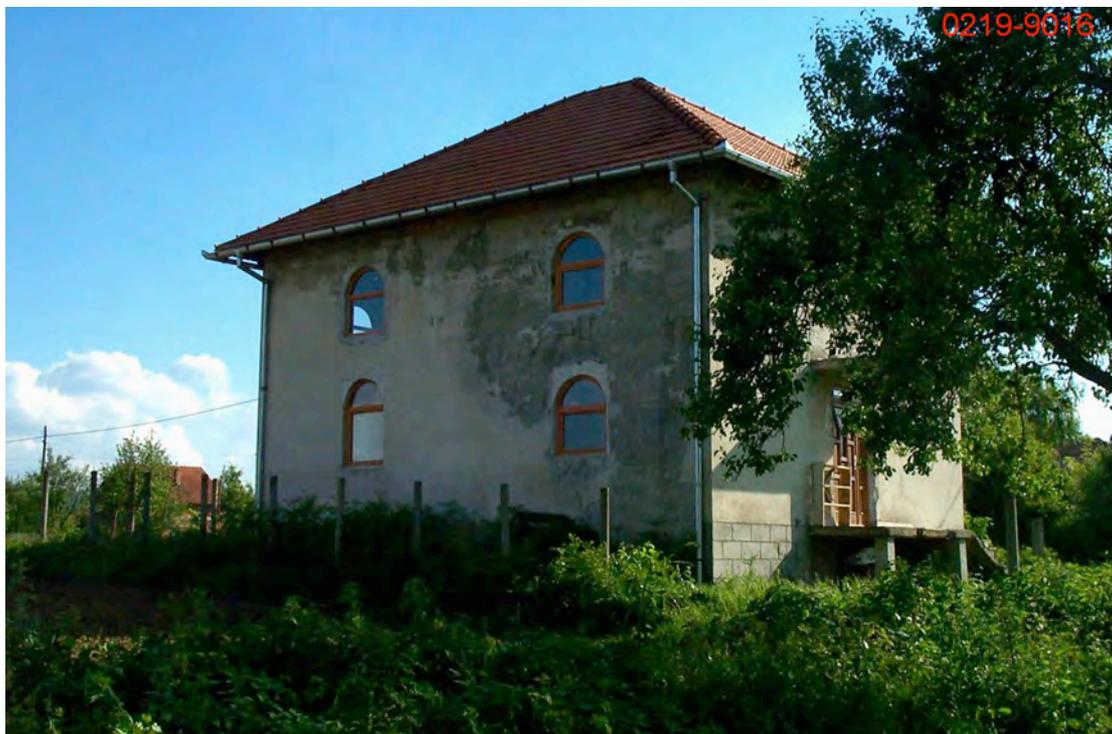
22.27. Glodi mosque – photo 1

Mosque undergoing reconstruction, with a new roof and recent repairs to façade.
Photo (05/2002): ICTY OTP 0219-9016

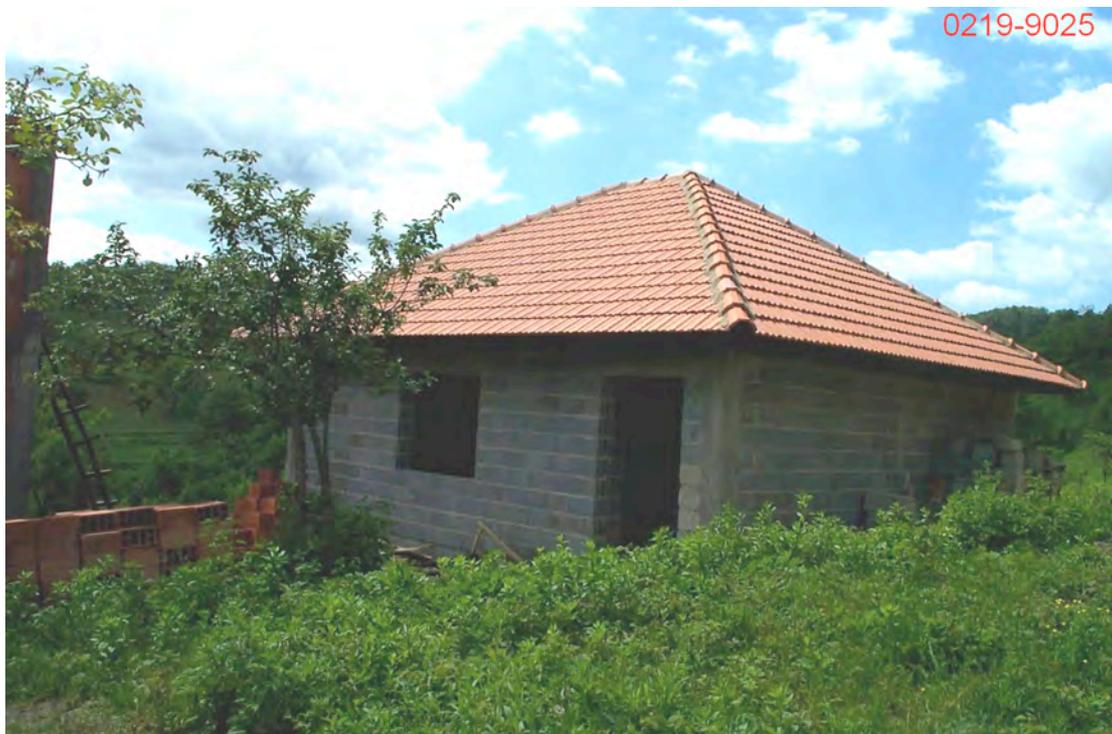
22.28. Seferovići mosque – photo 1

Mesdžid undergoing reconstruction, with new perimeter walls and a new roof.
