Municipality: 7. Brčko

7.1 Bijela Mosque

Neighborhood:	Kolobara
Town:	Brčko
GPS:	44°52'47.6"N 18°48'13.9" E
Construction:	19 th century (1881, rest. 1893)
Historical period:	Austro-Hungarian
Official status:	listed monument
Building use:	religious
Building type:	Mosque
Building setting:	city
Building condition:	completely destroyed under reconstruction

Damage description: Mosque completely destroyed, ruins razed, building materials removed.

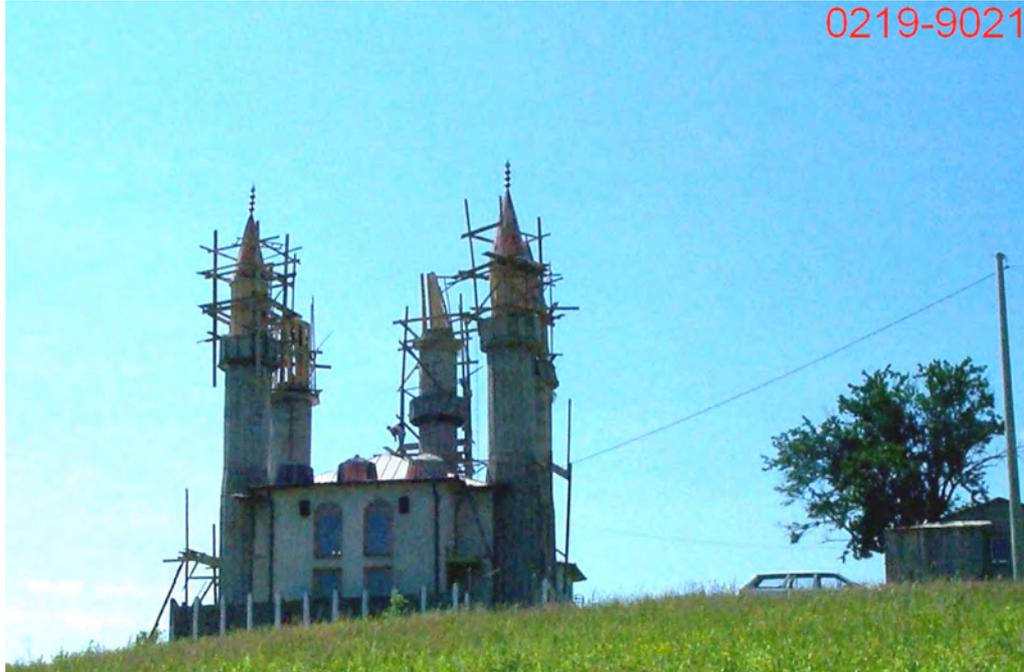
22.29. Avdo Tucić mosque in Kula Grad – photo 1

Avdo Tucić mosque undergoing reconstruction, with a hipped roof, three small domes over the entrance, different windows and different dimensions than before the war.

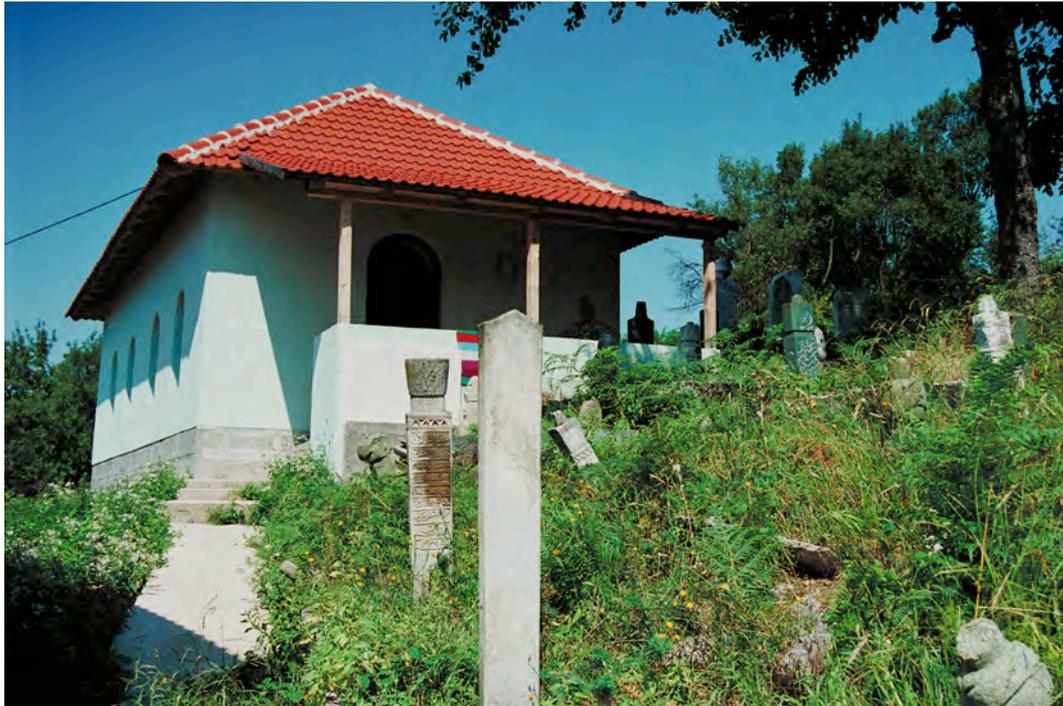
22.30. Turbe of Hasan Kaimija in Kula Grad – photo 3

Rebuilt Turbe of Hasan Kaimija, viewed from the same angle as in previous photos.
Photo by: András Riedlmayer (07/2002)

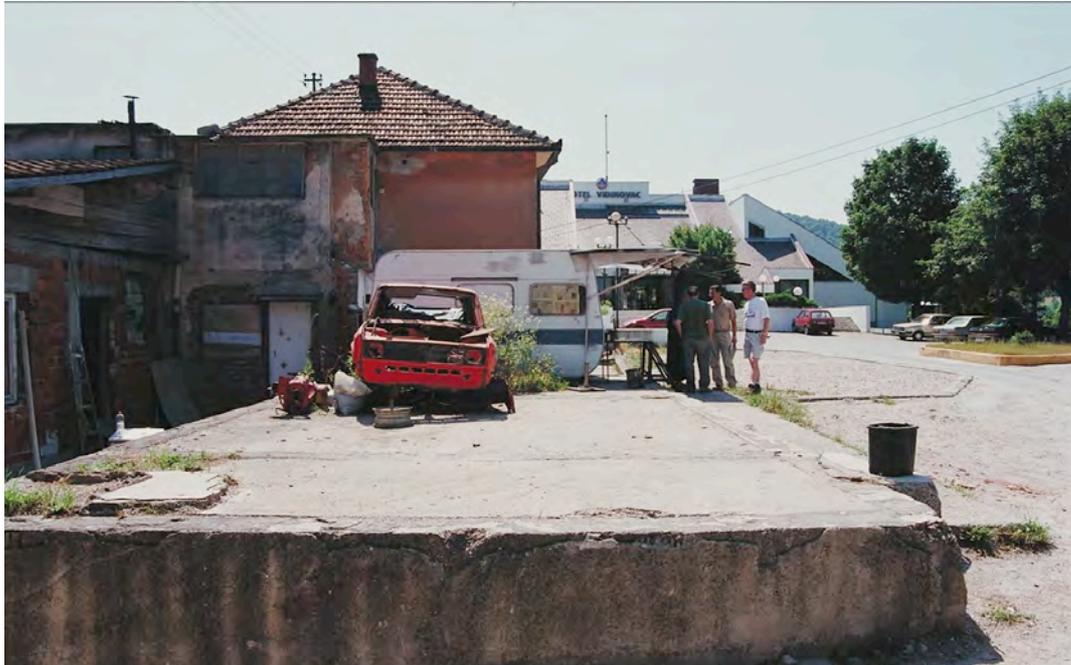
22.31. Dervish lodge and shrine at Divič – photo 1

Bare foundations of razed dervish lodge and shrine, saints' tombs under the junked automobile at the distant end of the foundations. Vidikovac hotel at end of street.
Photo by: András Riedlmayer (07/2002)

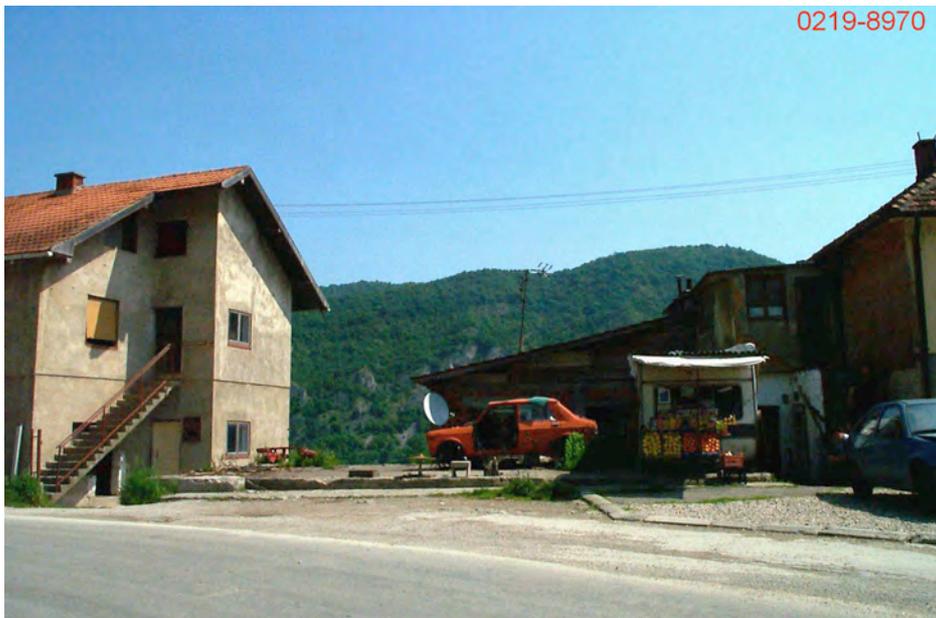
22.31. Dervish lodge and shrine at Divič – photo 2

Foundations of razed dervish lodge and shrine, viewed from street side. Note the building adjoining the shrine on the left, also seen in pre-war photo.
Photo (05/2002): ICTY OTP

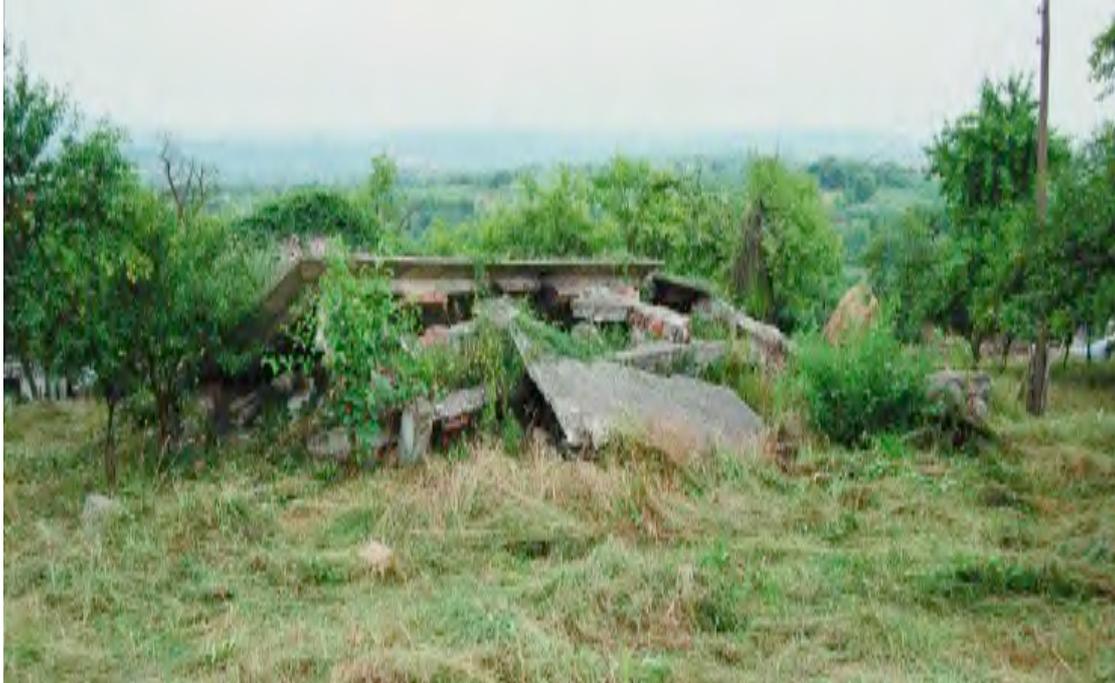
1.1 Bijeljina – Atmačići mosque – photo 1

Damage description: The mosque has totally collapsed. What remains is a jumbled pile of rubble and slabs of broken concrete and masonry ca. 3.5 m high. A small part of the rear wall remains standing. The shattered concrete is an indication of heavy blast damage.

Remains of the mosque in Atmačići, viewed from the uphill side looking SE.

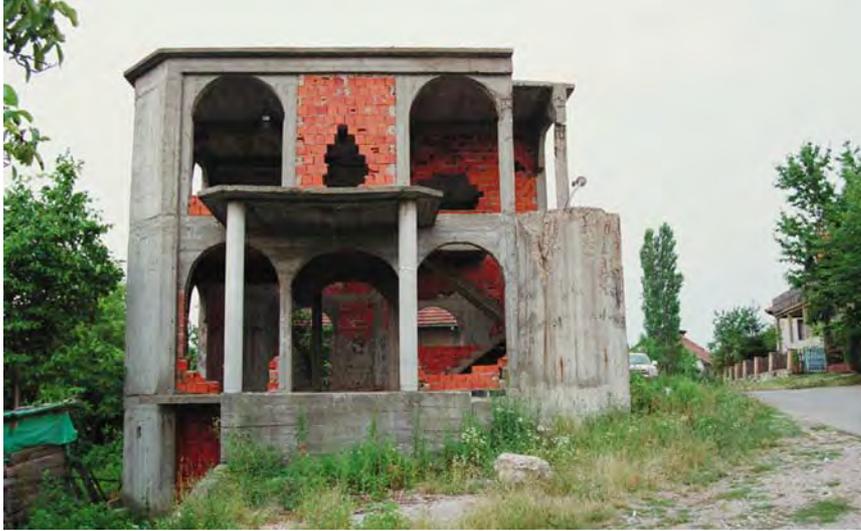
1.2 Bijeljina – Janjari – photo 1

Damage description: The mosque was vandalized. Building materials (bricks and window frames) have been ripped out of the walls and taken away. Radiating soot marks seen on interior walls (sign of explosion or fire).

Entrance façade of the Janjari mosque; the base of the unfinished minaret is at right. Graffiti in Serbian (CPC = Serbian Radical Party) seen on interior walls.

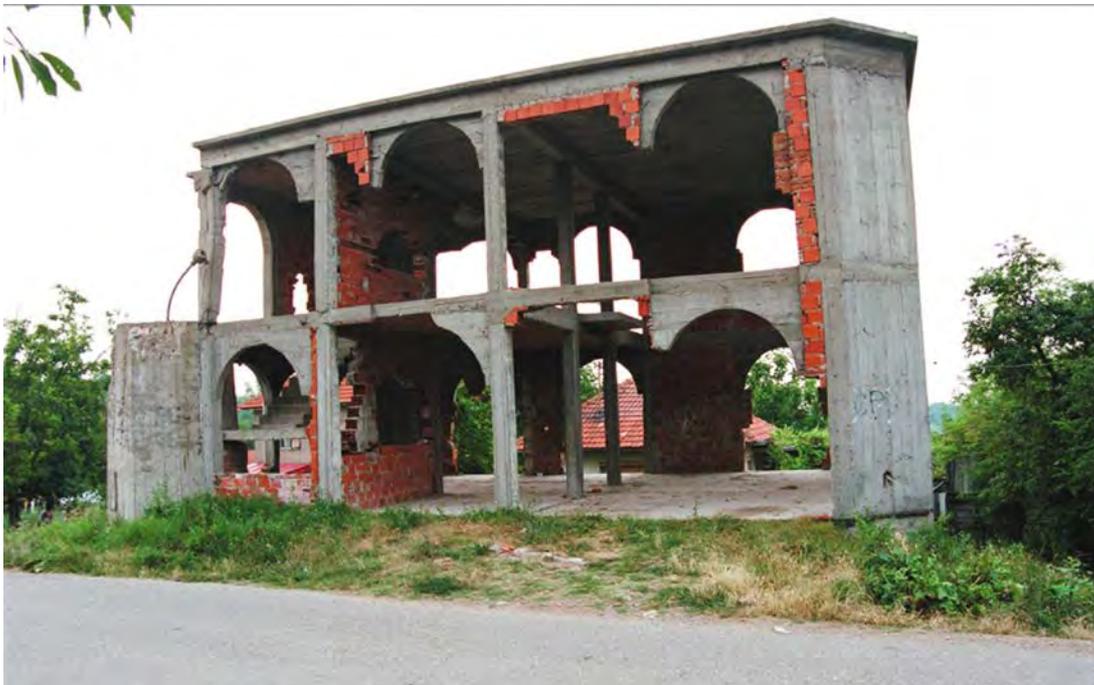
1.2 Bijeljina – Janjari – photo 2

SW side of the Janjari mosque; the base of the minaret is at left. Graffiti in Serbian Cyrillic: CPC (SRS, Serbian Radical Party) can be seen on the base of the minaret, on an interior wall at right center, and on the exterior of the *mihrab* wall (at right).

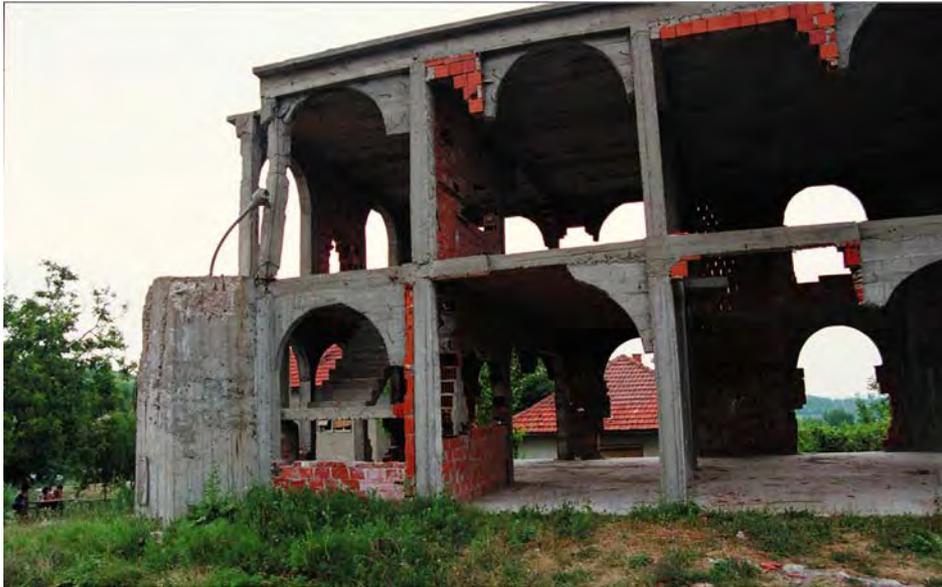
1.2 Bijeljina – Janjari – photo 3

Close-up side view of new mosque at Janjari, showing extent of damage to walls from removed building materials; base of minaret at left, with fading Serbian graffiti: SRS.

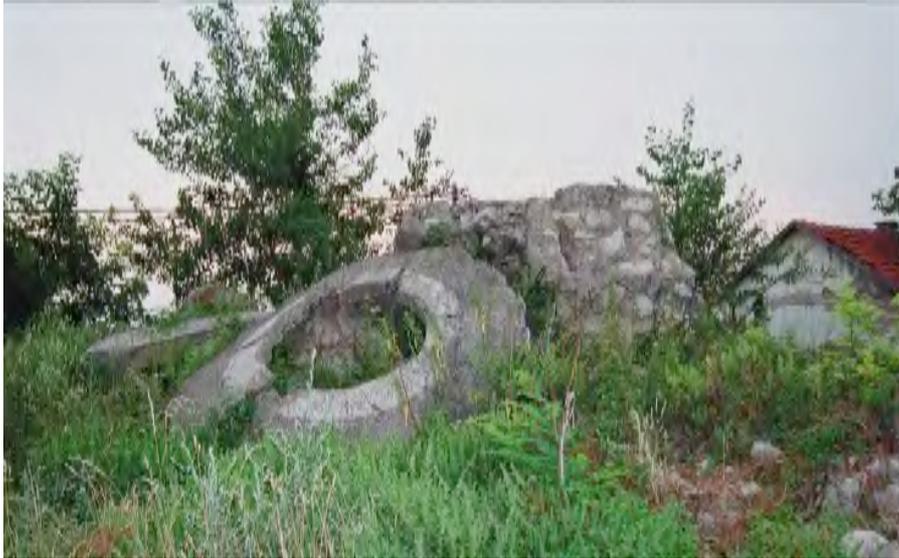
1.3 Bijeljina – Srednja Trnova – photo 1

Damage description: The mosque in Srednja Trnova was completely destroyed. The massive, circular remains of the muezzin's balcony (*šerefe*) from the toppled minaret can be seen next to the stone base of the minaret, lying on top of the rubble. The shattered masonry is an indication of heavy blast damage.

Ruins of the mosque at Srednja Trnova / Srnja Trnava, stone base of minaret at right. Circular remains of the minaret balcony can be seen next to the base of the minaret.

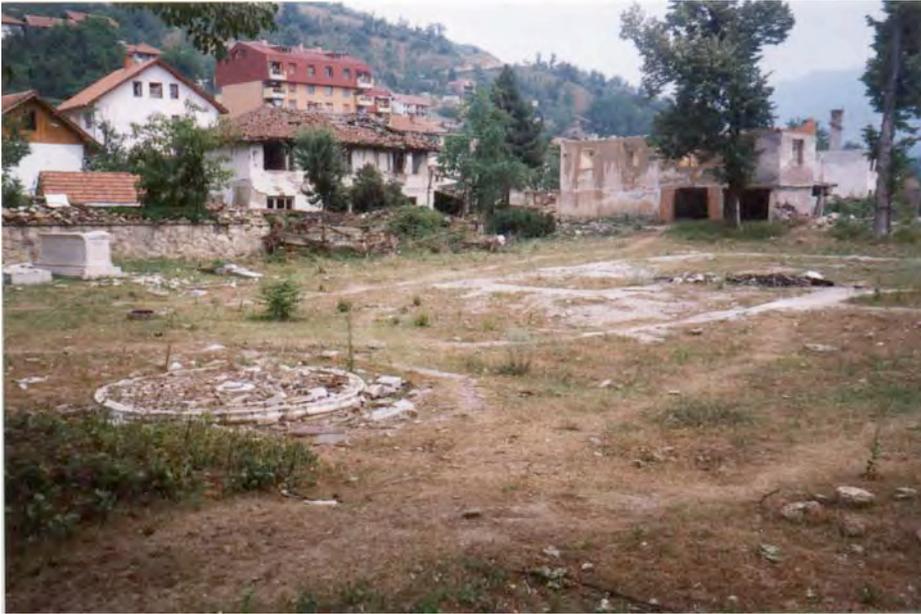
5.1 Aladža mosque – photo 1

Damage description: The circular base of the mosque's ablution fountain, scattered stones from the destroyed building, and the outlines of the mosque's foundation are all that still remained on the mosque site at the time of the author's survey visit. The site was being used as a parking lot for buses and was littered with rubbish. The imam's house, in the rear of the mosque site, was burned out. Other houses in the surrounding neighborhood appeared to be intact.

Outlines of the razed Aladža mosque's foundations (at right) and of the circular base of the mosque's ablution fountain (at left). The burned-out imam's house can be seen at the rear of the site.

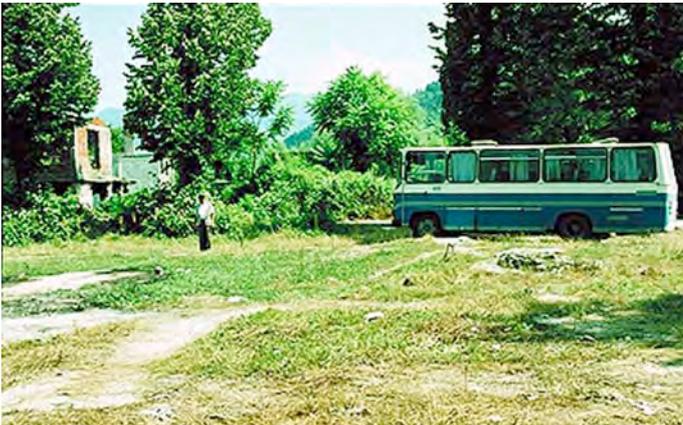
5.1 Aladža mosque – photo 2

The site of the destroyed Aladža mosque, being used as a parking lot for buses. Traces of the mosque's foundations can be seen in the foreground at left. The burned-out imam's house is in the rear of the mosque site, at left.

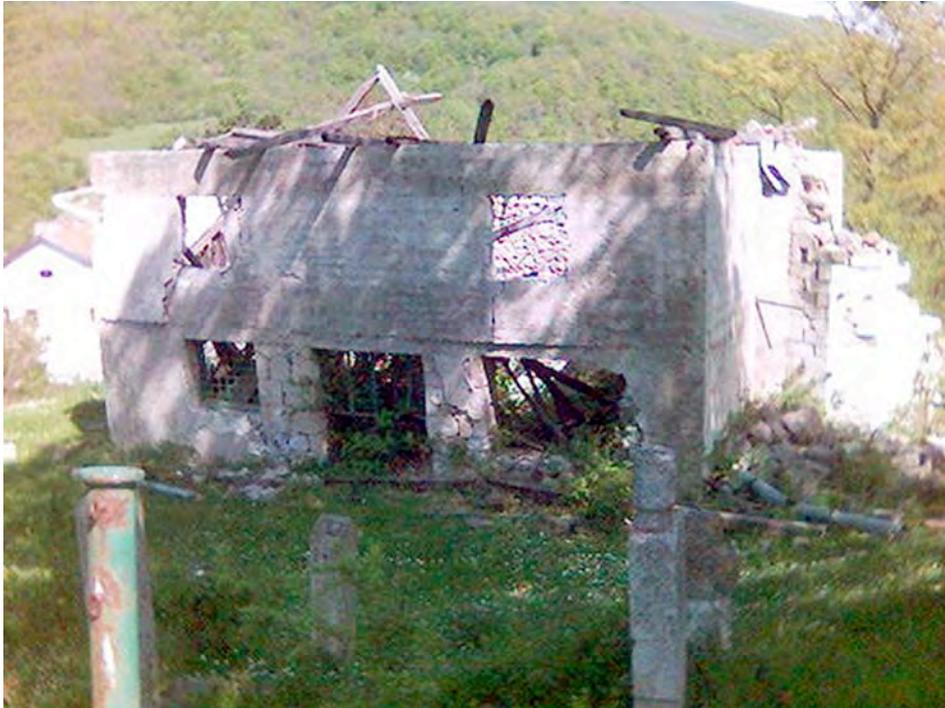
6.1 Ulog mosque – photo 1

Damage description: In photographs taken after the war, the Ulog mosque is heavily damaged by blast, its interior gutted, the roof collapsed. The stone perimeter walls of the historic main section of the mosque remain standing up to the roofline. Shattered roof timbers, collapsed into the mosque's interior, can be seen protruding above the walls. The stone minaret of the mosque has been destroyed by a powerful blast; only its shattered base remains, surrounded by stones of the fallen minaret.

Ruins of the mosque viewed from N: stump of minaret at right, shattered roof timbers projecting from the interior; old Muslim tombstones in foreground at right.

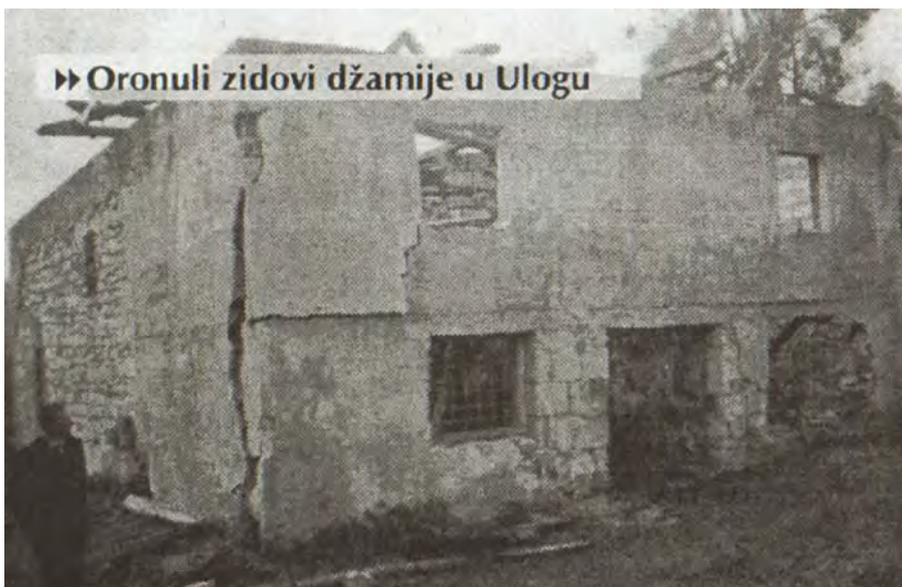
6.1 Ulog mosque – photo 2

The modern concrete entrance portico of the mosque, a 20th-century addition, has also lost its roof and is heavily damaged, its walls cracked and buckled outward by the force of the blast. Old Ottoman-era Muslim tombstones of the mosque cemetery can be seen in front of the ruined building.

Ruins of the mosque viewed from NNE, showing walls buckled by force of blast.

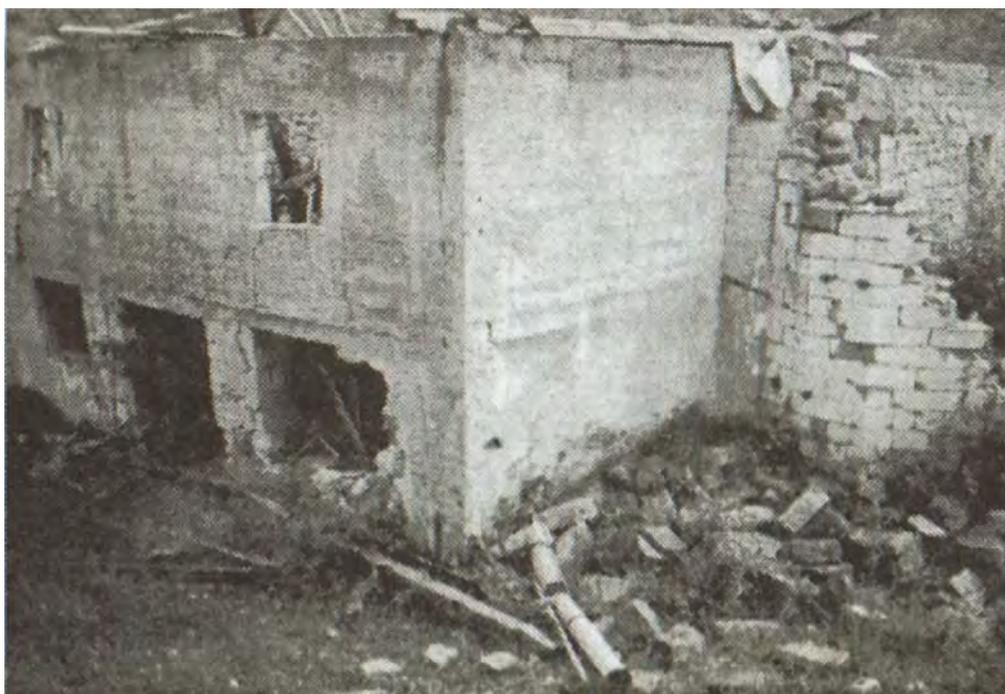
6.1 Ulog mosque – photo 3

Ruins of the mosque viewed from NW, entrance portico at L, base of minaret at R.

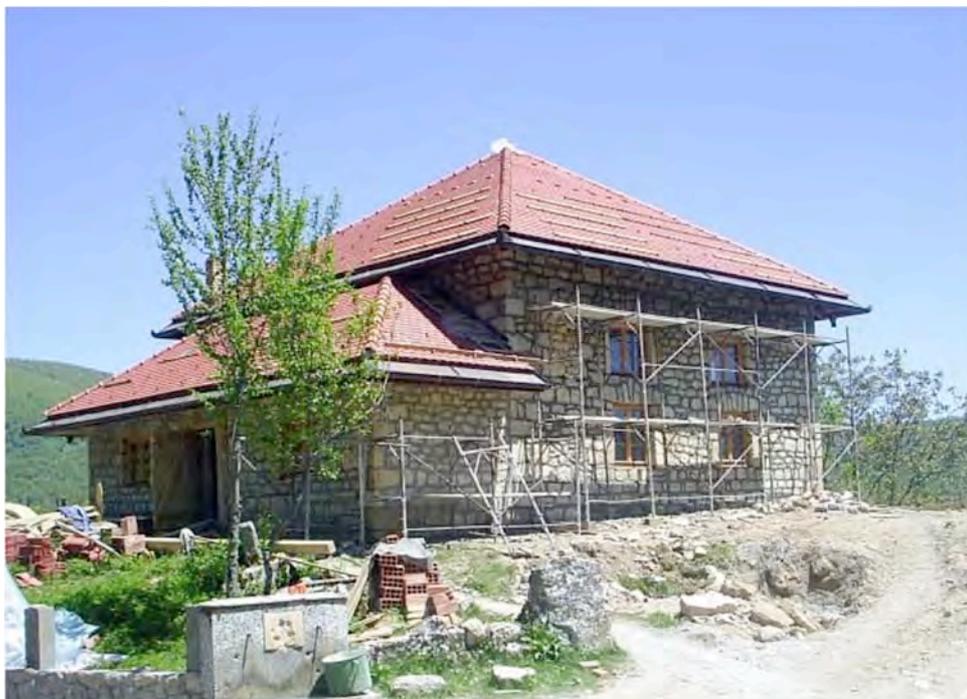
6.2 Hotovlje mosque – photo 1

In post-war photos, taken in 2006, the mosque is seen undergoing reconstruction and is still missing its minaret. The circular stone foundations of the mosque's pre-war minaret can still be seen to the right of the entrance of the mosque. Adjacent to the newly-rebuilt Hotovlje mosque one can see the mosque's old graveyard, with Ottoman-era gravestones.

The Hotovlje mosque, viewed from the W, undergoing postwar reconstruction, its minaret not yet rebuilt. The circular, stone foundation of the destroyed pre-war minaret, with vegetation growing inside it, can be seen to the right of the entrance.

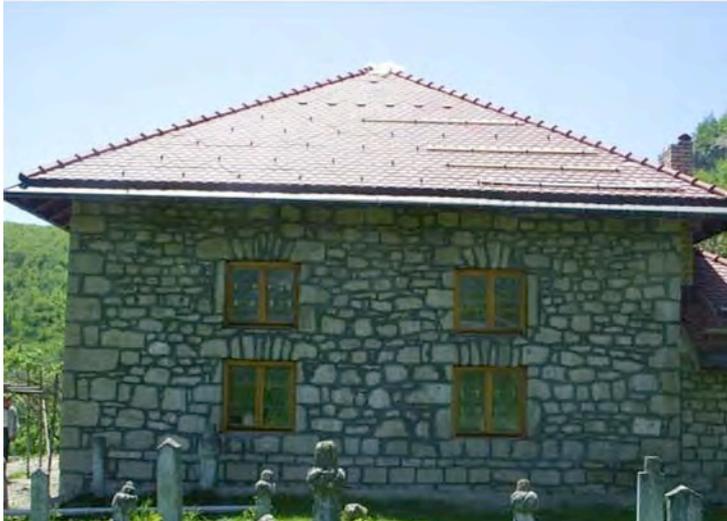
6.2 Hotovlje mosque – photo 2

The newly rebuilt Hotovlje mosque, with a new roof and newly-mortared wall, still without its minaret; view from the NE, facing the mosque's old Muslim graveyard.

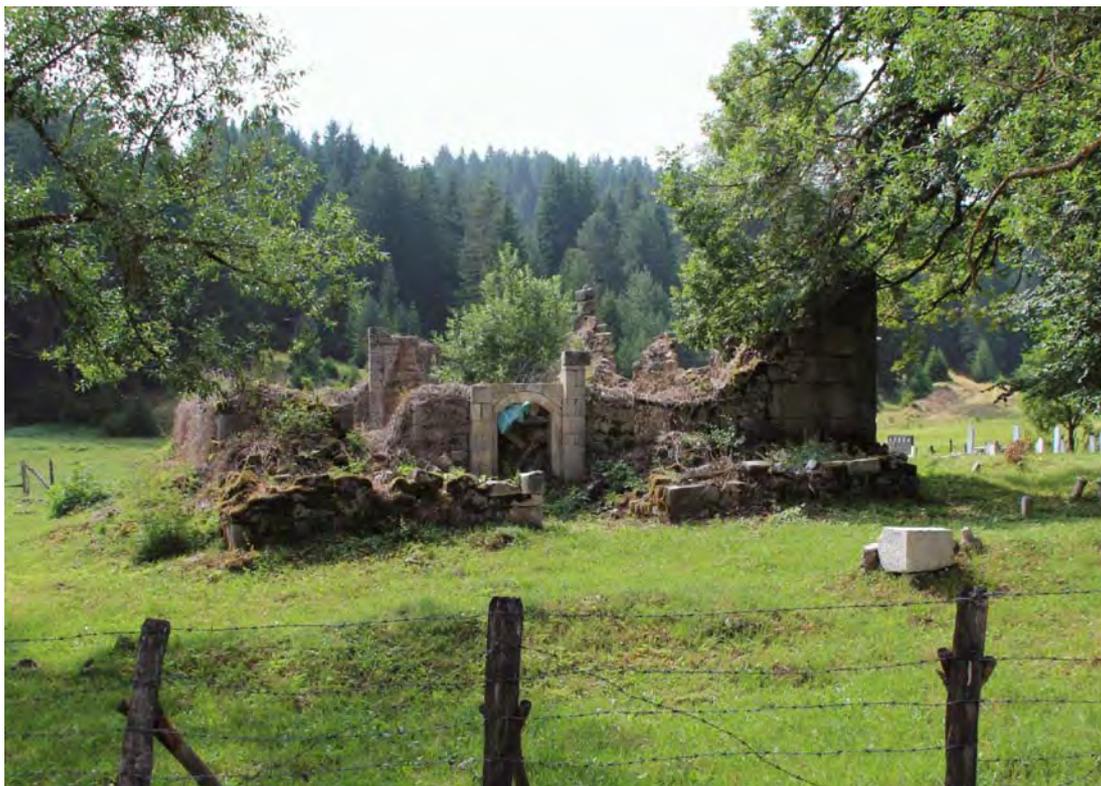
6.3 Jelašca mosque – photo 1

Damage description: The historic Jelašca mosque is heavily damaged, its roof and minaret are destroyed, only parts of the mosque's stone perimeter walls remain standing, up to a height of 2-3 m at the front of the mosque, less at the sides. On the NW corner, to the right of the entrance, the stone base of the destroyed minaret still stands to a height of 4-5 m. Trees and other vegetation can be seen growing in the interior of the ruined building, which is filled with rubble. The Muslim cemetery next to the ruined mosque appears to be intact and still in use.

Ruins of the mosque in Jelašca: view of the NW (entrance) façade. The base of the minaret is at the right. The mosque's monumental *mihrab* can be seen at the rear, to the left of the entrance. The low ruins in the front are the remains of the portico.

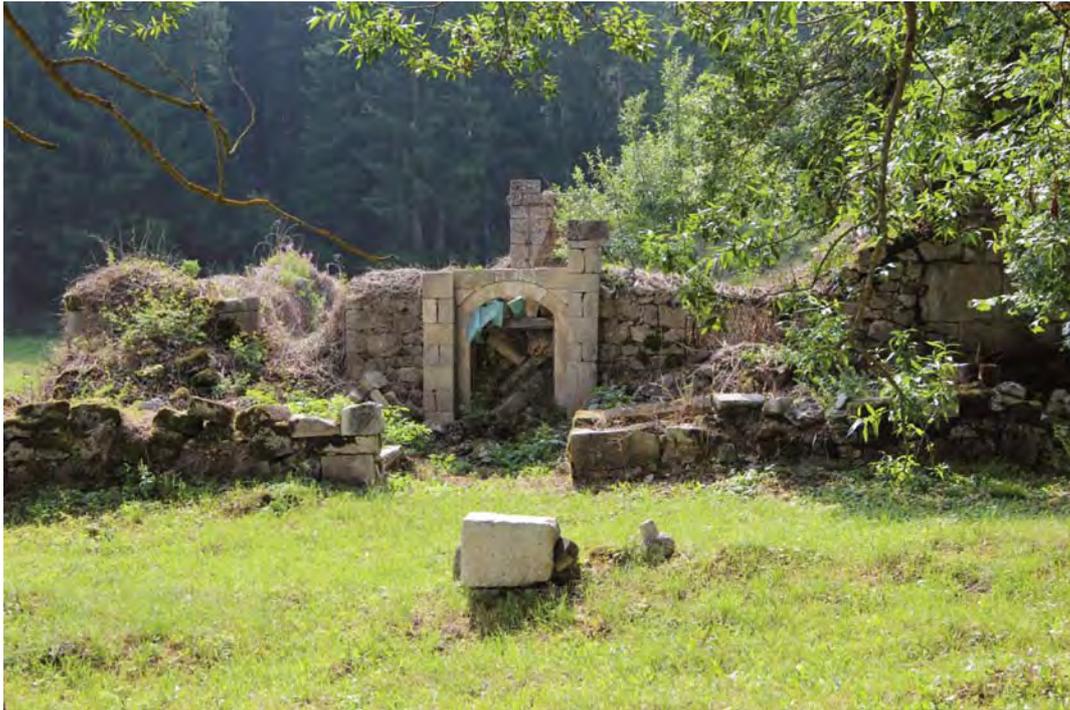
6.3 Jelašca mosque – photo 2

Ruins of the mosque in Jelašca: close-up view of the entrance façade from the NW.

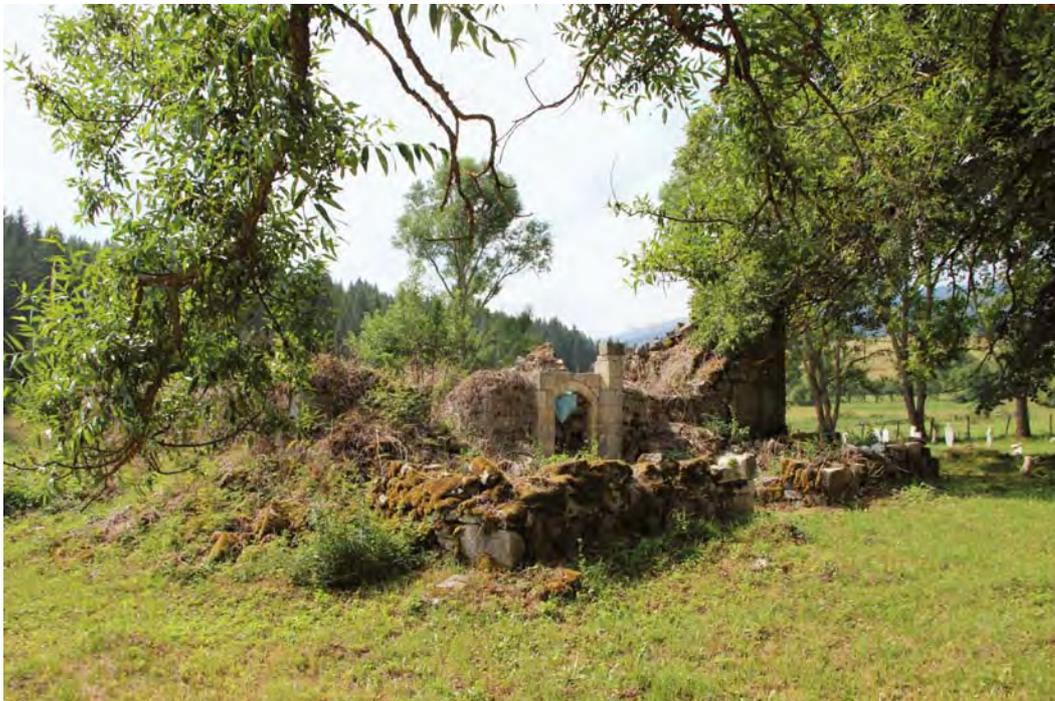
6.3 Jelašca mosque – photo 3

Ruins of the mosque in Jelašca, viewed from the N; weathered remains of the mosque's entrance portico in the foreground.

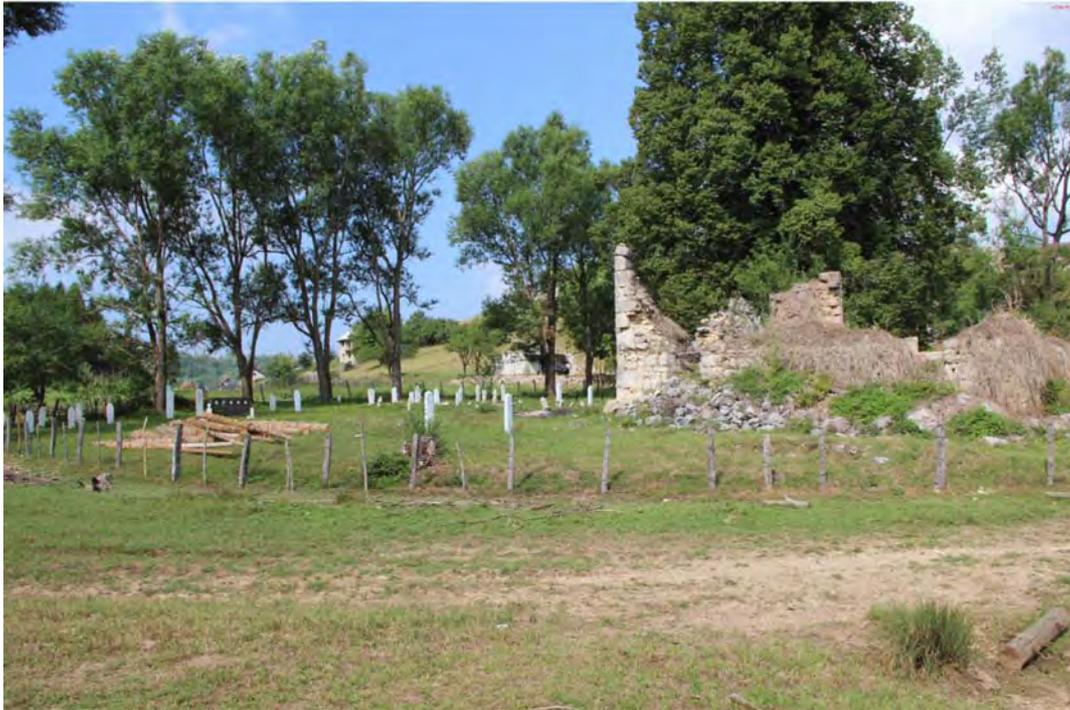
6.3 Jelašca mosque – photo 4

Ruins of the mosque in Jelašca, viewed from the SE side. The old Muslim cemetery can be seen in the background at left, to the W of the mosque.

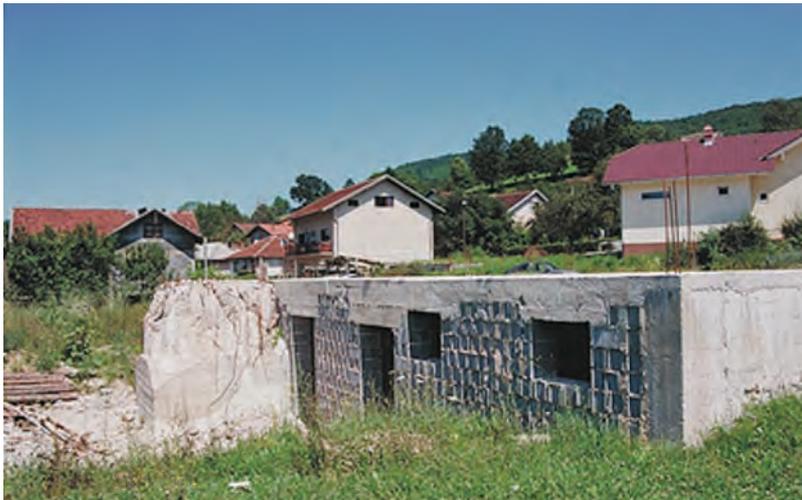
7.1 Town mosque in Ključ – photo 1

Damage description: Only the bare foundations of the new Town mosque and the large, weathered stump of the destroyed minaret remain at the site. In photographs taken immediately after the end of the war, signs of blast damage can be seen (fissures in the base of the minaret), along with rubble that has since been cleared.

Ruins of the new Town mosque, looking north; stump of destroyed minaret at left.

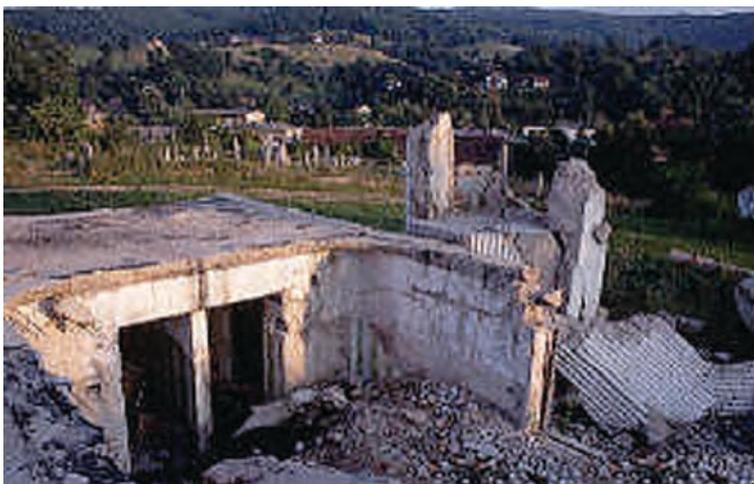
7.1 Town mosque in Ključ – photo 2

Ruins of the new Town Mosque, looking south; stump of destroyed minaret at right. The site of the old Town Mosque (Atik džamija), is in the background at left.

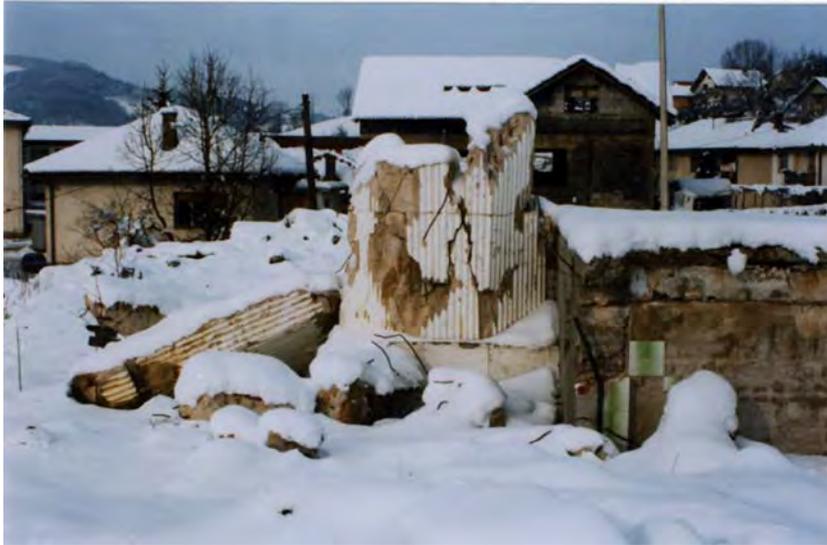
7.1 Town mosque in Ključ – photo 3

Ruins of the new Town Mosque at the end of the war; stump of the destroyed minaret, with signs of blast damage, at center.

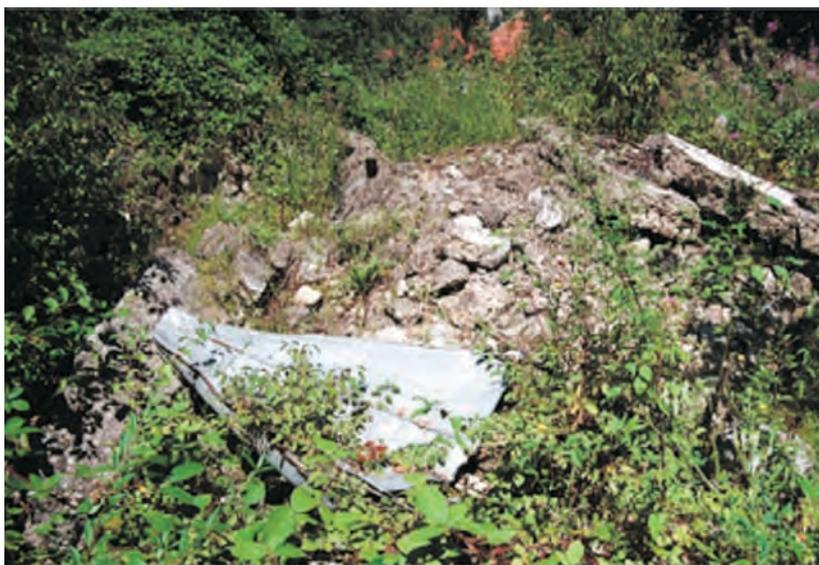
7.2 Biljani-Džaferagići mosque – photo 1

Metal cap of the minaret of the destroyed Biljani mosque, lying atop the rubble.

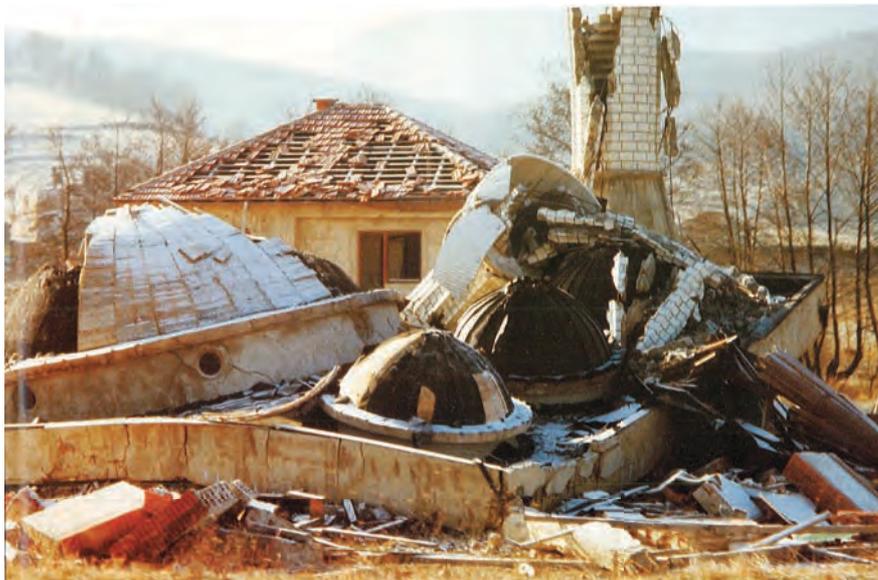
7.3 Pudin Han-Velagići mosque – photo 1

Damage description: In photographs taken after the war, the Pudín Han-Velagići mosque is seen completely destroyed by a series of blasts, with the broken roof slab coming to rest atop the rubble of the collapsed building.

The mosque in Pudin Han-Velagići (Hadžići), showing first stage of destruction. Mosque in foreground, damaged imam's house in rear, behind the shattered minaret.

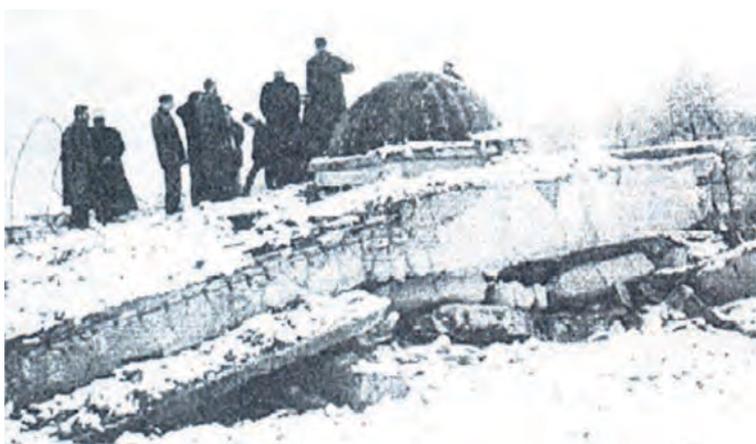
7.3 Pudin Han-Velagići mosque – photo 2

Ruins of the mosque at the end of the war, showing effects of subsequent mining.

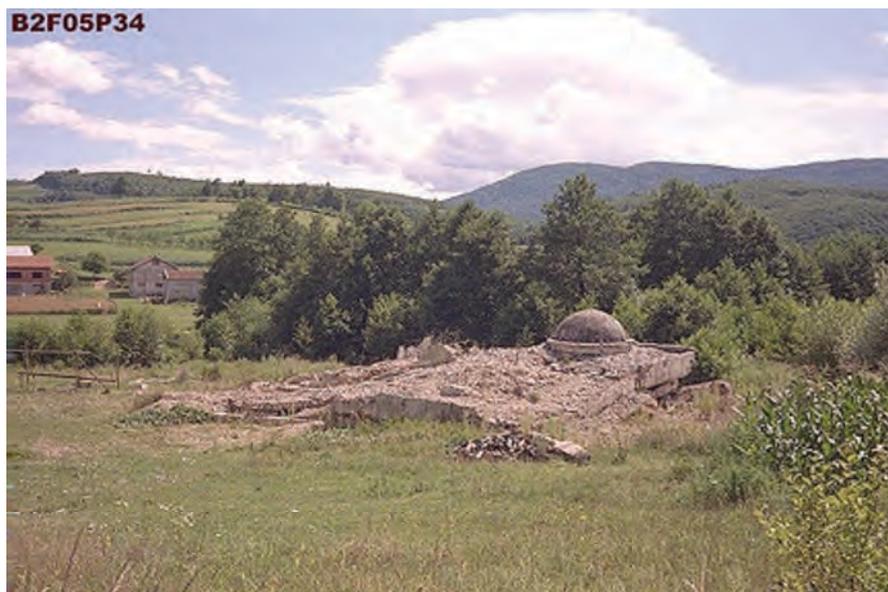
7.3 Pudín Han-Velagići mosque – photo 3

Ruins of the mosque after the end of the war, only one small dome left resting atop the rubble. Remains of the destroyed imam's house in the rear, behind the mosque.

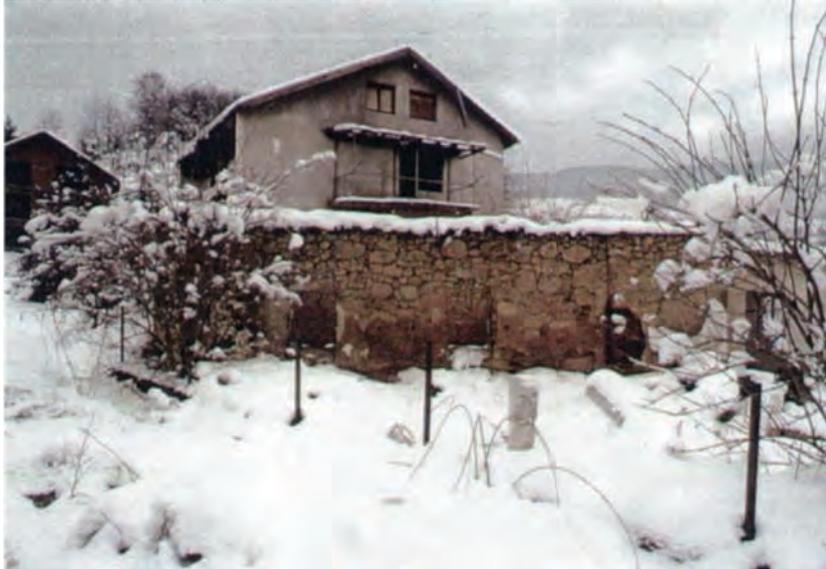
7.4 Donji Budelj mosque – photo 1

Photo (12/1995) Kemal Zukić, published in: Zukić (1999).
Remains of the Donji Budelj mosque at the end of the war.

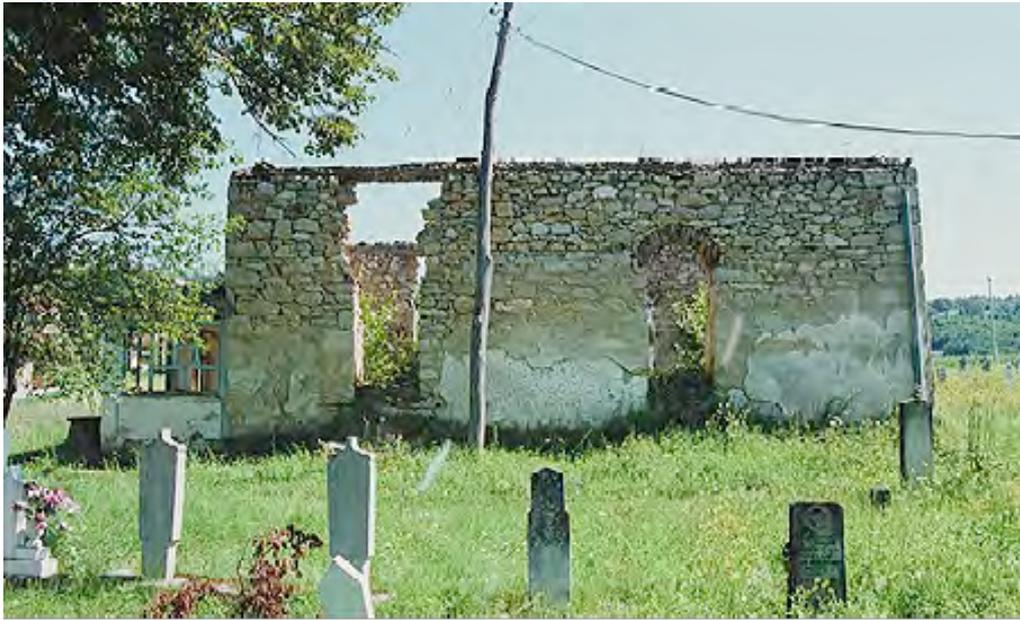
7.5 Humići mosque – photo 1

The burned-out mosque, a large hole blasted in its perimeter wall; view from the SW, entrance portico at left.

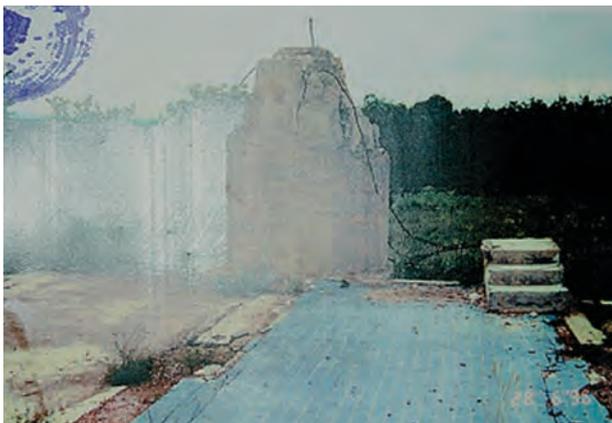
7.6 Krasulje mosque – photo 2

Foundations of the destroyed Krasulje mosque at the end of the war; the stump of minaret can be seen at left, the destroyed imam's house at right.

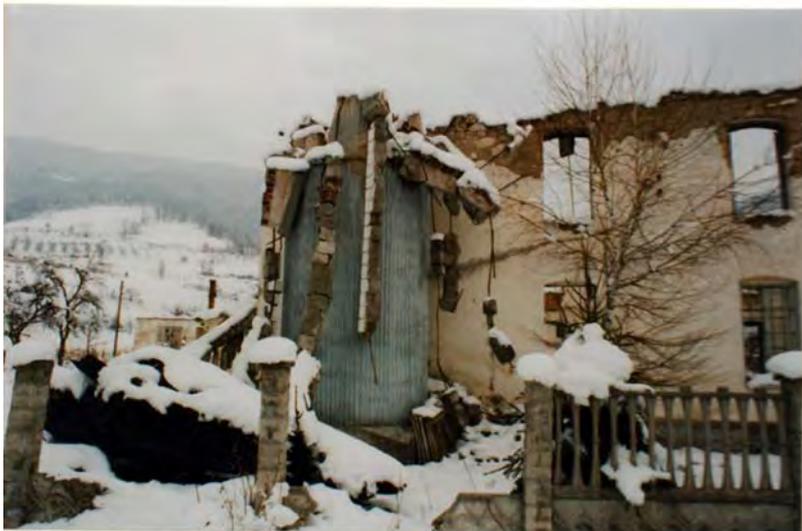
7.7 Sanica mosque – photo 2

The Sanica mosque at the end of the war, view from the WSW; note the rebar rods of the concrete minaret, bent outwards by the blast. The burned-out mosque is at right.

Damage description: In photographs taken after the end of the war, the mosque is completely burned out, its roof and minaret are gone, its interior is gutted and open to the sky. The perimeter walls are damaged but remain standing up to the roofline. The stump of the destroyed minaret shows signs of blast damage, with ribbons of concrete fragments dangling from iron rebar rods bent outwards by the blast.

According to information in the records of the Islamic Community of Ključ, the Sanica mosque was set on fire on 26 June 1992 and was completely burned out. All of the sacral objects inside the mosque, including many copies of the Holy Qur'an, as well as 72 old prayer carpets and 52 *čilims* (traditional Bosnian flat-weave prayer carpets), were looted or burned. The minaret was blown up on 1 August 1992.

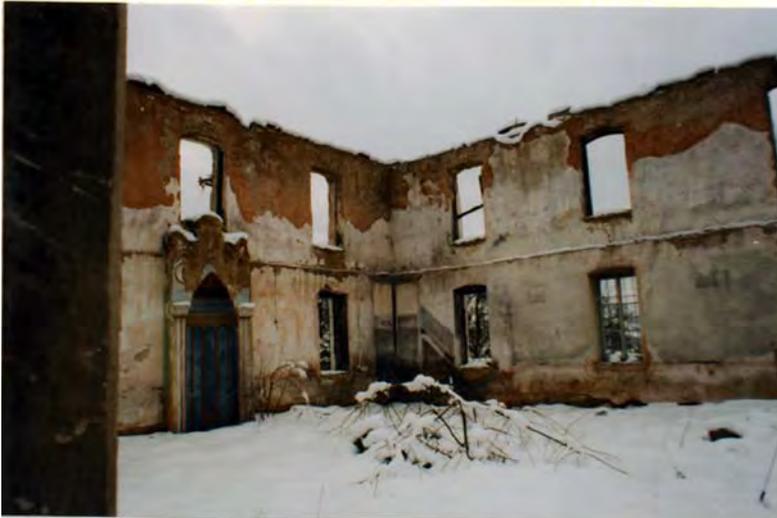
7.7 Sanica mosque – photo 3

Interior of the Sanica mosque at the end of the war; view looking towards the south. The mosque's *mihrab* (prayer niche) is seen at left.

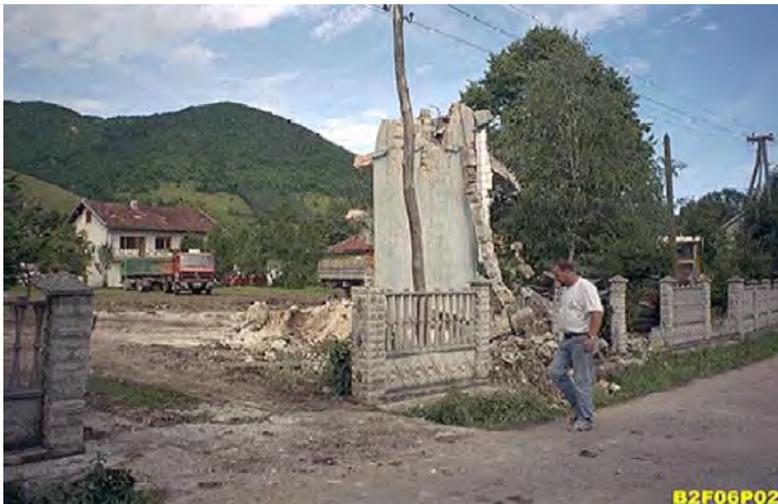
7.7 Sanica mosque – photo 4

Site of the Sanica mosque; the stump of the minaret is in the foreground, the newly cleared site of the ruined mosque is in the rear.

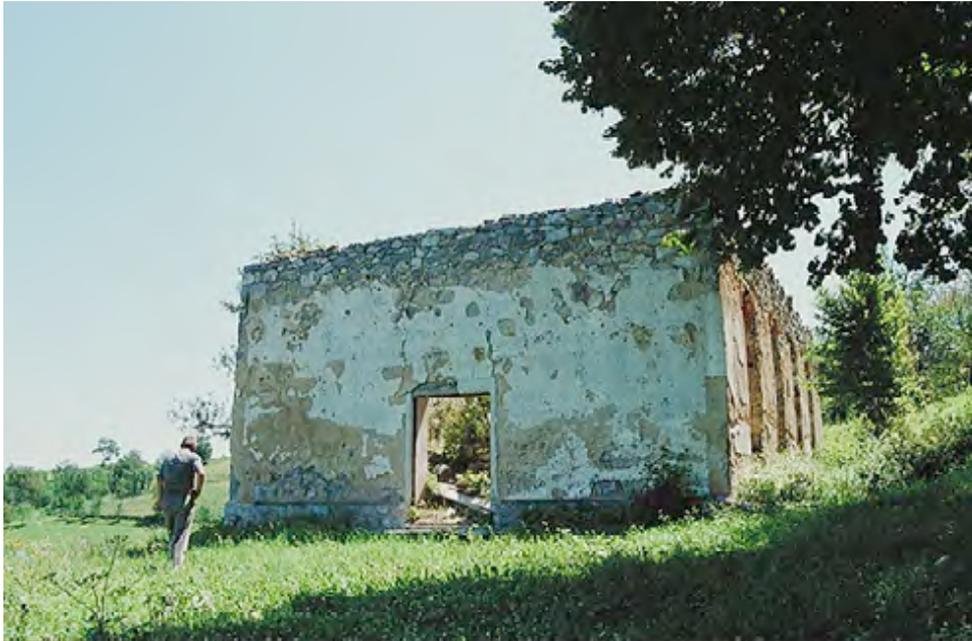
7.8 Tićevići mosque – photo 1

Entrance façade of the burned-out mosque, viewed from the WNW. The plastered surface on the front wall (which was an interior wall facing the portico) indicates the former extent of the mosque's burned entrance portico.

Damage description: The old mosque in Tićevići is burned out, its roof and minaret are completely destroyed. The interior of the mosque is gutted and open to the sky, filled with rubble and overgrown with vegetation and tree saplings. The mosque's stone perimeter walls are damaged but still standing up to the roofline. Charred wooden elements embedded in the stone perimeter walls indicate damage from fire.

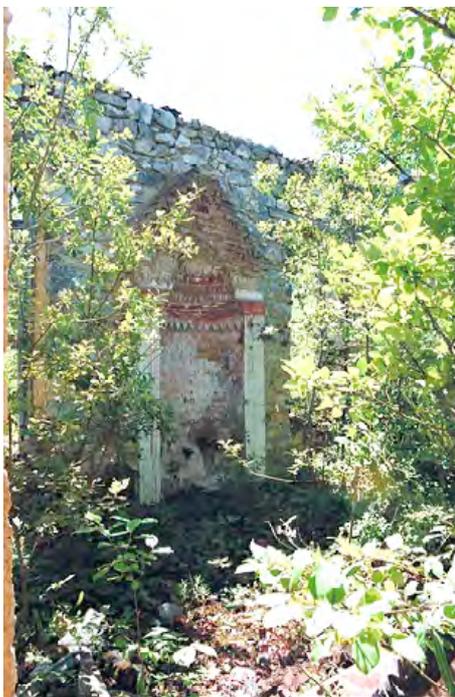
7.8 Tićevići mosque – photo 2

Interior of the burned-out mosque in Tićevići, facing the SE wall and the *mihrab*.

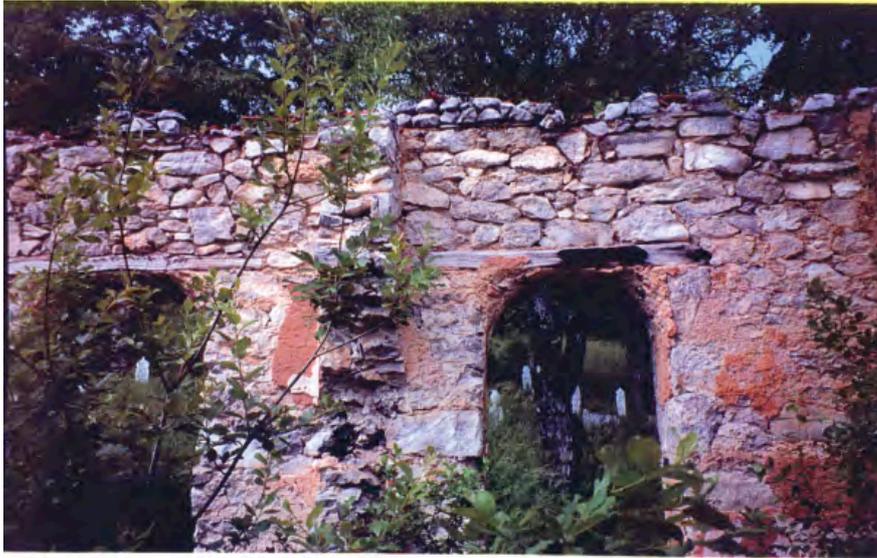
7.8 Tićevići mosque – photo 3

Detail view of the interior of the burned-out mosque in Tićevići. Note the char marks on the wall at center left and on the wooden lintel above the window at right.
