Municipality: 7. Brčko

7.1 Bijela Mosque

Neighborhood:	Kolobara
Town:	Brčko
GPS:	44°52'47.6"N 18°48'13.9" E
Construction:	19 th century (1881, rest. 1893)
Historical period:	Austro-Hungarian
Official status:	listed monument
Building use:	religious
Building type:	Mosque
Building setting:	city
Building condition:	completely destroyed under reconstruction

Damage description: Mosque completely destroyed, ruins razed, building materials removed.

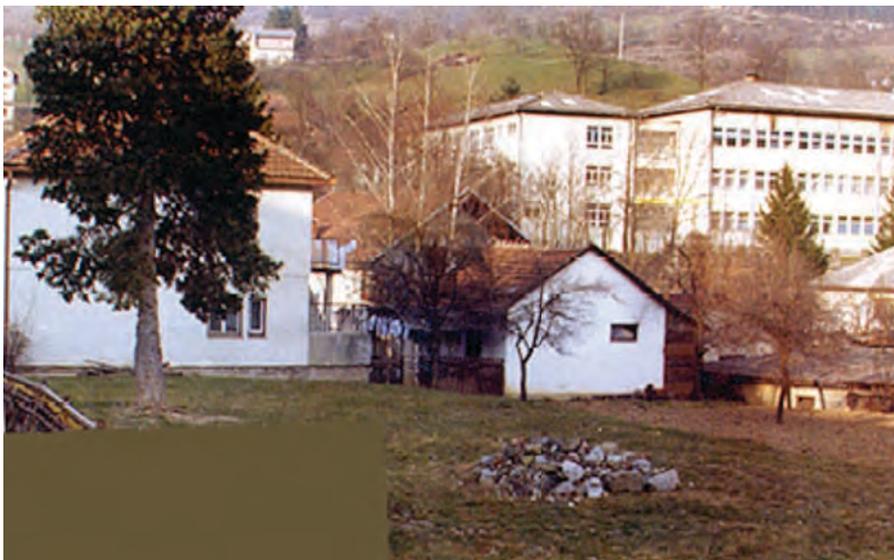
7.9 Town Catholic church in Ključ – photo 2

A small pile of rubble marks the site of the razed Catholic parish church.

Damage description: The Catholic parish church, in the center of the town of Ključ, was destroyed by a blast, according to information from the Roman Catholic Diocesan authorities and photographs from multiple independent sources, taken after the end of the war. The ruins of the church were razed and its site cleared, A Council of Europe survey team in 1998 found only a small pile of rubble and grass growing on the leveled site of the destroyed church.

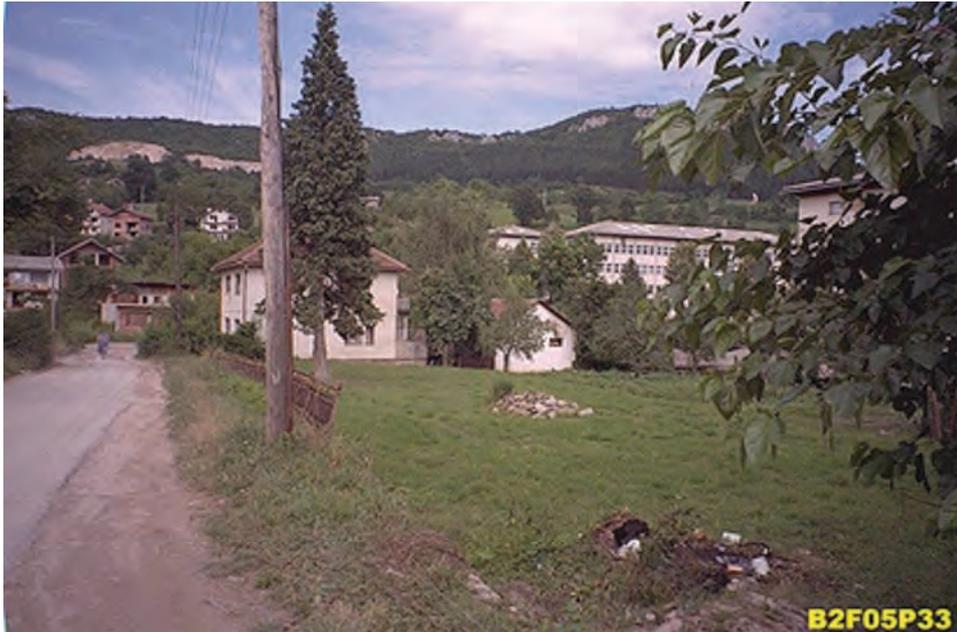
7.9 Town Catholic church in Ključ – photo 3

Empty site of the razed Roman Catholic parish church in Ključ.

(Note: This is a view from the opposite end of the road, as compared to Photo 1.)

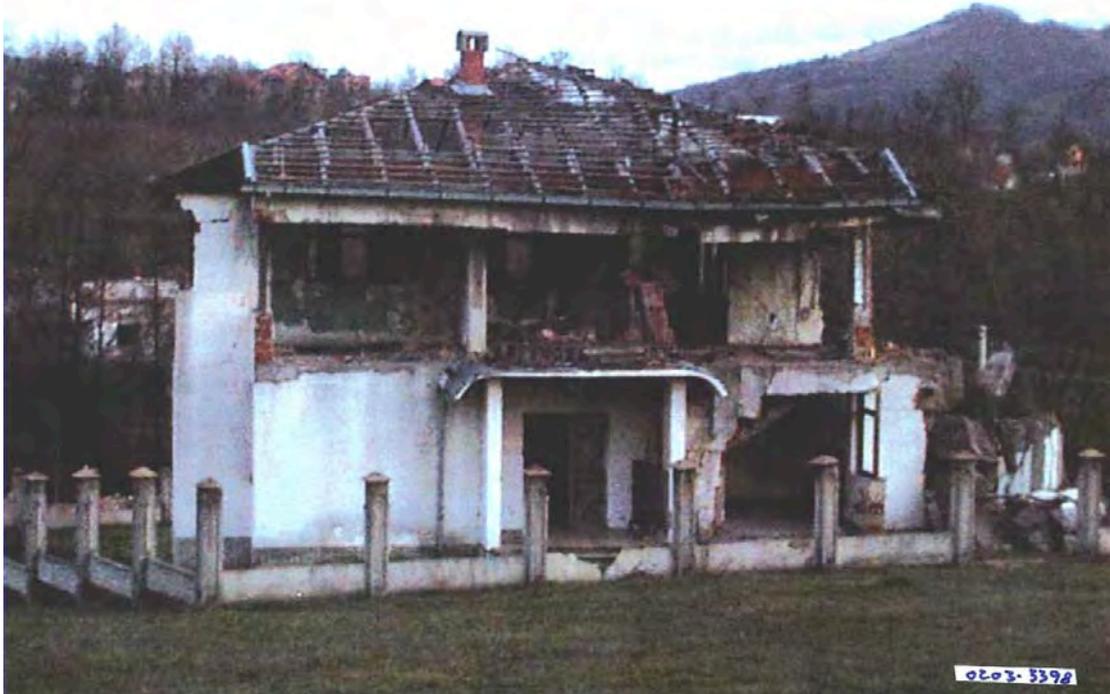
8.1 Hanifići mosque – photo 1

View of the entrance (NW) façade of the Hanifići mosque, base of minaret at right.

Damage description: The Hanifići mosque is completely burned out. Soot marks on its perimeter walls and the burned wooden roof structure indicate destruction by fire. The mosque's interior is gutted. The tall, concrete minaret to the right of the mosque's entrance has been toppled by a blast. In photographs taken after the war, the broken shaft of the toppled minaret can be seen lying on the ground, next to the mosque.

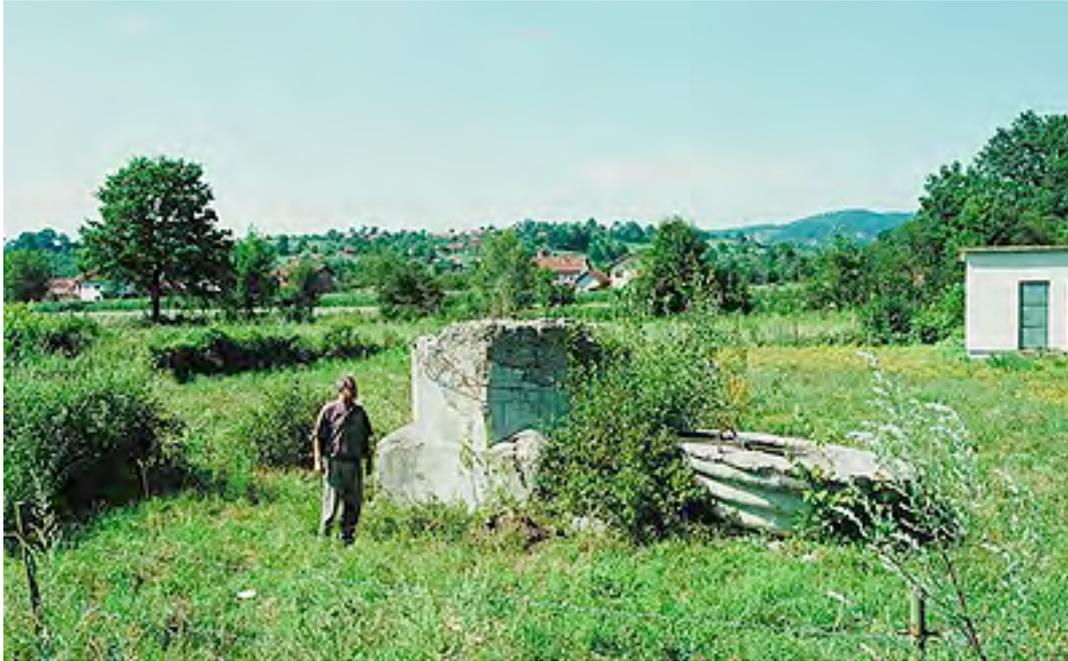
8.2 Vrbanjci mosque – photo 1

Site of Vrbanjci mosque; stump of minaret and muezzin's balcony (*šeref*) at right.

Damage description: The Vrbanjci mosque is completely destroyed, the site leveled, all building materials removed. At the time of the author's survey visit one could still trace the outlines of the mosque's foundations. The only part remaining above ground is the massive stump (ca. 2.5m tall) of the destroyed minaret, and the circular base of the muezzin's balcony (*šeref*) of the minaret, lying on the ground next to the stump.

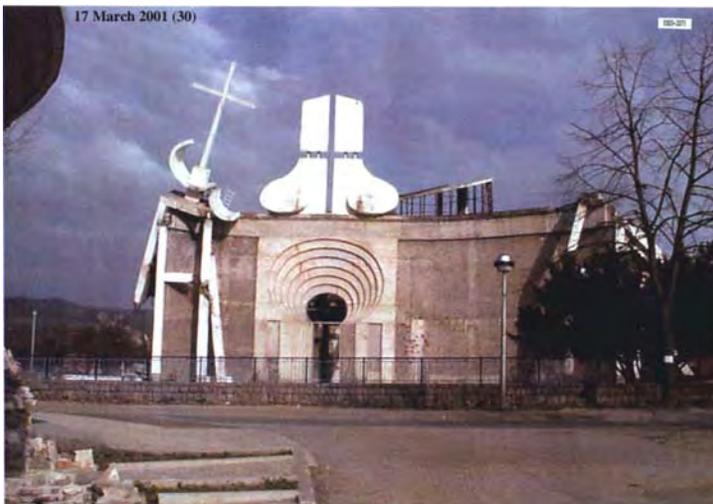
8. 3 Catholic church in Kotor Varoš – Photo 2

Exterior view of the church, with the remains of the blown-up church steeples.

Damage description: The Town Catholic church's twin steeples were toppled by a blast. The roof of the church has substantially collapsed and the church's interior is completely burned out. Graffiti in Serbian were seen on the damaged interior walls of the church. One of the two felled church steeples toppled into the adjacent parish center, causing heavy damage. The damaged parish center, seen in photographs taken during the war, has since been torn down.

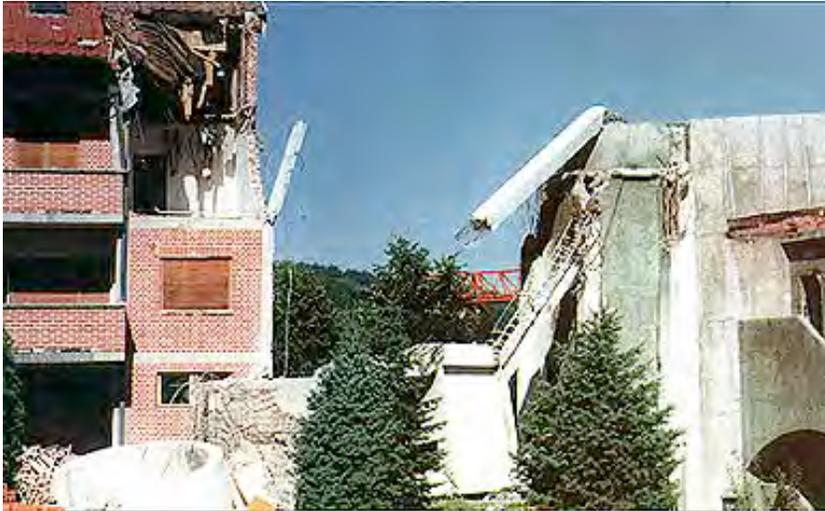
8.3 Catholic church in Kotor Varoš – Photo 3

Blown-up church steeple, collapsed into the adjacent parish house.

Informant statement: The parish church in Kotor Varoš was set on fire on 2 July 1992 and burned out completely. The church's two belfries were blown up in August 1993; one of them collapsed into the parish house, which stood next to the church.

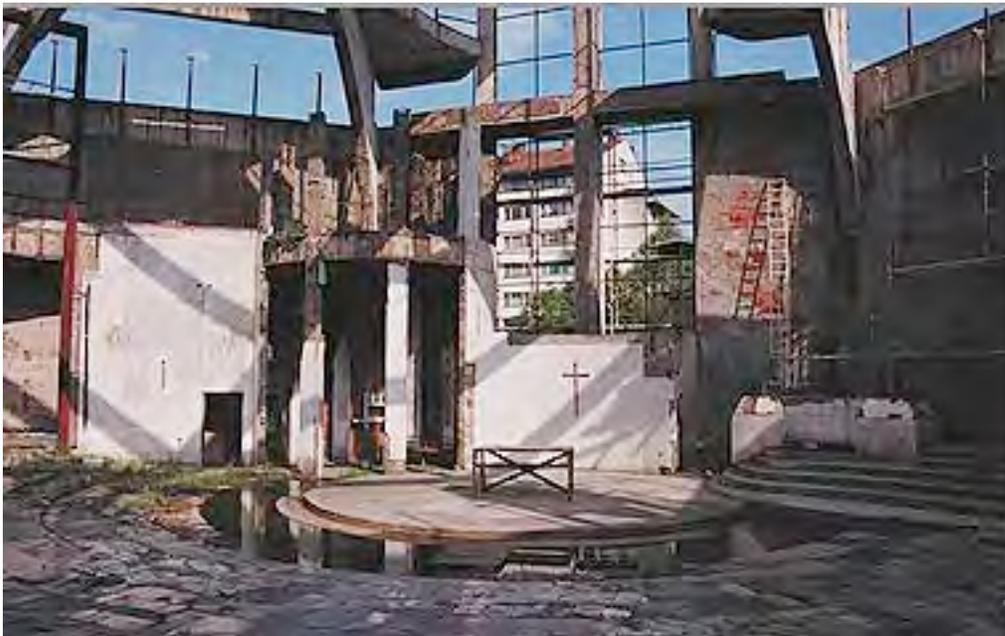
8.3 Catholic church in Kotor Varoš – Photo 4

Burned-out and roofless interior of the Catholic parish church, facing towards the altar.

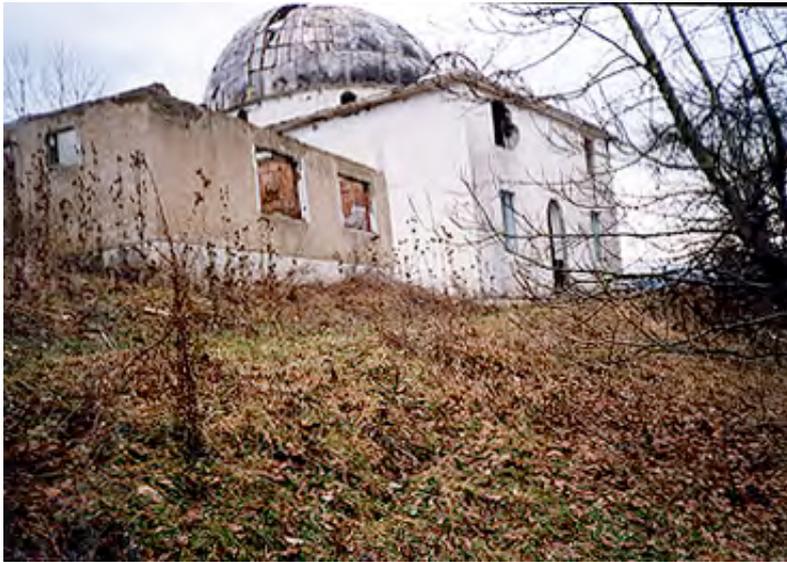
8.4 Hrvaćani mosque – photo 1

The Hrvaćani mosque at the end of the war, viewed from the north; entrance at right.

Damage description: In photos taken after the war, the Hrvaćani mosque's minaret is completely destroyed. The mosque itself is damaged by fire and by multiple projectile impacts. Its main dome is split and there are projectile holes in its perimeter walls. Large cracks can be seen in the mosque's *mihrab* wall. An adjacent small building, the mosque annex, is also burned out and has lost its roof.

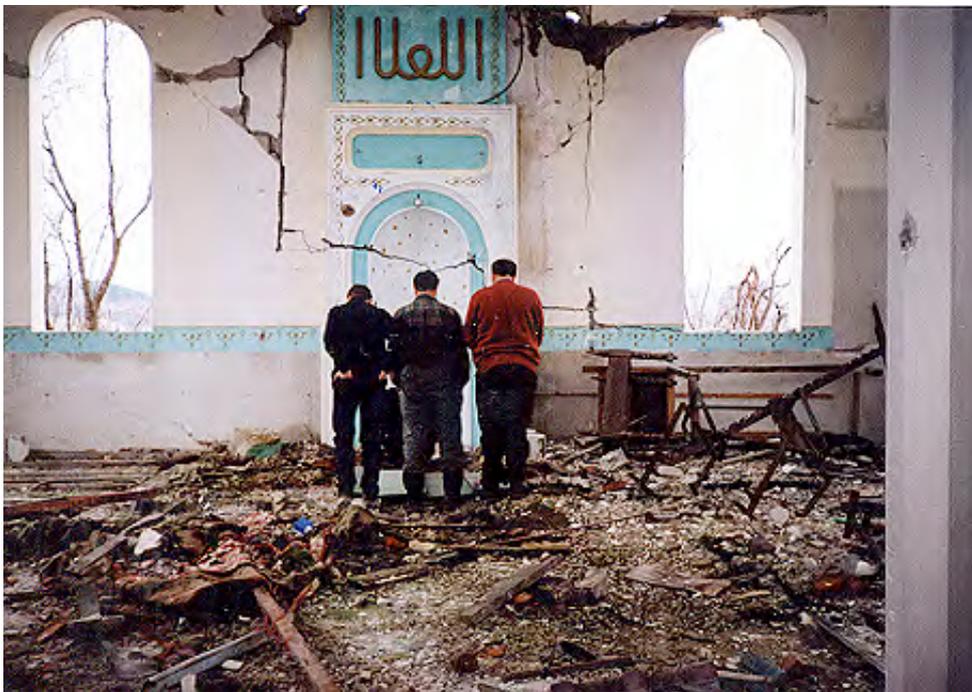
8.4 Hrvaćani mosque – photo 4

Interior view of the mosque in Hrvaćani at the end of the war. Note signs of fire damage to the interior and extensive blast damage to the mosque's *mihrab* wall.

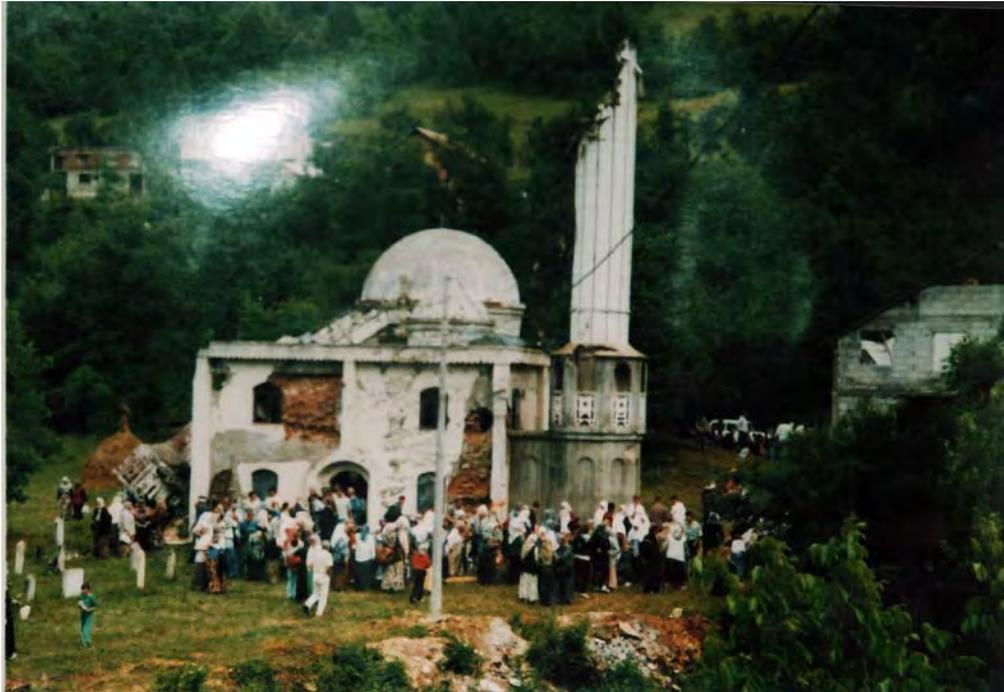
8.5 Old mosque in Večiči – photo 1

The Old mosque in Večiči after the end of the war. The shaft of the toppled minaret can be seen on the ground to the left of the mosque and on top of the entrance portico.

Damage description: The minaret is decapitated, its severed top half toppled onto the mosque, damaging the building. In a photo taken after the end of the war, the shaft of the minaret can be seen on top of the mosque and on the far side (the NE side) of the building. The bottom half of the broken shaft of the minaret is still standing but has multiple projectile impact holes. The northwest and northeast perimeter walls of the mosque are damaged by multiple projectile impacts. Multiple projectile impact holes penetrate the large main dome of the mosque. Two of the three small domes over the entrance and the roof of the portico of the mosque were smashed and destroyed by the fallen minaret.

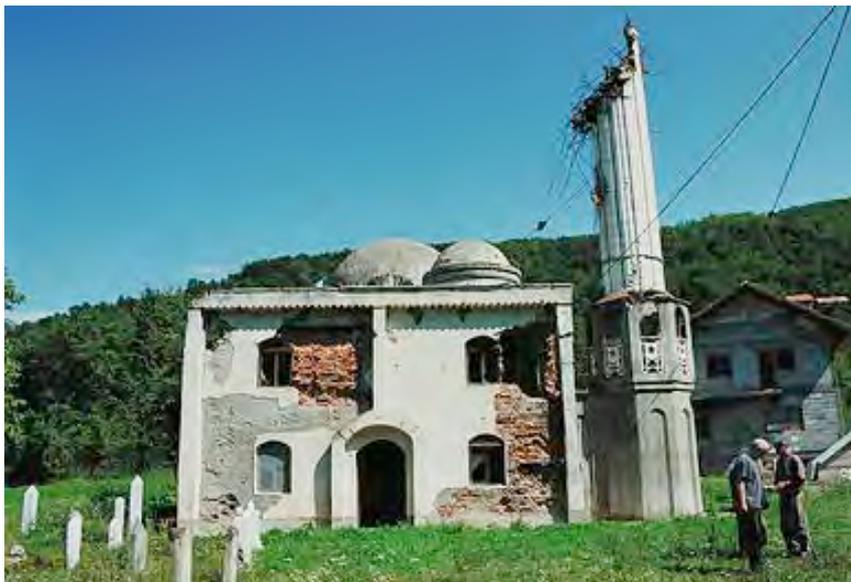
8.5 Old mosque in Večiči – photo 2

Damaged NW façade, decapitated minaret; note missing small domes at left.

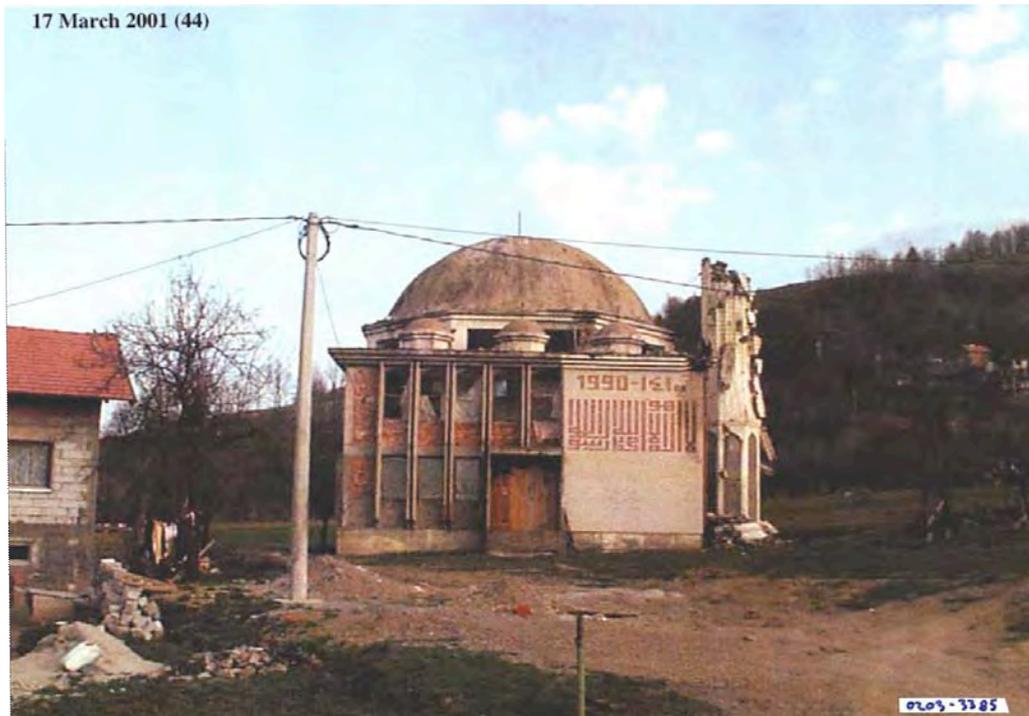
8.6 New mosque in Večiči – photo 1

View of the entrance façade of the New mosque, the stump of the minaret at right, rebuilt imam's house at left.

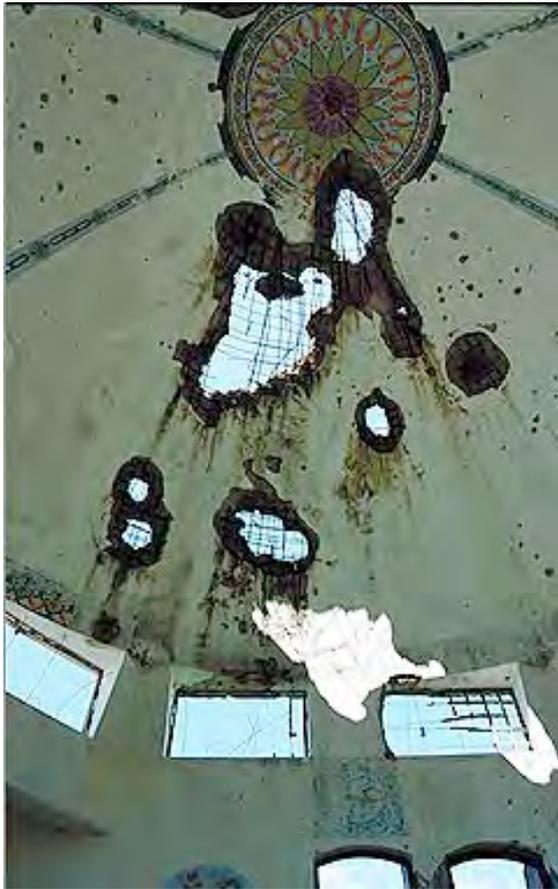
8.6 New mosque in Večići – photo 3

Interior view of the New mosque, showing projectile damage to the main dome.

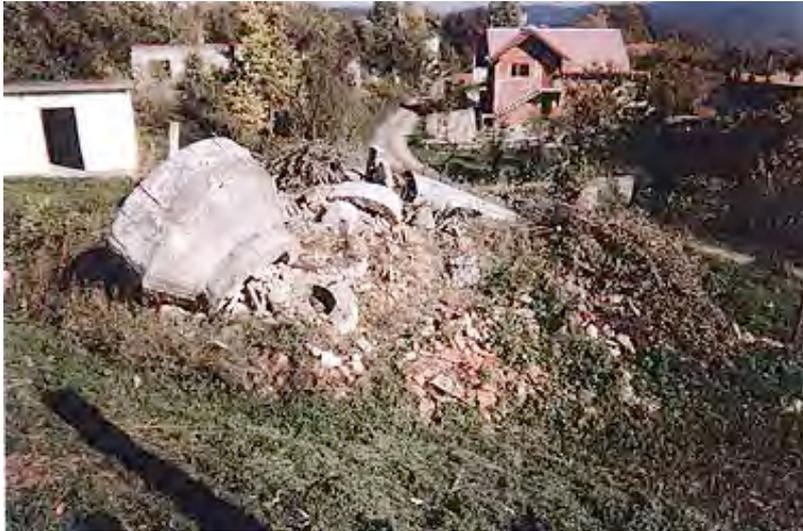
8.8 Ravne mosque – photo 1

Ruins of the Ravne mosque after the end of the war. The only recognizable element remaining is the concrete muezzin's balcony (*šerefe*), at center left, and fragments of the destroyed minaret.

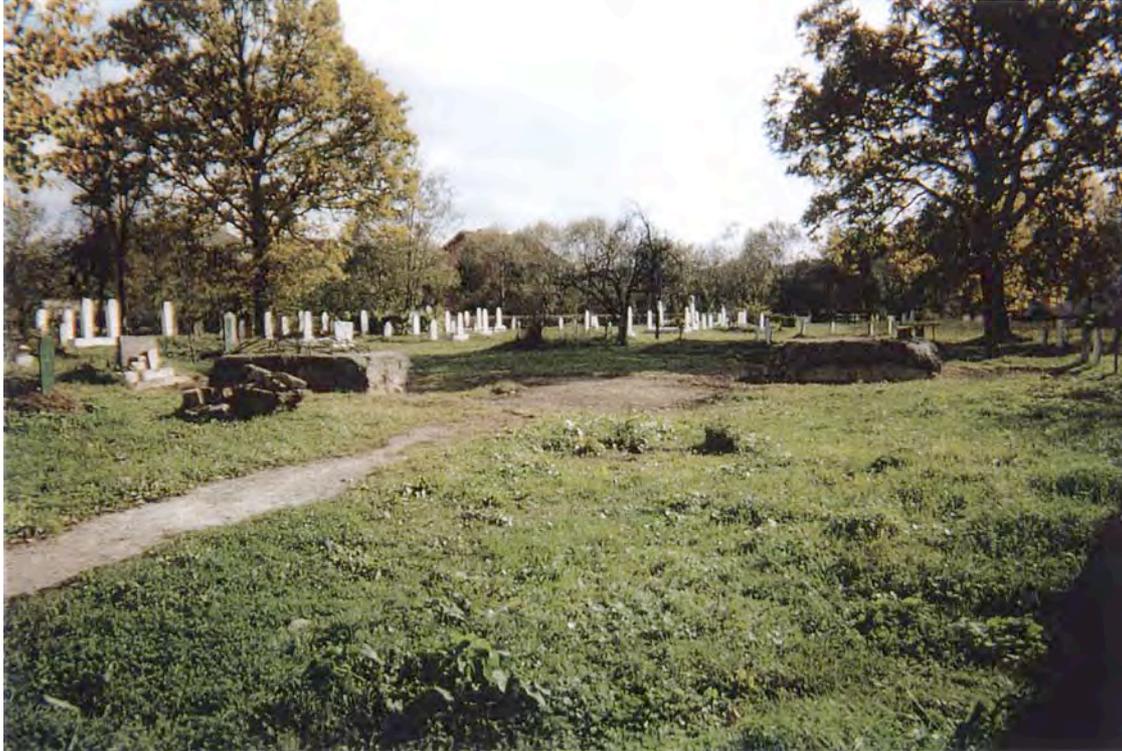
8.9 Donja Varoš mosque – photo 1

Foundations of the destroyed Donja Varoš mosque.

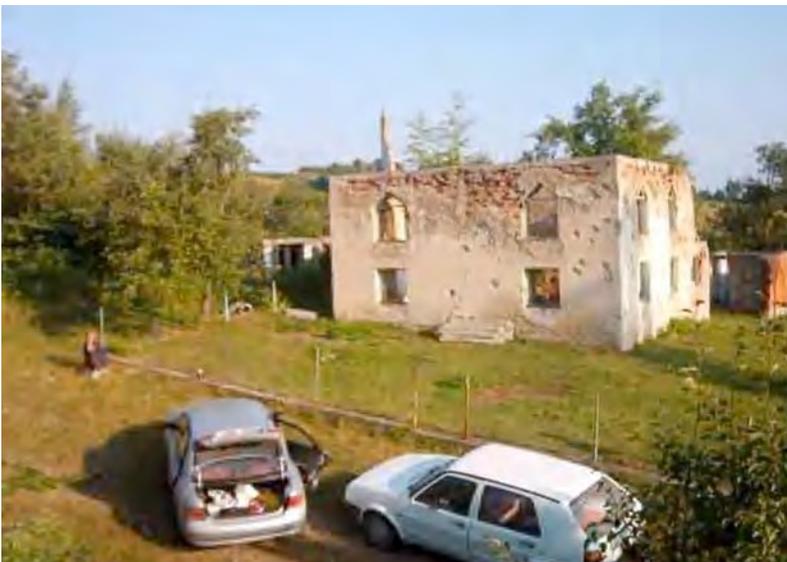
8.10 Hadrovci mosque – photo 2

Ruins of the Hadrovci mosque, view from ESE. Note the pattern of three projectile impacts in the center of the *mihrab* (SE) wall, also seen in Photo 1. Part of the broken minaret can be seen projecting above the walls from behind the mosque, at center left.

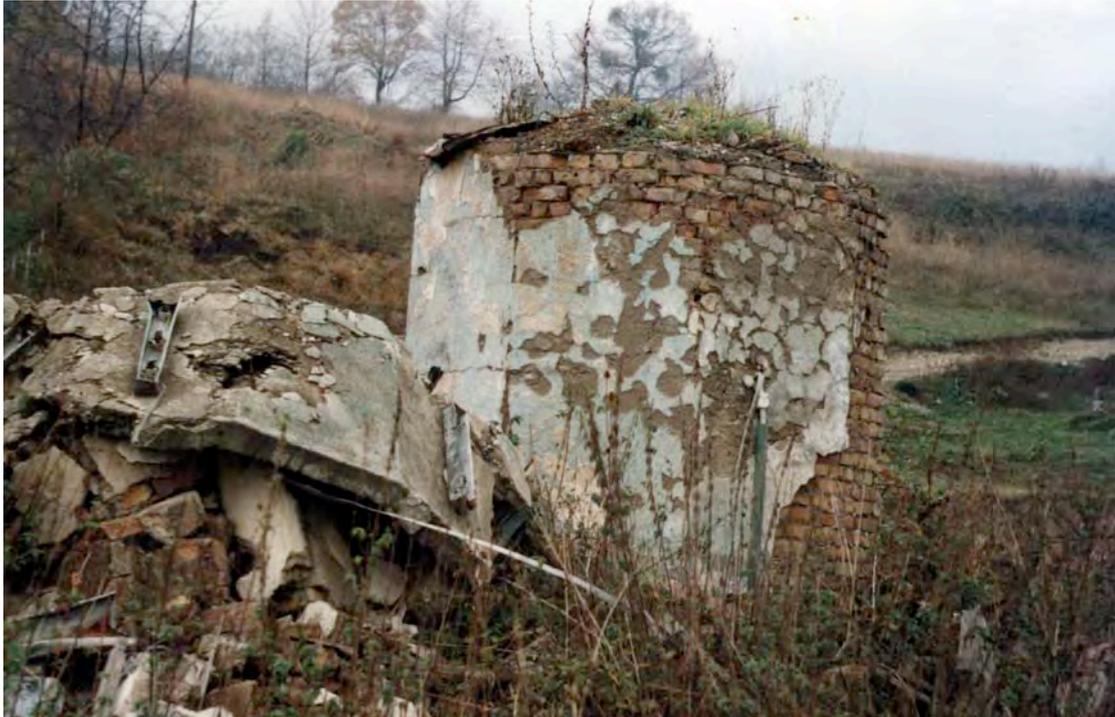
9.1. Ahatovići mosque – photo 1

Damage description: In photos of the Ahatovići mosque taken immediately after the end of the war, only the stump of the minaret is left standing. Other identifiable elements of mosque (such as a column with painted arabesque decoration) can be seen among the building debris next to the base of the minaret.

Photo (1996) Kemal Zukić, Center for Islamic Architecture, Community of BiH.
Stump of the minaret and rubble of Ahatovići mosque.

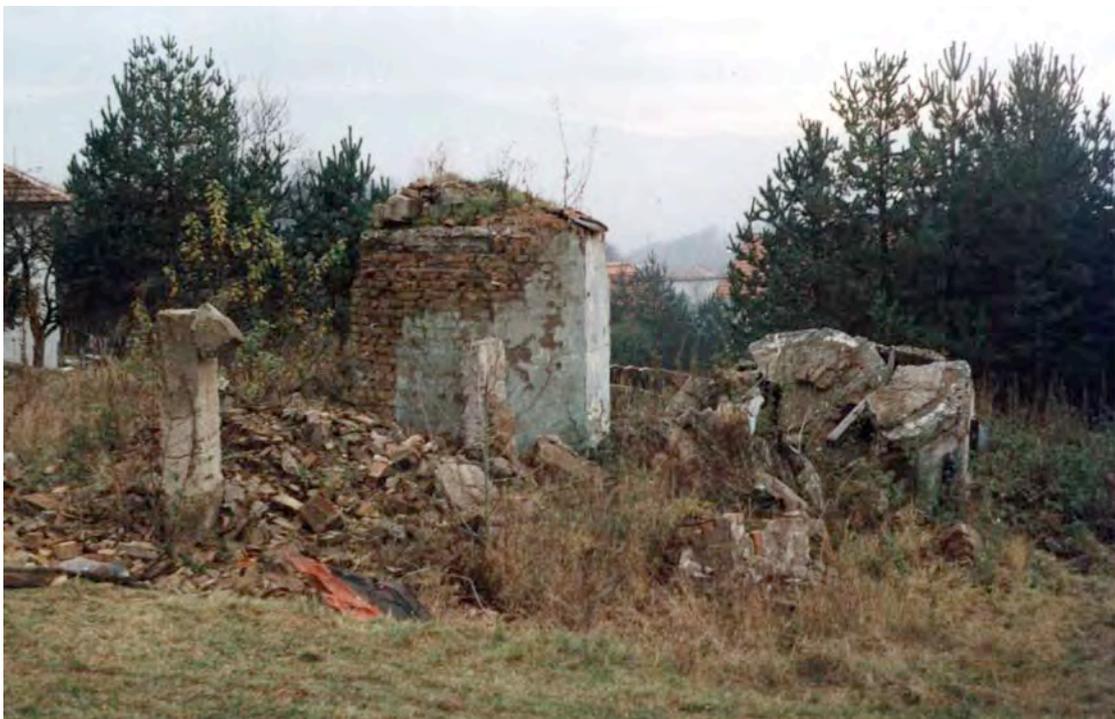
9.1. Ahatovići mosque – photo 2

Photo (1996) Kemal Zukić, Center for Islamic Architecture, Community of BiH.
Stump of the minaret and rubble of Ahatovići mosque.

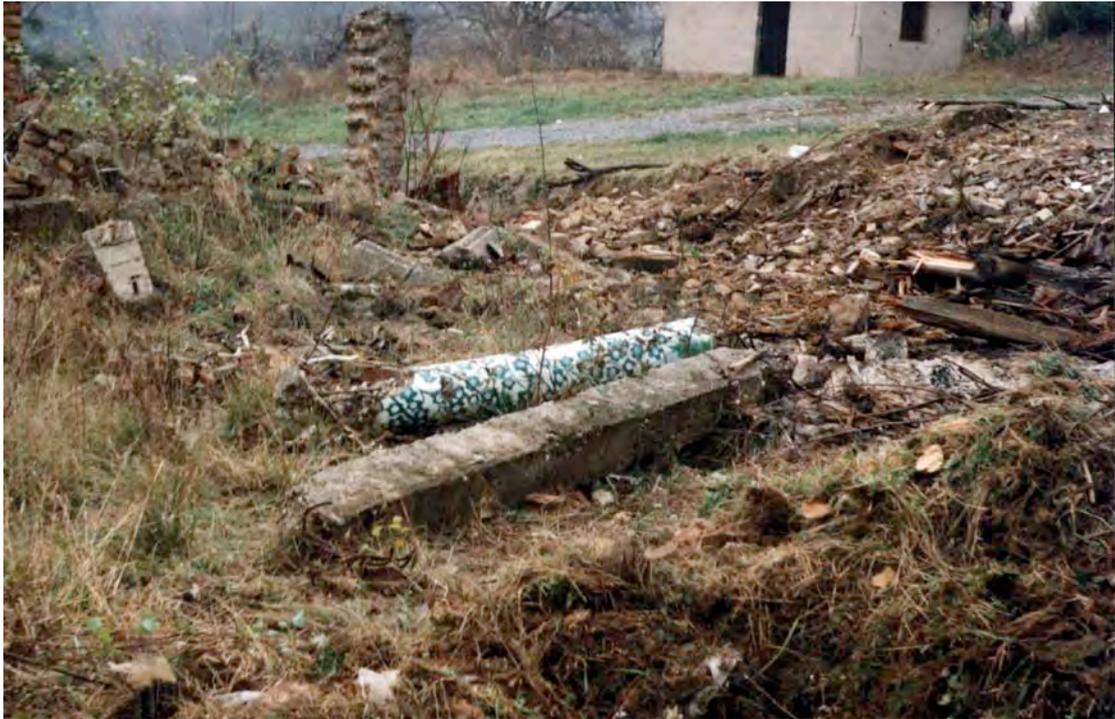
9.1. Ahatovići mosque – photo 3

Photo (1996) Kemal Zukić, Center for Islamic Architecture, Community of BiH.
Fragment of ornamental element from the mosque's interior in rubble at edge of site.

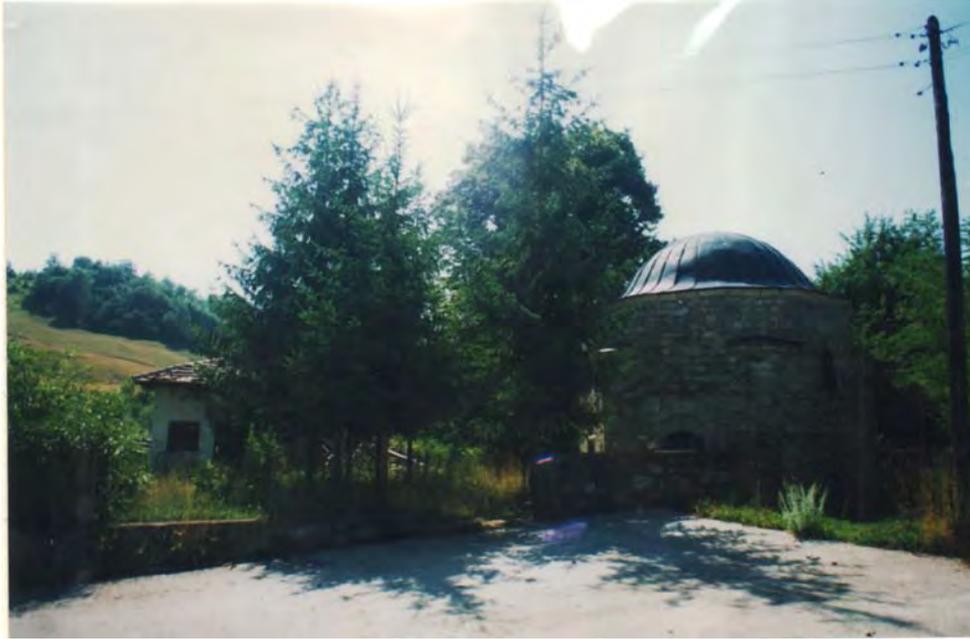
10.1. Prača mosque – photo 1

Damage description: In photographs taken after the end of the war, the Semiz Ali Pasha mosque in Prača is completely destroyed, its ruins razed, the site leveled. Most of the building materials of the mosque have been removed. All that remains is a pile of cut stones at the rear of the site of the razed building.

Photo: Kemal Zukić, Islamic Community of Bosnia and Herzegovina (1996).
Site of razed mosque at end of war (L) and the turbe of Semiz Ali Pasha (R).

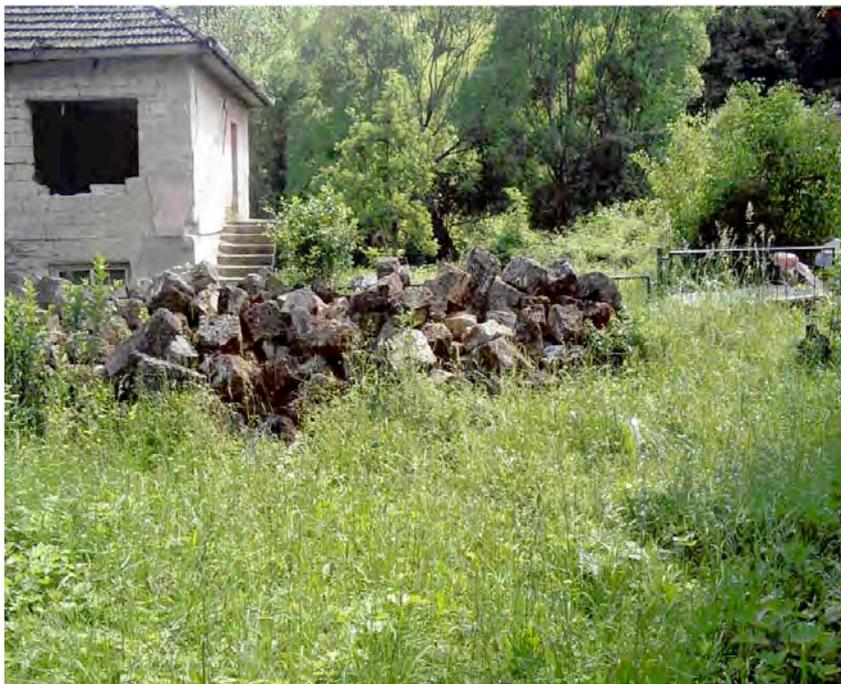
10.1. Prača mosque – photo 2

Photo: Commission to Preserve National Monuments of BiH. ICTY OTP 0617-9146.
Site of razed Semiz Ali Pasha Mosque after end of war, cut stones piled at rear of site.

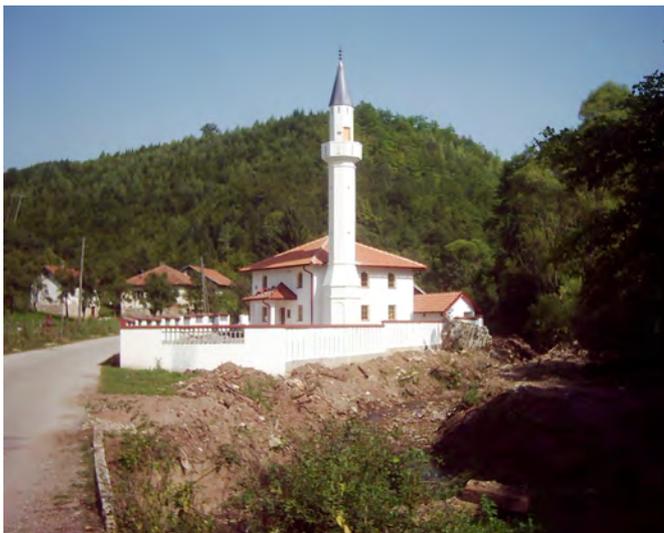
10.2. Podvitez mosque – photo 2

Photo (2008) Center for Islamic Architecture, Islamic Community of BiH.
The Podvitez mosque, rebuilt after the war at the same site. Note the skyline behind the mosque and the changed structure of the rebuilt mosque and its portico.

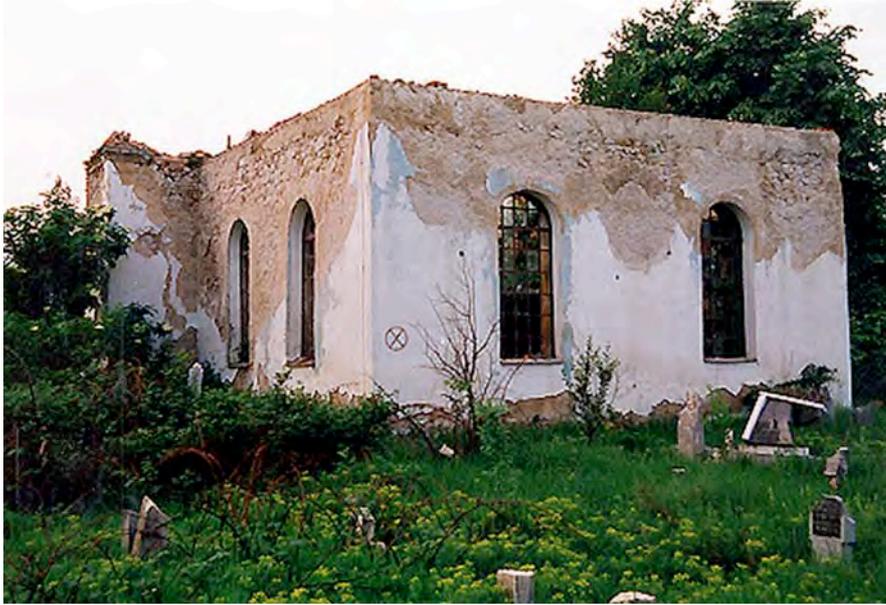
11.1. Kozaruša mosque – photo 1

Damage description: In photographs taken at the end of the war the mosque is seen completely burned out. The mosque's roof has collapsed, its interior gutted and open to the sky. The minaret has been destroyed by a blast. The mosque's perimeter walls remain standing up to roofline.

Burned-out mosque, stump of minaret at left, at end of the war; viewed from the SE.

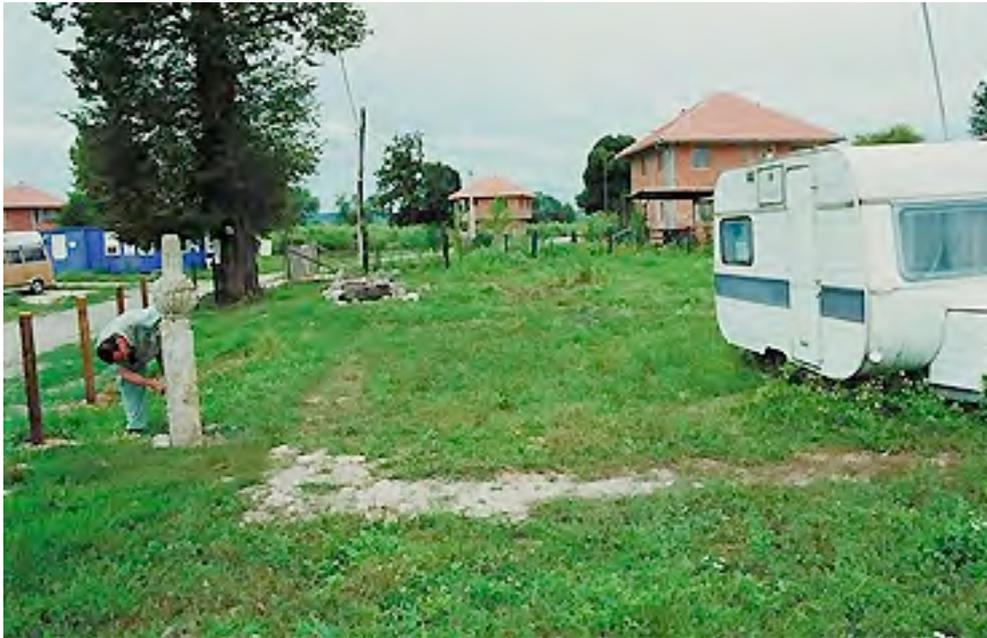
11.2. Stari Grad mosque in Prijedor – photo 1

Damage description: The Stari Grad mosque is completely destroyed, the ruins razed, all building materials removed from site. The mosque site has been leveled with heavy equipment and is overgrown with grass. All but one of the old Ottoman-era Muslim gravestones that stood next to the old mosque have also been uprooted.

The outlines of the foundations of the razed mosque still visible in the grass. The old Muslim tombstone at left is the last one still standing at the site; cf. photo 3 below.

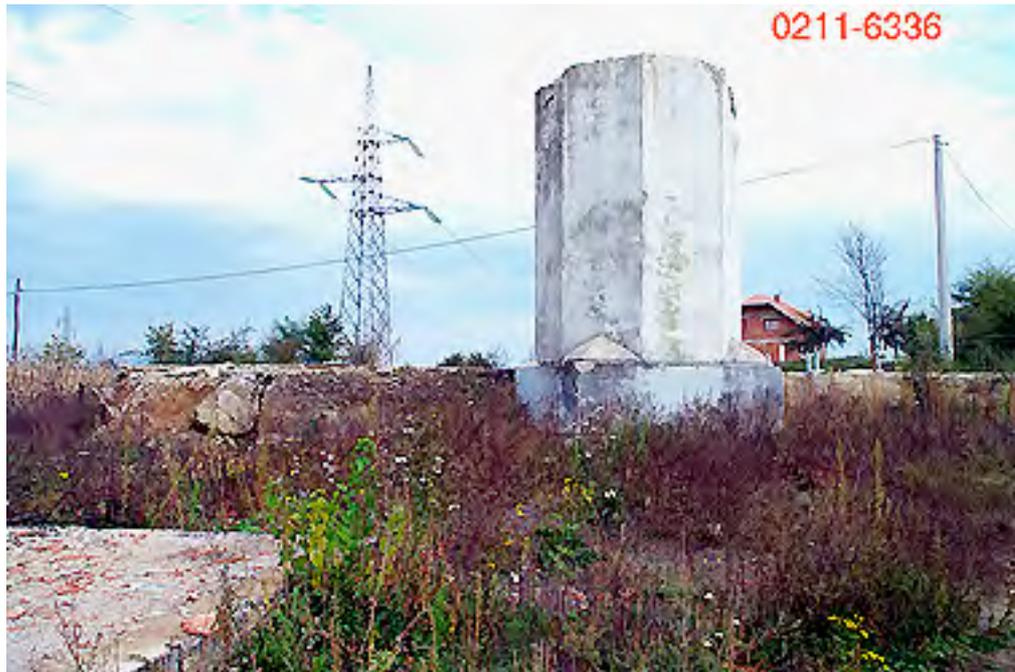
11.3. Čarakovo mosque – photo 1

Damage description: The Čarakovo mosque is almost completely destroyed, only the massive stump of the minaret and the mosque's foundations remain at the site.

Stump of the destroyed minaret and foundations of razed mosque; view from SW.

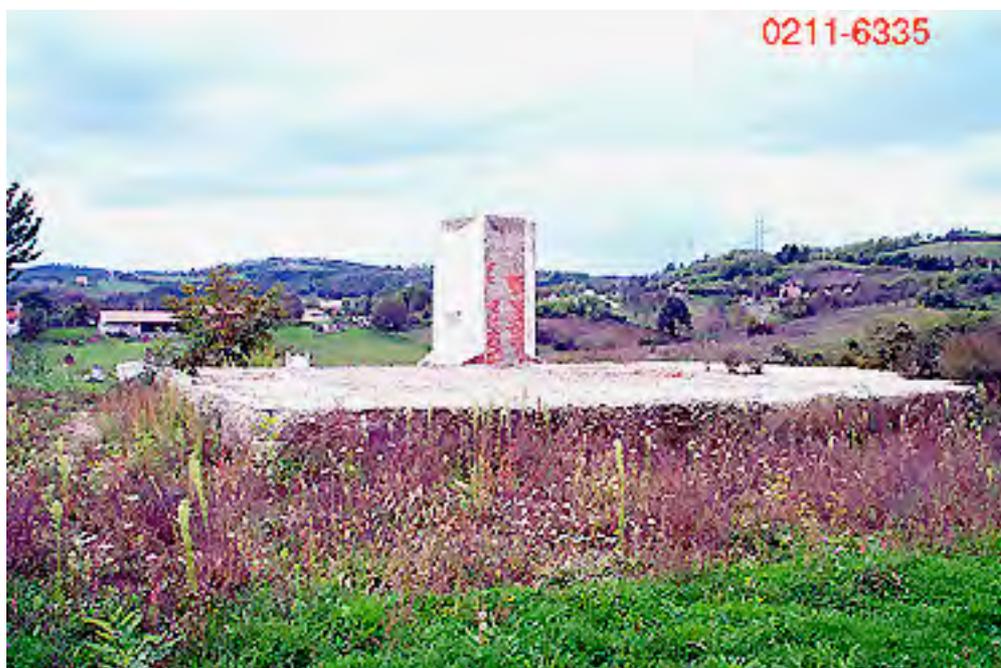
11.3. Čarakovo mosque – photo 2

Foundations of the razed mosque and stump of minaret, viewed from the NE.

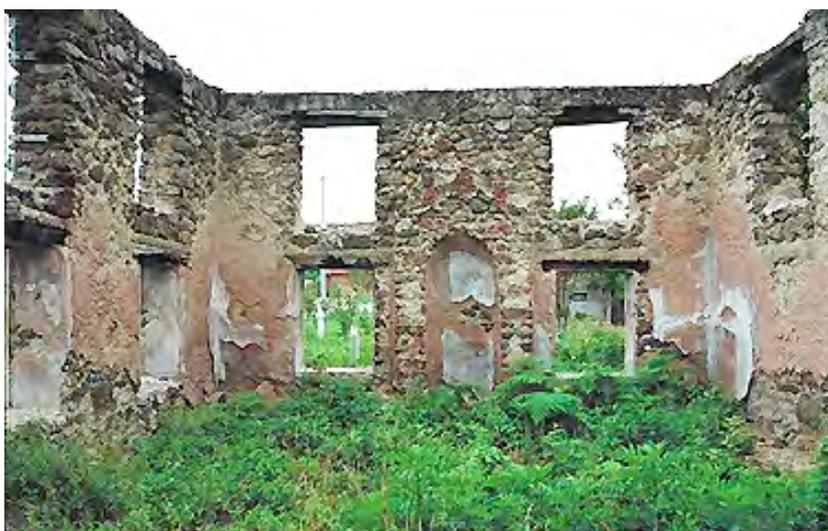
11.4. Old mosque in Hambarine – photo 1

Damage description: The Old Mosque in Hambarine is a burned out ruin, its roof and minaret gone, its interior gutted and open to the sky. Charred timbers and scorch marks on walls signal destruction by fire. The perimeter walls remain standing up to the roofline. The plastered walls of the entrance portico of the mosque are scorched near the door and windows and pitted with scattered bullet holes.

Interior view of burned-out mosque, facing the *mihrab* (prayer niche)

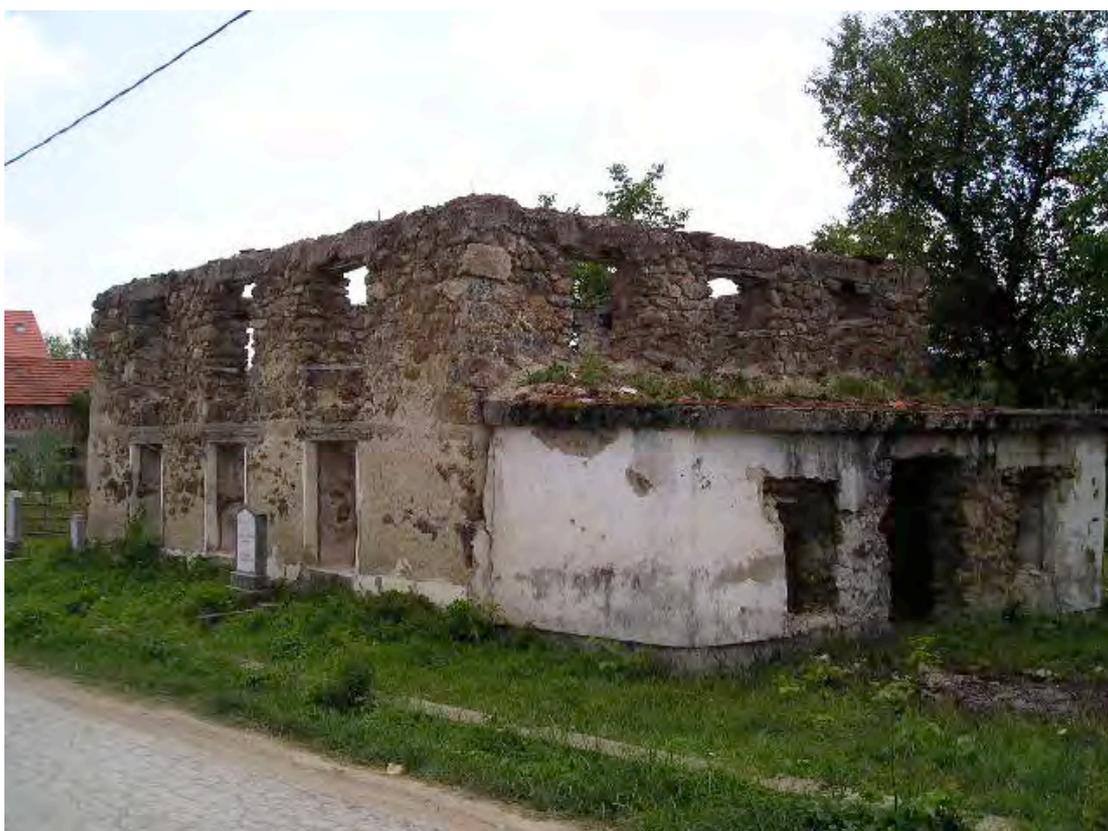
11.4. Old mosque in Hambarine – photo 2

Exterior view of burned-out mosque, viewed from the north, entrance at right..

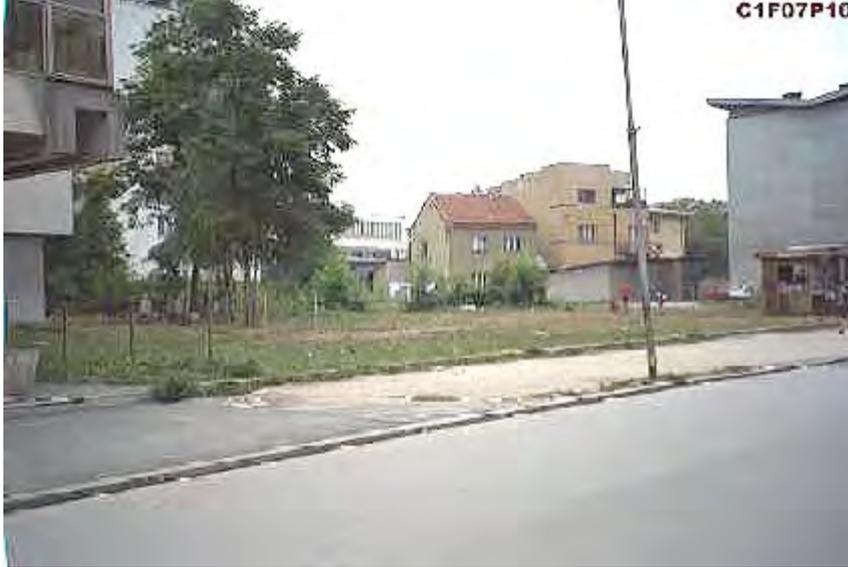
11.5. Čaršijska mosque in Prijedor – photo 1

Damage description: The Čaršijska mosque is completely destroyed, the site leveled, all building materials removed. The empty site of the destroyed mosque is being used for market stalls and for dumping rubbish.

Site of the Čaršijska mosque. Note the modern buildings flanking the site of the mosque, also seen in the pre-war photo of the mosque (photo 3).

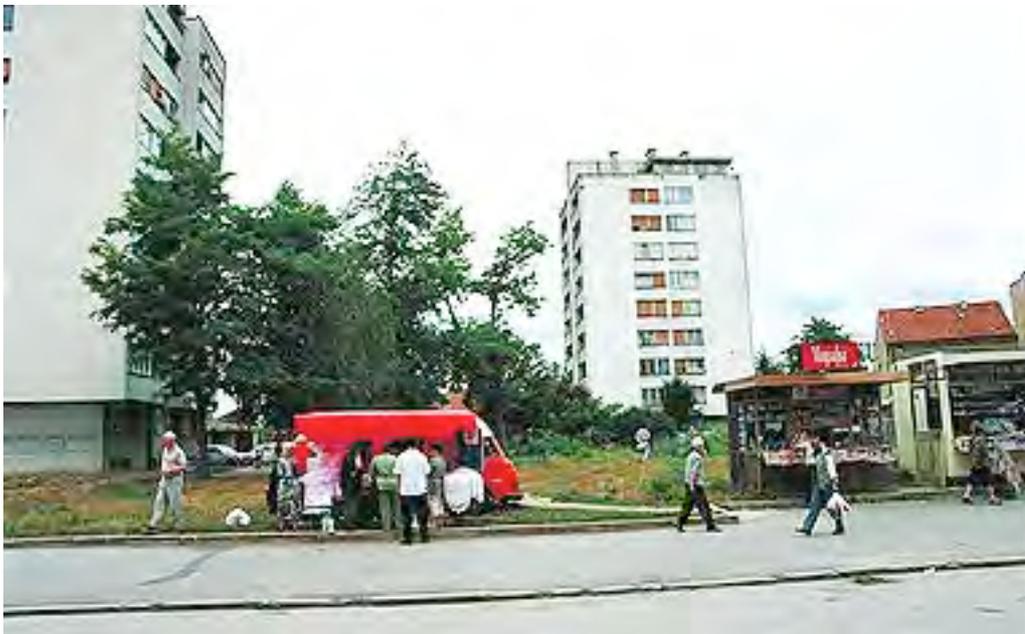
11.5. Čaršijska mosque in Prijedor – photo 2

Site of the razed Čaršijska mosque being used for market stalls.

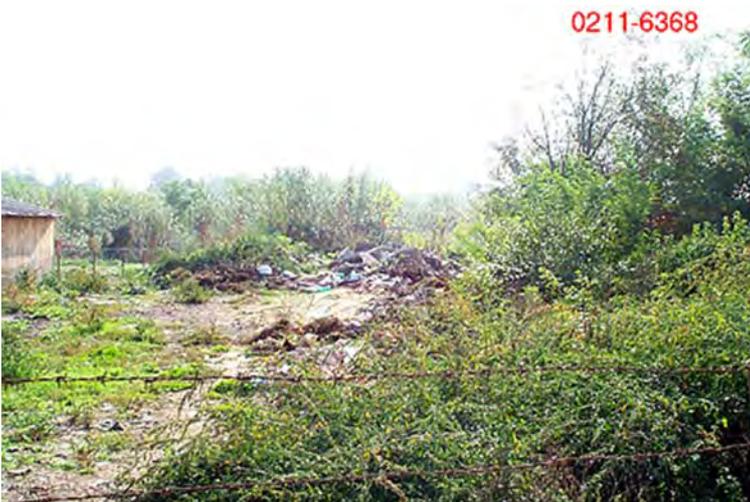
11.6. Zagrad mosque in Prijedor – photo 2

Photo (2001) ICTY OTP 0211-6368.
Rubbish dumped at the site of the destroyed Zagrad mosque.

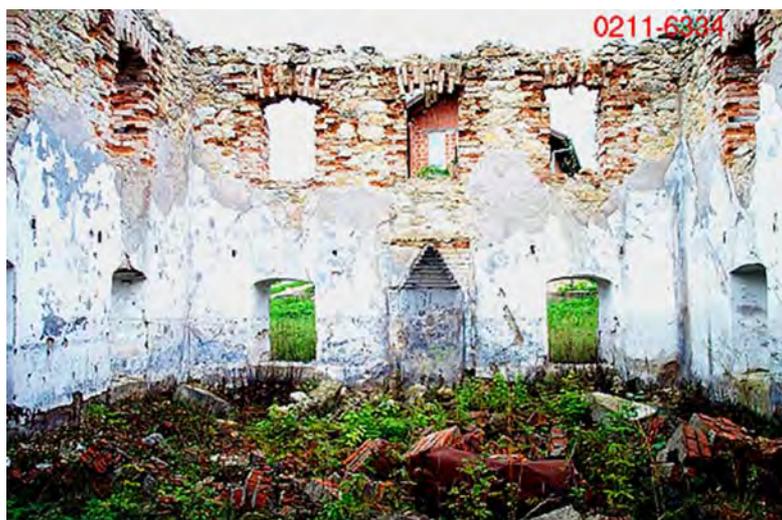
11.7. Bišćani mosque – photo 1

View of the burned-out interior of the mosque, facing the *mihrab* (prayer niche).

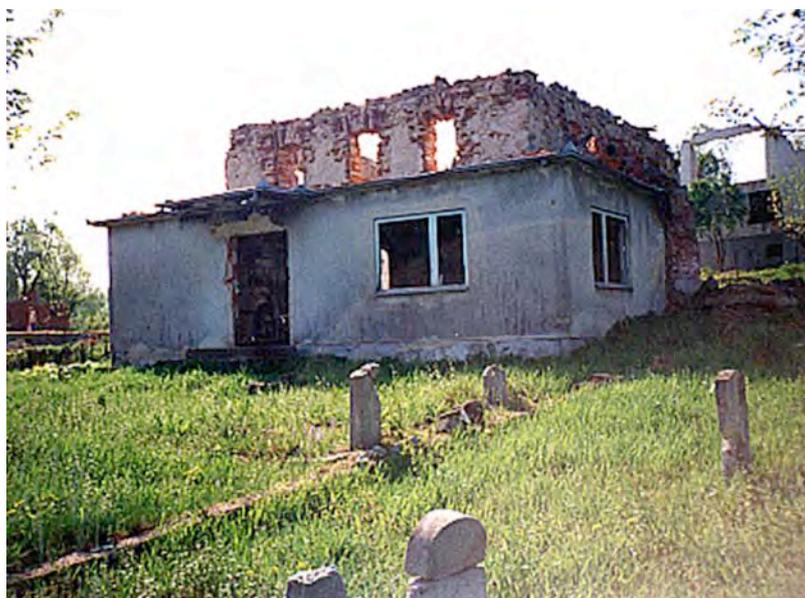
11.7. Bišćani mosque – photo 2

Exterior view of the burned-out mosque, broken Muslim tombstones in cemetery.

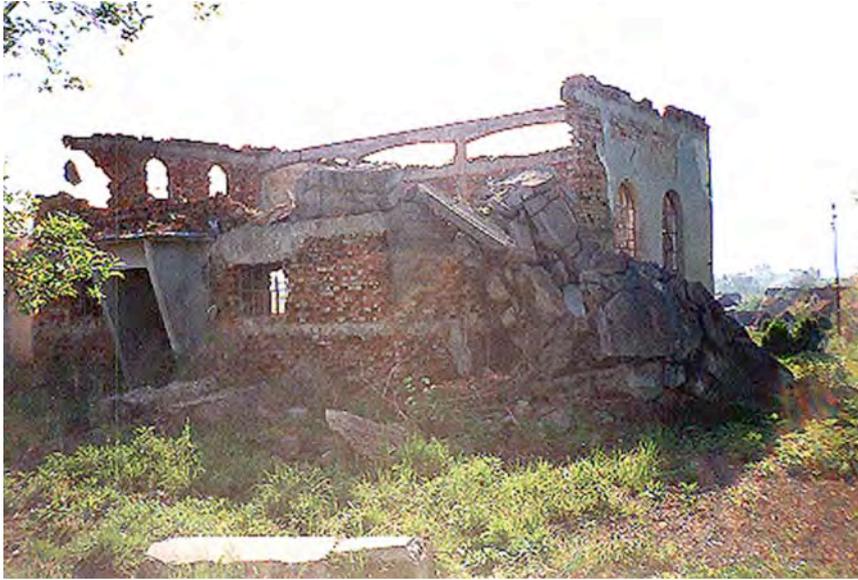
11.8. Gornja Puharska mosque – photo 1

Ruins of the Gornja Puharska mosque at the end of the war: view of collapsed entrance façade. The base of the destroyed minaret can be seen at the right.
