Municipality: 7. Brčko

7.1 Bijela Mosque

Neighborhood:	Kolobara
Town:	Brčko
GPS:	44°52'47.6"N 18°48'13.9" E
Construction:	19 th century (1881, rest. 1893)
Historical period:	Austro-Hungarian
Official status:	listed monument
Building use:	religious
Building type:	Mosque
Building setting:	city
Building condition:	completely destroyed under reconstruction

Damage description: Mosque completely destroyed, ruins razed, building materials removed.

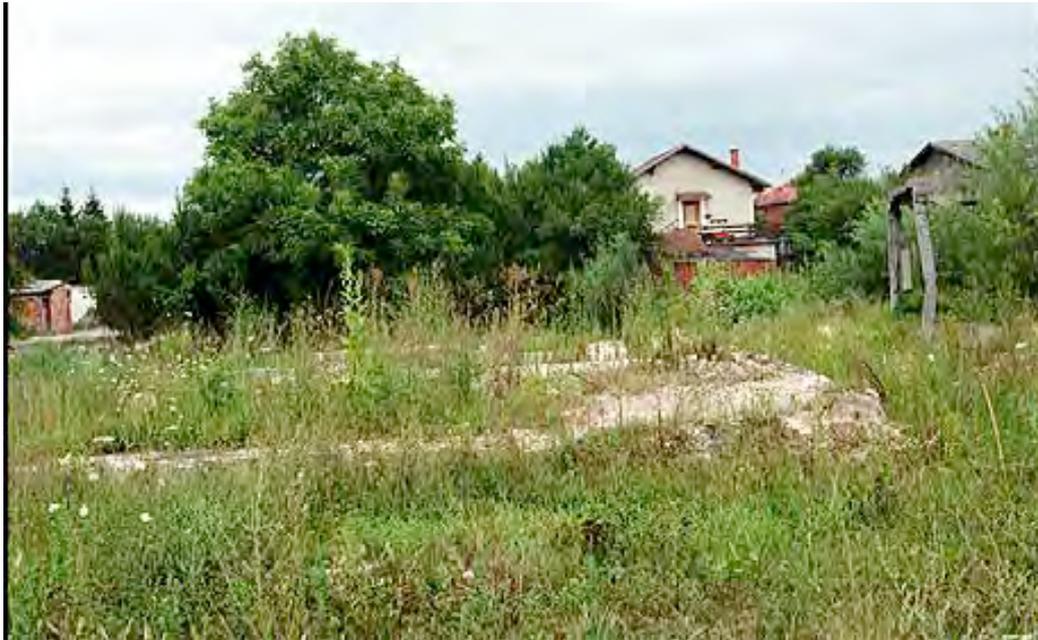
11.9. Donja Puharska mosque – photo 1

Site of the Donja Puharska mosque; only the foundations remain.

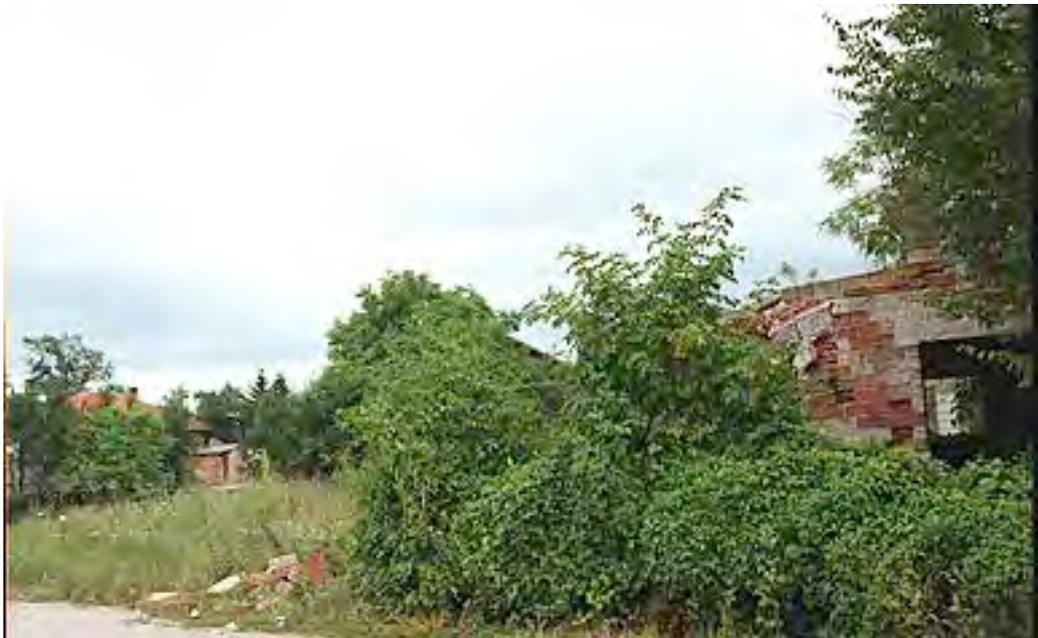
11.9. Donja Puharska mosque – photo 2

Mosque site at left; roofless ruin of the imam's house at right.

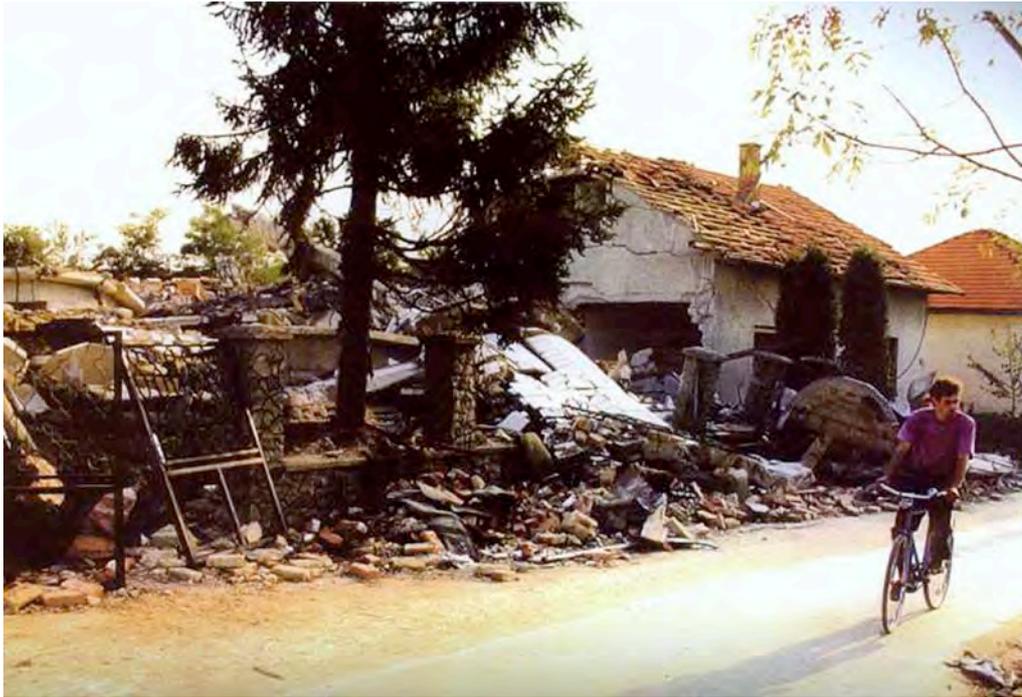
11.9. Donja Puharska mosque – photo 3

The Donja Puharska mosque shortly after its destruction. The rubble of mosque is at left. The shaft of the toppled minaret is lying atop the rubble between the tree and the imam's house (at right, with part of its roof smashed in). The circular base of the conical metal cap of the minaret can be seen on the ground in front of the house, to the left of the man on the bicycle.

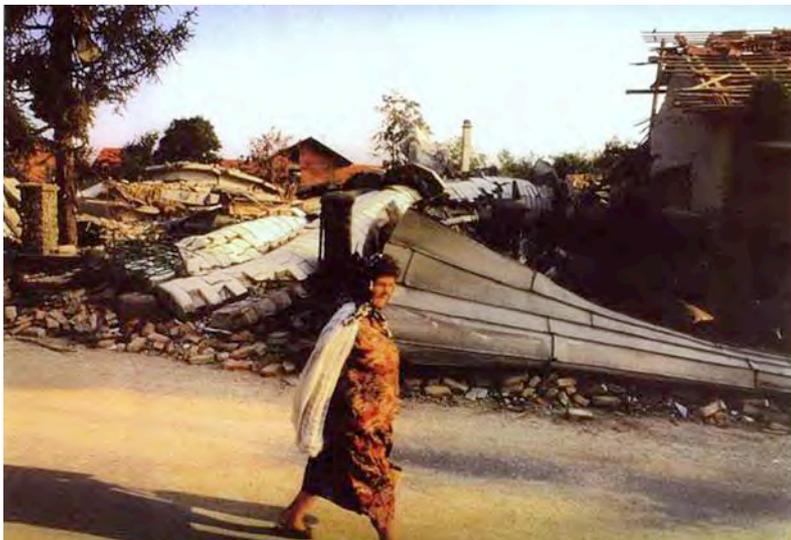
11.9. Donja Puharska mosque – photo 4

Rubble of the mosque and shaft of toppled minaret, with its decorative brick covering at left; conical cap of minaret lying on the ground in front of imam's house at right.

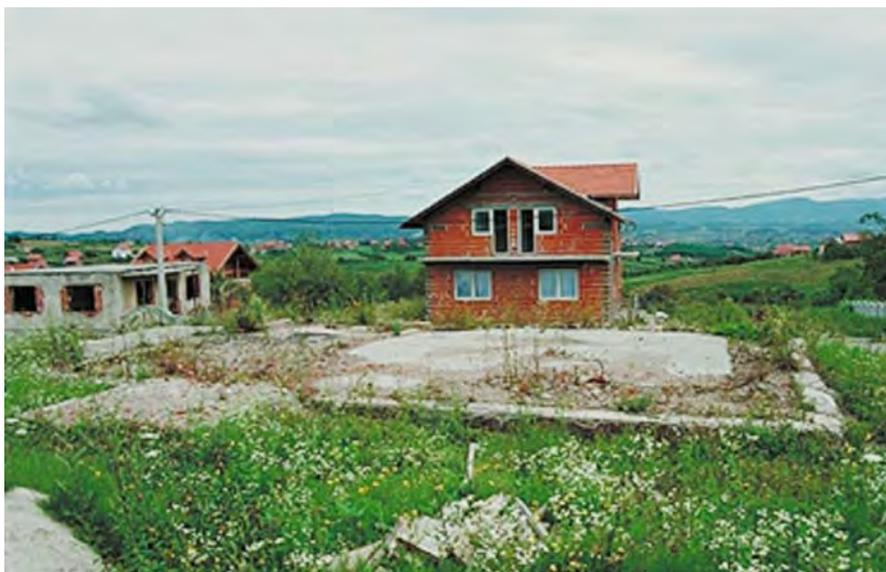
11.10. Rizvanovići mosque – photo 1

Foundations of the razed mosque in Rizvanovići.

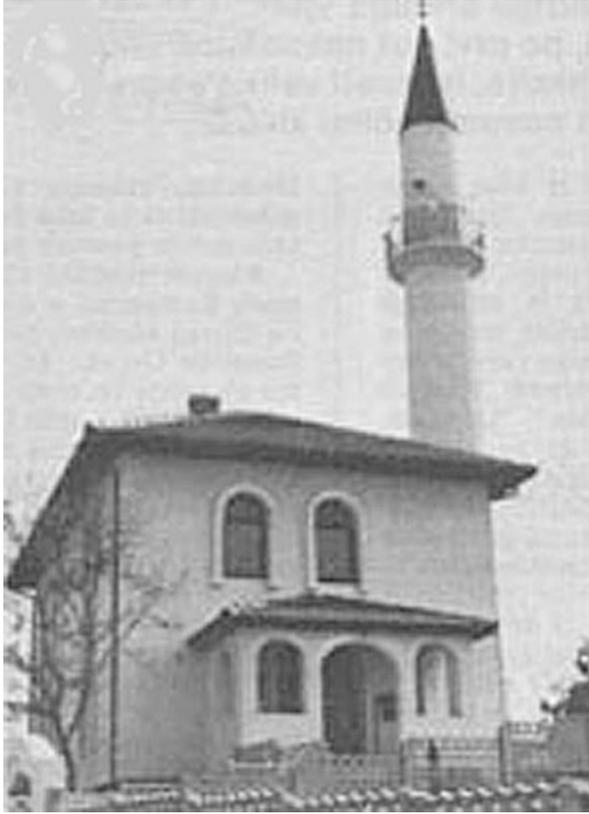
11.10. Rizvanovići mosque– photo 3

Pre-war photo published in Omerdić (1999).

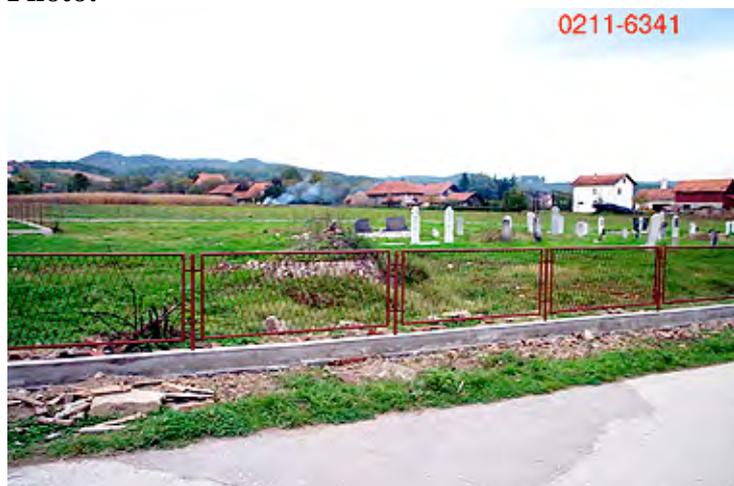
**11.11. Brezičani mosque – photo 1**

Damage description: In photographs taken immediately after the end of the war, the mosque in Brezičani is completely destroyed, the building materials removed from the site. As of 2001, only a mound of stones, remains of the mosque's foundations, could be seen next to the old mosque cemetery.

Photo (2001): ICTY OTP 0211-6341.

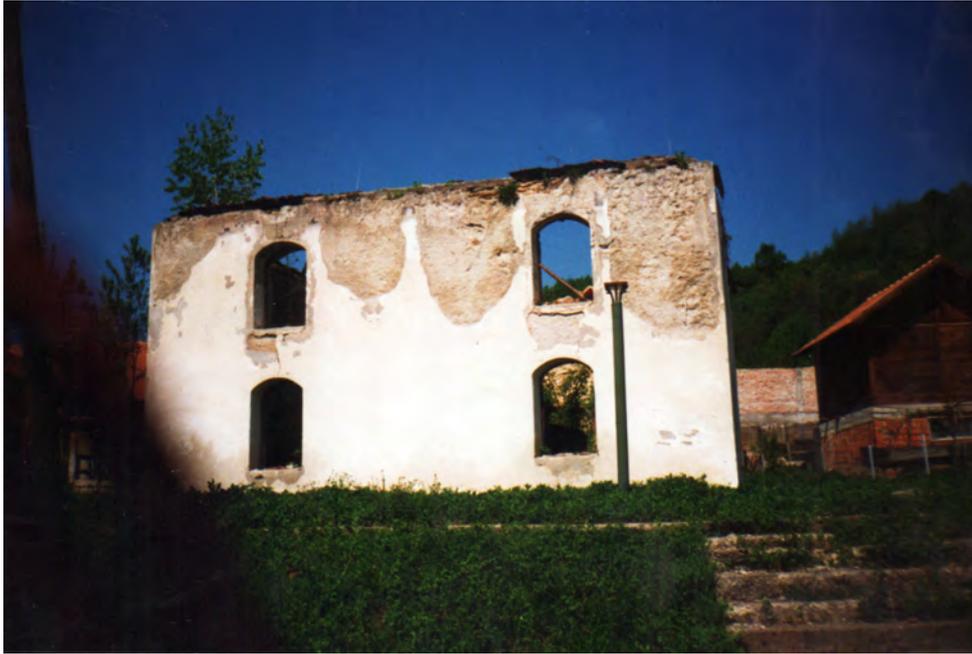
11.12. Ališići mosque – photo 1

Damage description: In photographs taken at the end of the war the Ališići mosque is completely burned out. The mosque's roof and minaret are gone, the mosque's interior is gutted and open to the sky. Shattered roof timbers can be seen inside the ruined building. The perimeter walls remain standing up to the roofline.

Post-war photo (1996): Medžlis of the Islamic Community of Prijedor.
The Ališići mosque at the end of war, viewed from the SE.

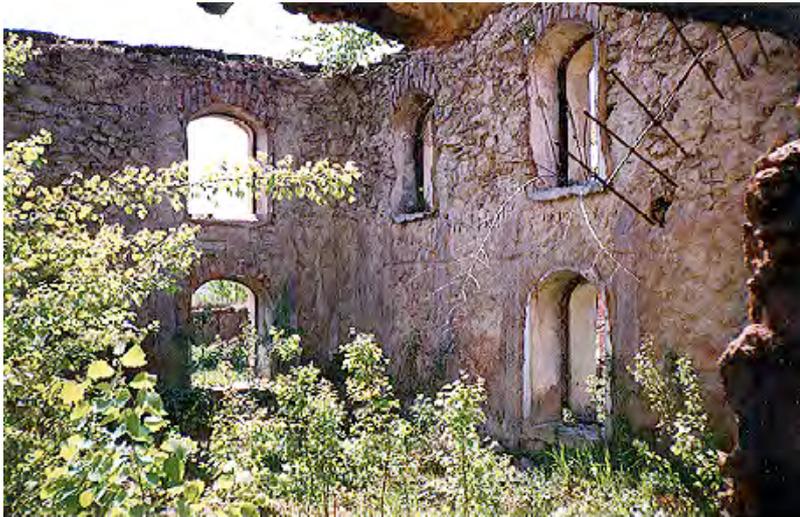
11.13. Zecovi mosque – photo 1

Photo (1996) Medžlis of the Islamic Community of Prijedor.
Interior of the burned-out mosque in Zecovi at the end of the war.

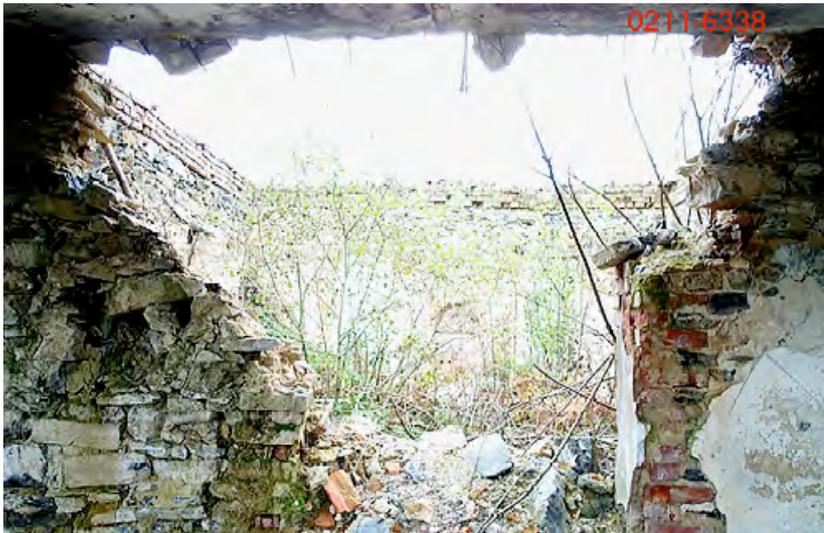
11.13. Zecovi mosque – photo 2

Damage description: In photographs taken at the end of the war, the mosque is burned out; its roof and minaret are gone; the interior is completely gutted and open to the sky. Large holes in the perimeter wall, around the door connecting the entrance portico and the main prayer hall, and in the northeast perimeter wall suggest blast damage. Otherwise, the perimeter walls remain standing up to the roofline. Charred roof beams point to destruction by fire.

Photo (2001): ICTY OTP 0211-6338

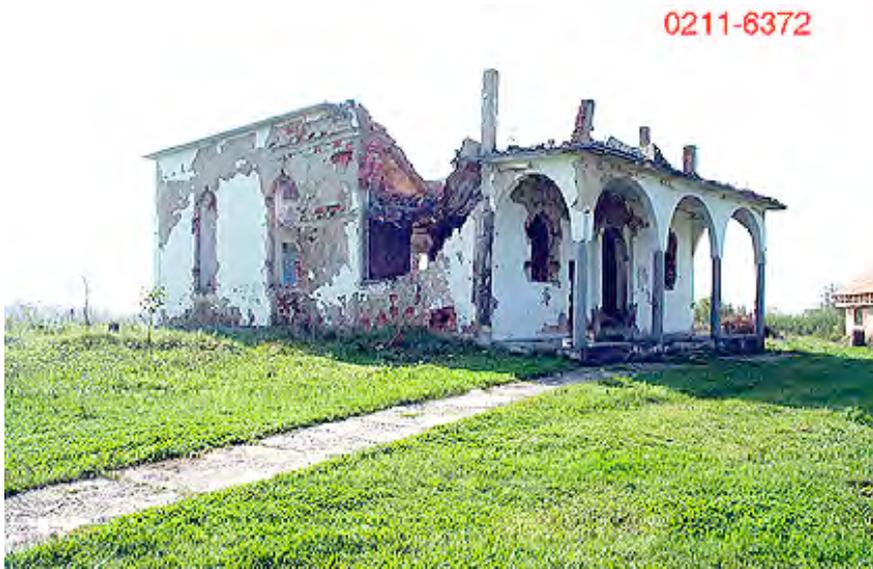
11.14. Čejreci mosque – photo 1

Damage description: In photographs taken immediately after the end of the war, the Čejreci mosque is heavily damaged. Its roof has collapsed, its interior is gutted and open to the sky, its minaret was toppled by a blast and fell across the mosque. The second storey of the entrance portico, which housed the mosque's women's gallery, has almost entirely collapsed, crushed by the toppled minaret. Three of four perimeter walls of the mosque remain standing up to the roofline. The fourth perimeter wall of the main prayer hall, facing the mosque's entrance portico, was crushed by the falling minaret.

Photo (2001): ICTY OTP 0211-6372

Ruins of the mosque, viewed from the NNE; the part behind entrance portico has been crushed by the falling minaret.

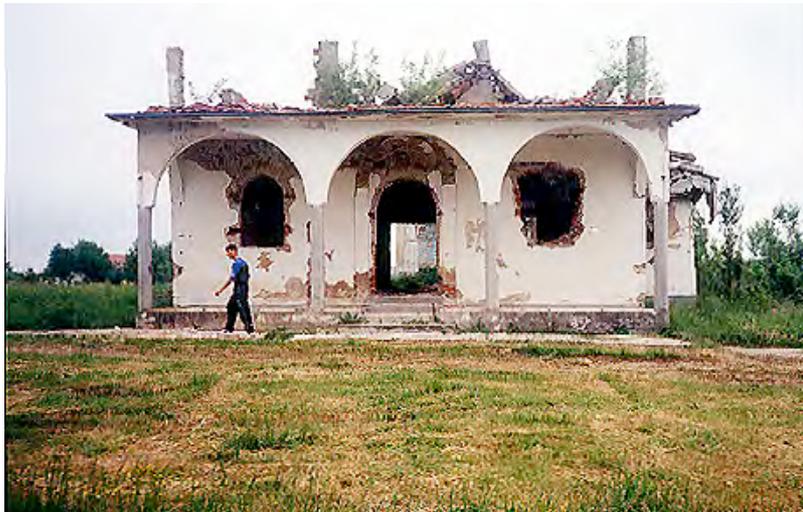
11.14. Čejreci mosque – photo 2

Photo (1996): Medžlis of the Islamic Community of Prijedor.

View of the NW (entrance) façade, the base of the toppled minaret is at right.

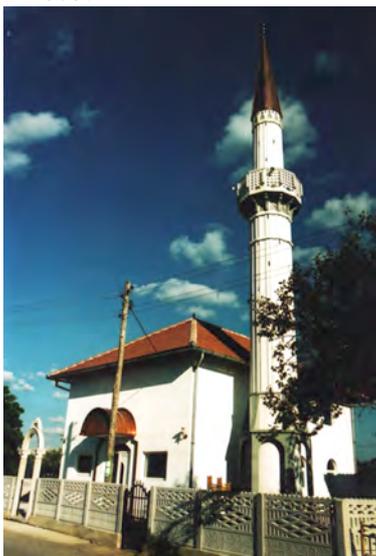
11.15. Gomjenica mosque – photo 1

Damage description: The *mesdžid* in Gomjenica, a small mosque that had no minaret before the war, was reportedly set on fire and suffered interior damage. In 2002, the mosque was undergoing reconstruction.

The Gomjenica mosque, following post-war reconstruction.

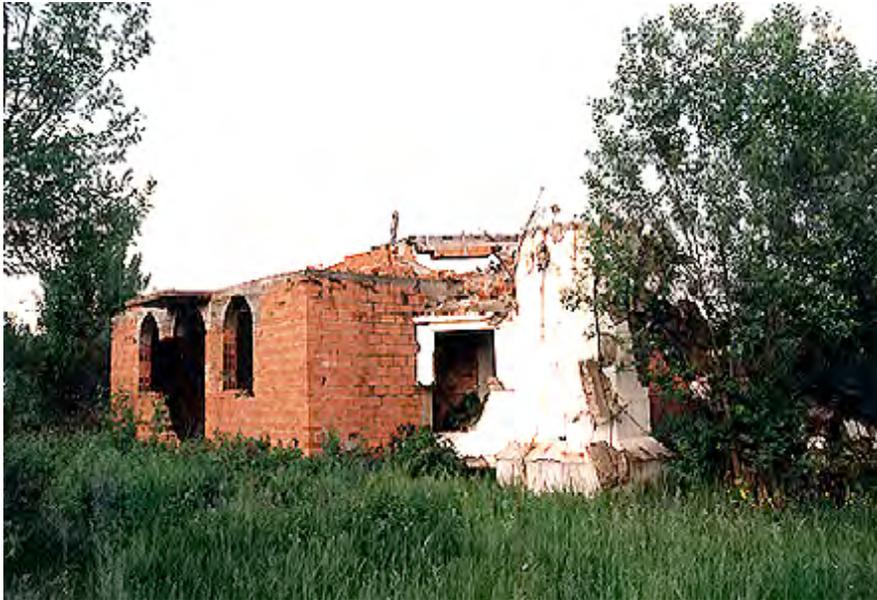
11.16. Kevljani mosque – photo 1

Damage description: In photographs taken at the end of the war, the Kevljani mosque's roof is gone, its interior open to the sky. The perimeter walls remain standing up to the roofline. A large hole (blast damage?) can be seen in the front wall of the brick entrance portico of the mosque. The shaft of the mosque's minaret, toppled by a blast, can be seen lying on the ground next to the mosque. The massive base of the minaret, 3-4m high, remains in situ, fissured by the blast.

Photo (1996): Medžlis of the Islamic Community of Prijedor.

Ruined mosque at end of war, entrance portico at left, base of toppled minaret at right.

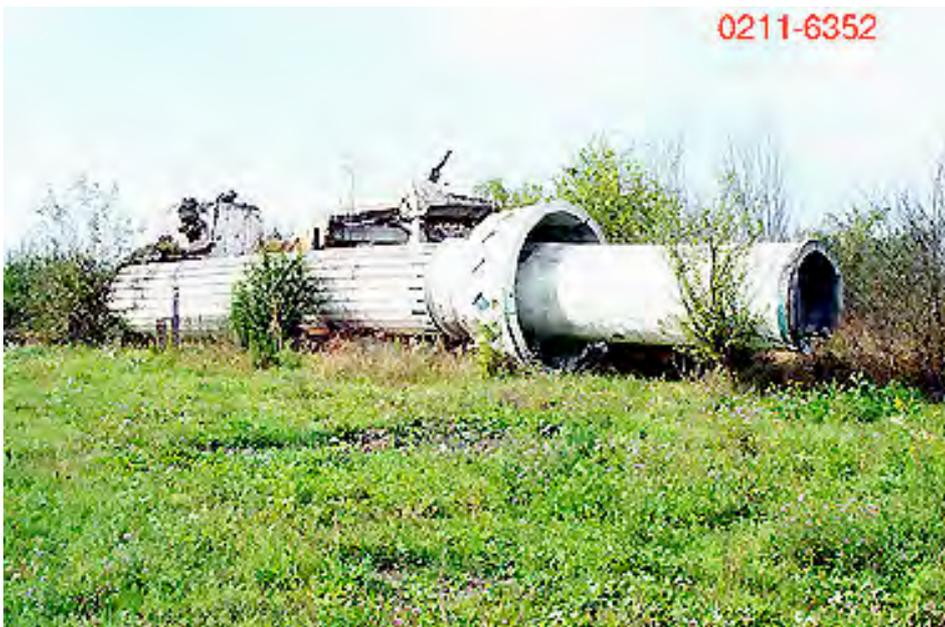
11.16. Kevljani mosque – photo 2

Photo (2001): ICTY OTP 0211-6352

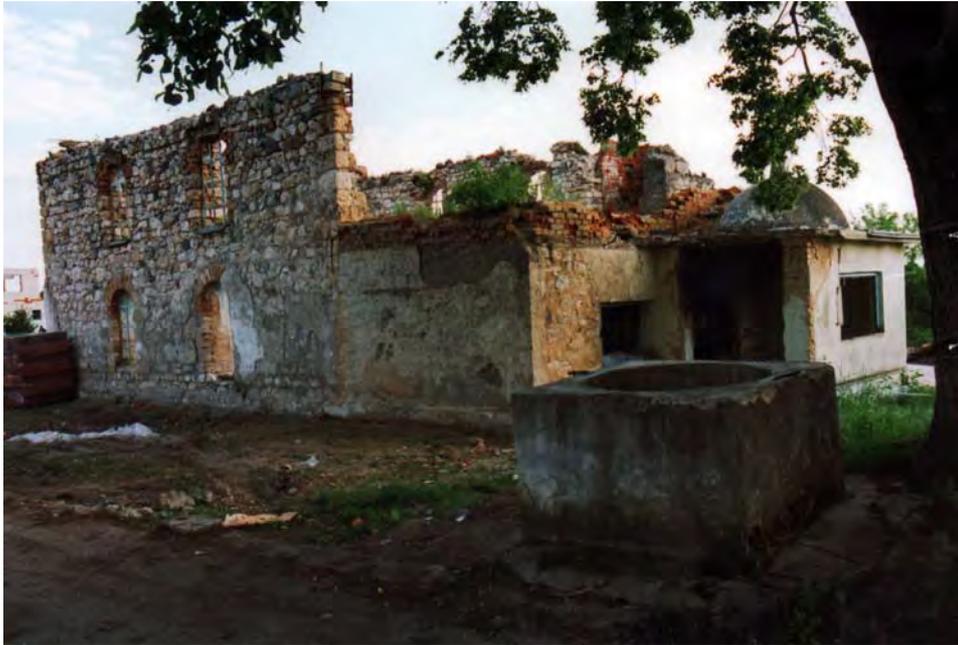
11.17. Kamičani mosque – photo 1

Damage description: In photographs taken at the end of the war, the old stone mosque is heavily damaged, its roof and minaret are gone, its interior is gutted and open to the sky. The massive stone perimeter walls remain standing up to the roofline on two of the four sides, but appear damaged on the side where the minaret stood (to the right of the entrance). The top half of the entrance façade of the mosque has collapsed. In a photograph taken immediately after the end of the war, the perimeter walls appear to be leaning outwards (sign of possible blast damage).

Photo (1996): Medžlis of the Islamic Community of Prijedor.

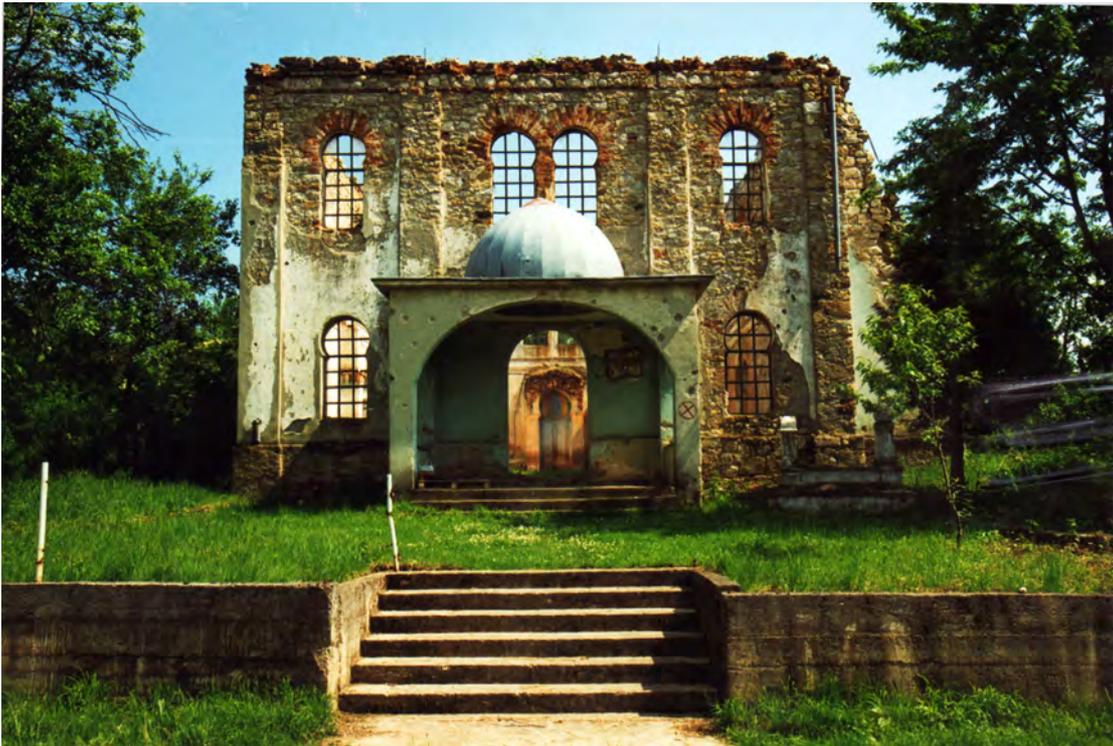
11.18. Mutnik mosque in Kozarac – photo 1

Damage description: The Mutnik mosque is burned out, its roof gone, its interior gutted and open to the sky. The perimeter walls remain standing up to the roofline. The mosque's tall, masonry minaret appears to have been destroyed by a powerful blast, leaving behind a shattered stump, parts of it extending up to the roofline. The small, domed entrance portico of the mosque, a modern addition, is pockmarked with bullet holes.

Photo (1999): Medžlis of the Islamic Community of Prijedor.
Ruins of the mosque after initial post-war cleanup of rubble and vegetation; view from the NW, remains of the base of the minaret can be seen at the right.

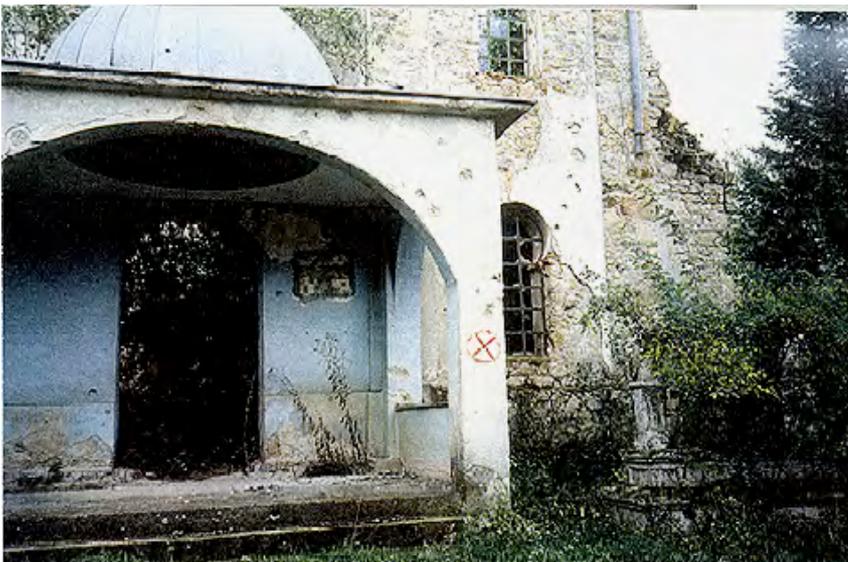
11.18. Mutnik mosque in Kozarac – photo 2

Photo (09/1998) Thomas Keenan.
Close-up view, before cleanup. Note the growth of vegetation inside the mosque and on top of the portico, bullet holes in the entrance façade; base of the minaret at right.

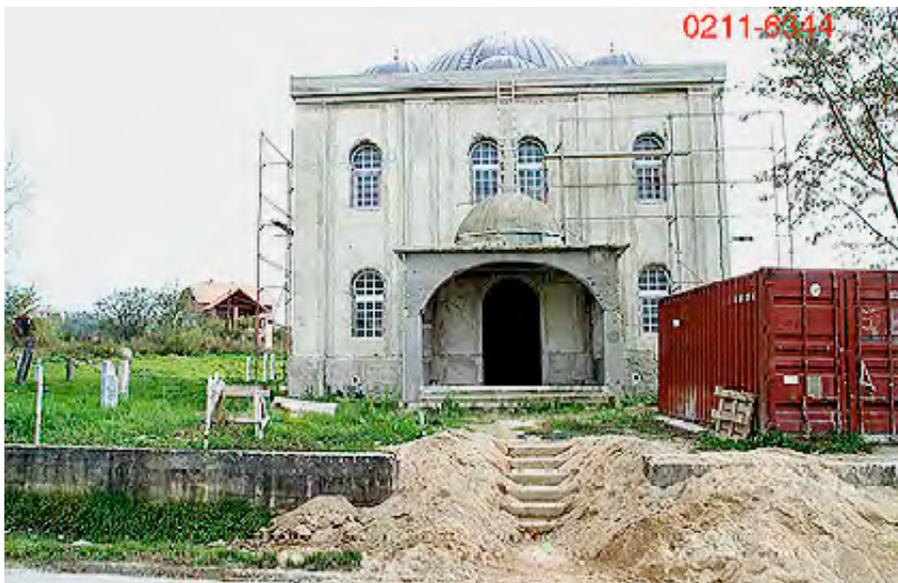
11.18. Mutnik mosque in Kozarac

Photo (2001): ICTY OTP 0211-6344
The Mutnik mosque undergoing post-war reconstruction.

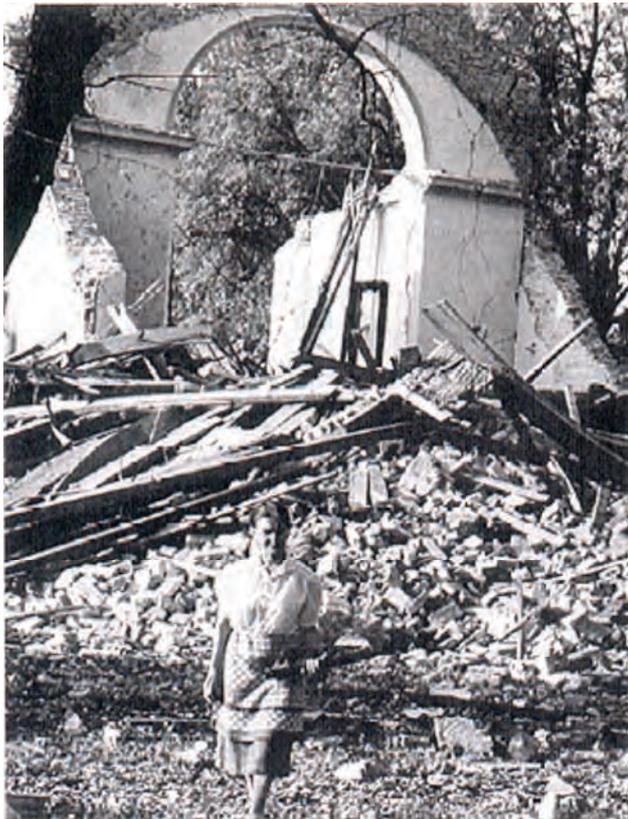
11.19. Prijedor Town Catholic church – photo 1

Photo (1992) by Boris Geillert/GAFF, published in Gutman (1993).

Unidentified woman gathering firewood from ruins of the Catholic parish church in Prijedor, following first phase of destruction (Sept. 1992). Church reduced to rubble by blast, only the arch above the entrance to the church's sanctuary remains standing.

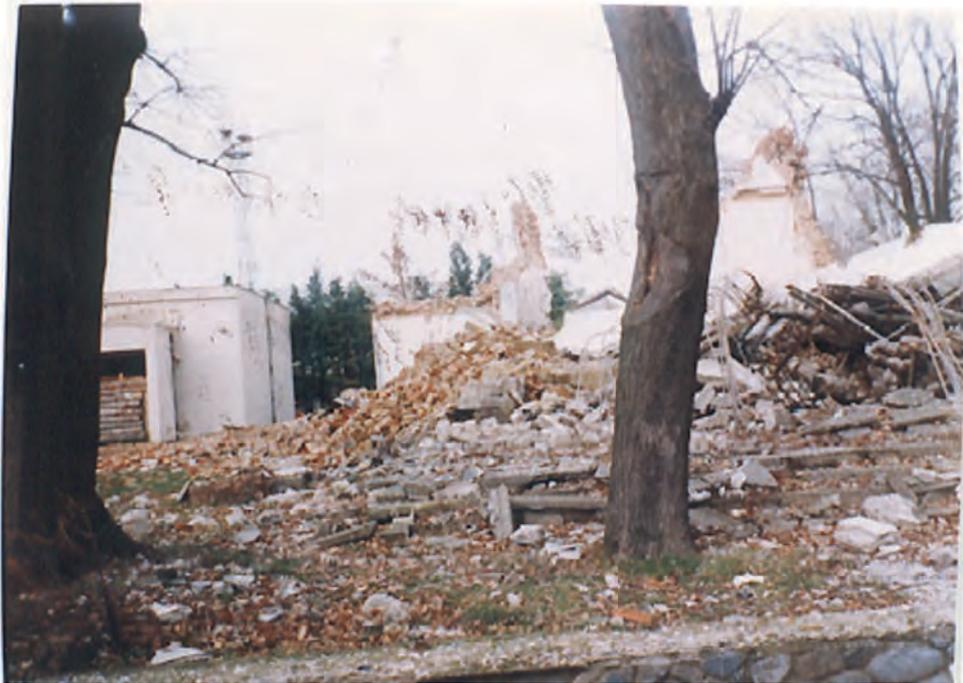
11.19. Prijedor Town Catholic church – photo 2

A second explosion, in August 1995, destroyed the top of the belfry and what remained of the church. The blast also damaged the parish center building next door.

Photo (1995): Ordinariate of Roman Catholic Diocese of Banja Luka.

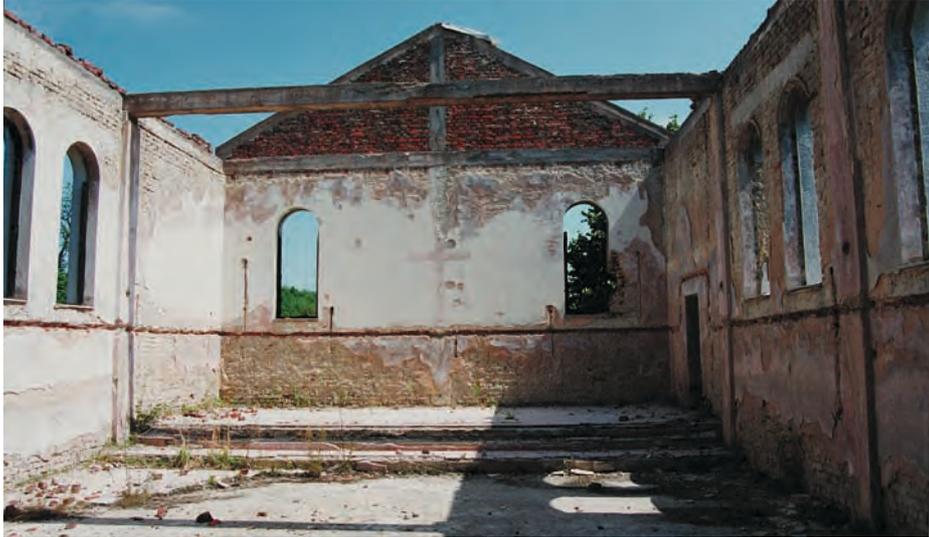
11.20. Briševo Catholic church – photo 1

Damage description: The Briševo church is completely burned out, its tile roof collapsed, the church's interior gutted and open to the sky. Soot marks still visible on interior and exterior walls; damage from projectile impacts on walls and windows. The top of the church steeple is missing.

The burnt roof tiles and debris, seen covering the floor of the church in photographs taken immediately after the end of the war, had been cleared out by the time of the author's survey visit (07/2002).

Photo (07/2002) András Riedlmayer.

View of the interior of the burned-out church, looking towards the altar.

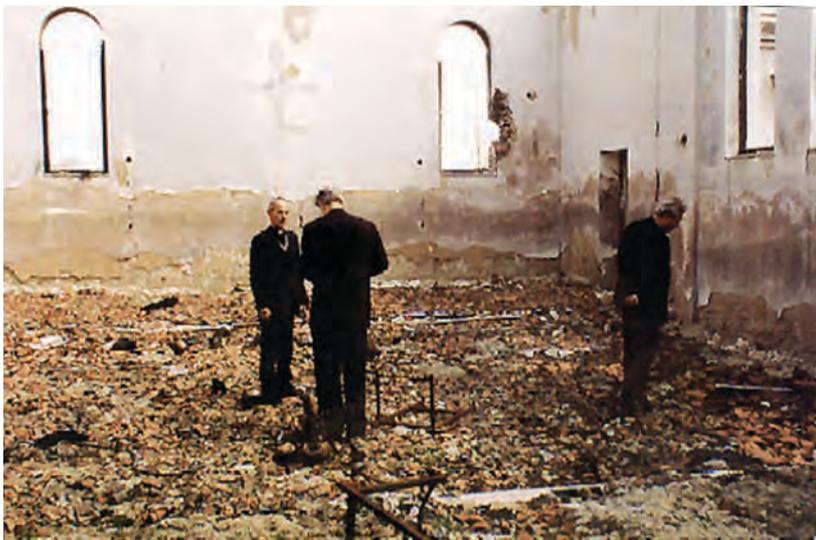
11.20. Briševo Catholic church – photo 2

Photo published in Živković (1997).

Interior of the church at the end of the war, covered with scorched roof tiles.

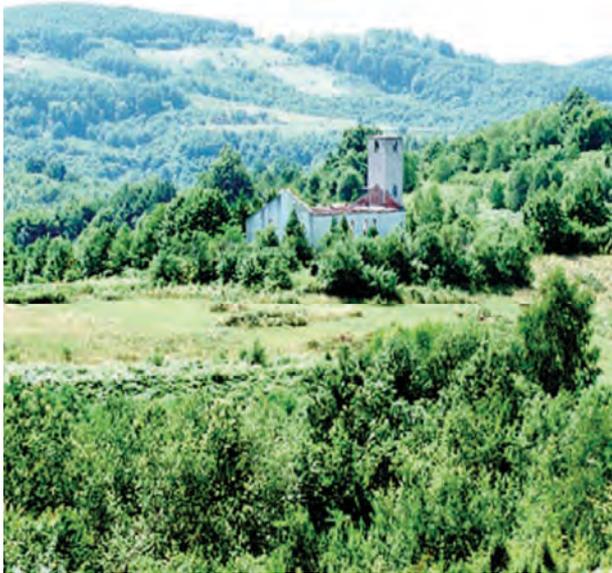
11.20. Briševo Catholic church – photo 3

Post-war photo (07/2002) András Riedlmayer.

View of Briševo with its burned-out church, surrounded by fields reverting to forest.

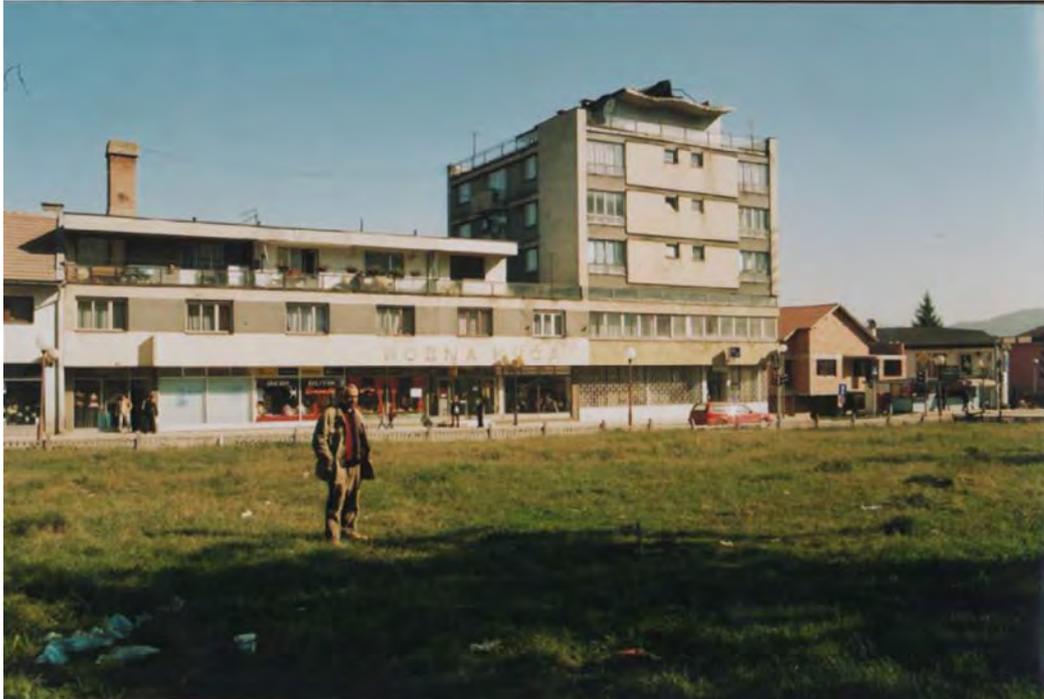
12.2. Čaršijska mosque in Rogatica – photo 1

Damage description: The mosque was completely destroyed, its ruins razed, all building materials removed. The mosque's site was still an empty lot, overgrown with vegetation, at the time of author's survey visit.

Photo (Oct. 2005): Kemal Zukić, Center for Islamic Architecture, Islamic Community of Bosnia and Herzegovina.

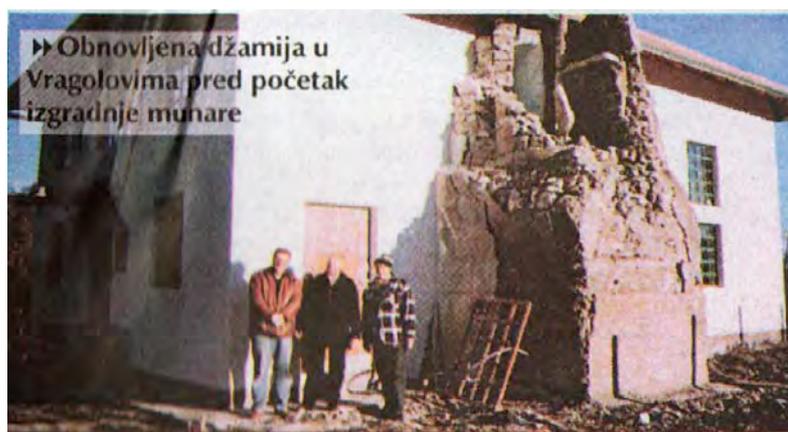
12.3. Vragolovi mosque – photo 1

Photo (2007): Center for Islamic Architecture, Islamic Community of BiH.
Vragolovi mosque under post-war reconstruction, stump of blown-up minaret at right.

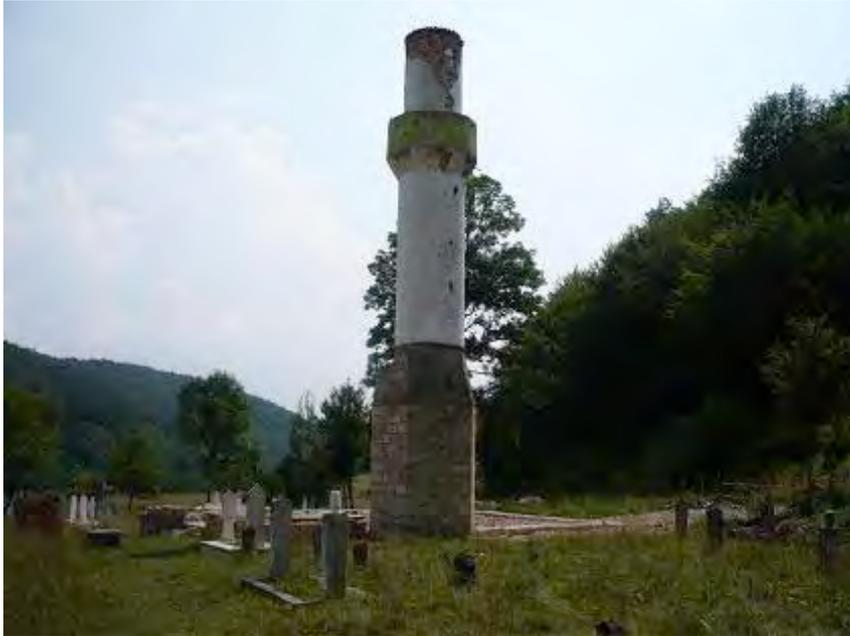
12.5. Rakitnica mosque – photo 1

Photo (2008). Medžlis of the Islamic Community of Rogatica.
Foundations of the Rakitnica mosque, next to the decapitated minaret.

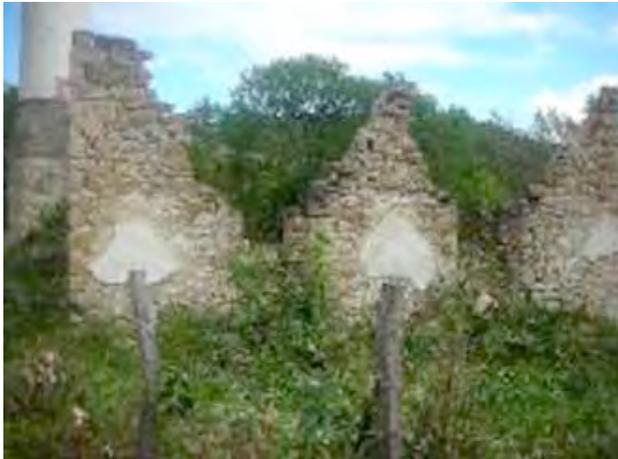
12.5. Rakitnica mosque – photo 2

Photo (2007): Medžlis of the Islamic Community of Rogatica
Rakitnica mosque, remains of the perimeter walls before demolition; minaret at left.

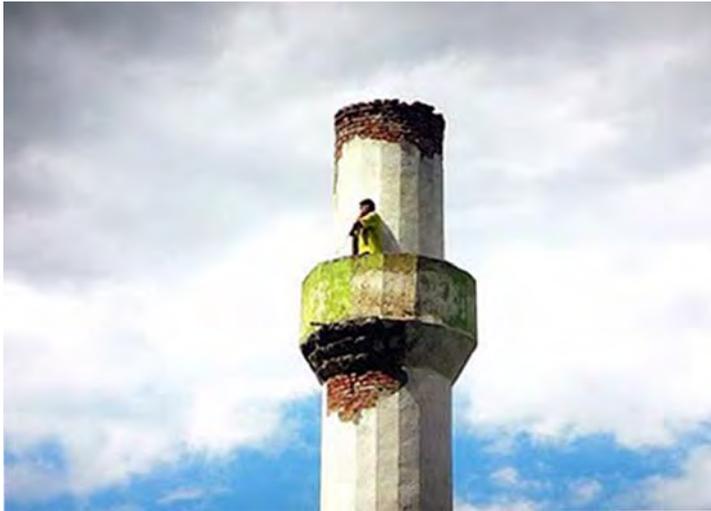
12.5. Rakitnica mosque – photo 3

Photo (2007) Medžlis of the Islamic Community of Rogatica.
Rakitnica mosque, close-up view of the decapitated minaret.

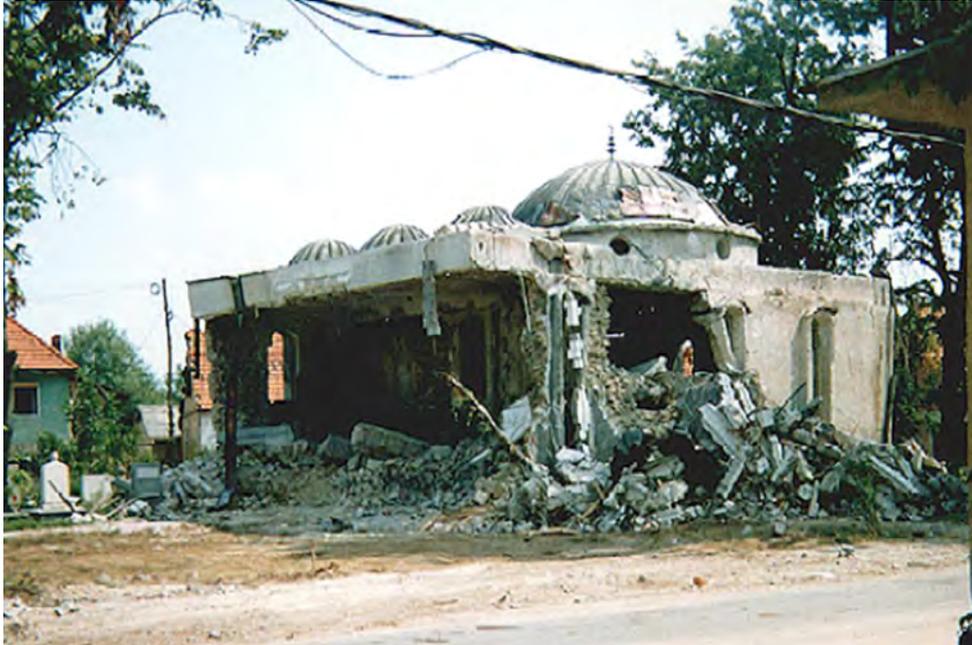
13.1. Town mosque in Sanski Most – photo 1

Photo (10/1992) from Medžlis of the Islamic Community of Sanski Most. Town Mosque in Oct. 1992, viewed from the west; rubble of minaret at right, entrance façade at left (photo taken by Senad Ramić 10/1992).

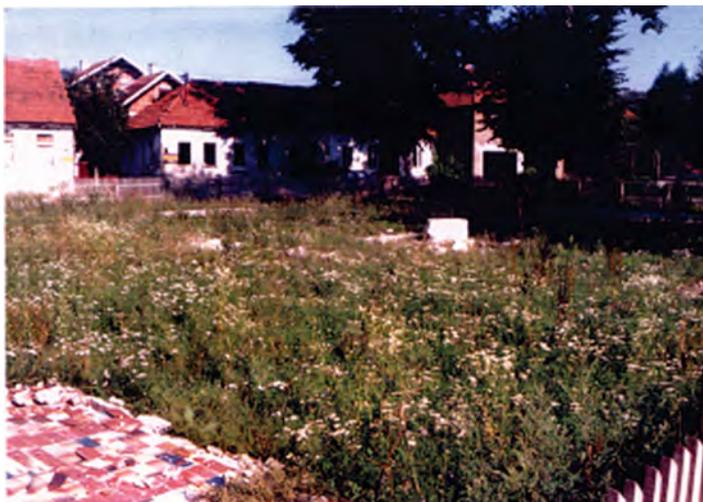
13.1. Town mosque in Sanski Most – photo 2

Post-war photo: Medžlis of the Islamic Community of Sanski Most. Empty site of the razed mosque after the end of the war; note the low buildings in the background, behind the mosque site, which can also be seen on photos 1 and 3.

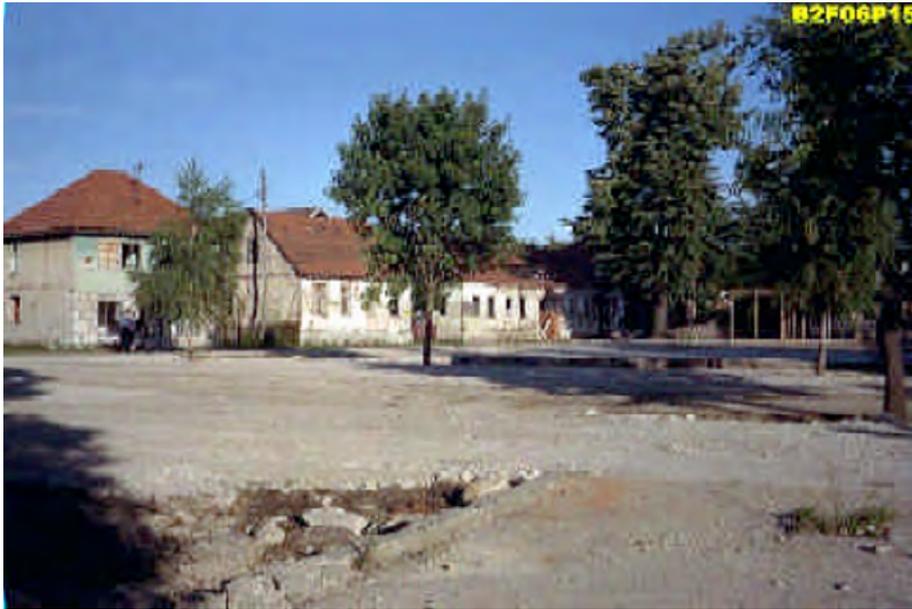
13.1. Town mosque in Sanski Most – photo 3

Photo (1997) Council of Europe - Cultural Heritage Division.
Empty site of the Town mosque in Sanski Most.

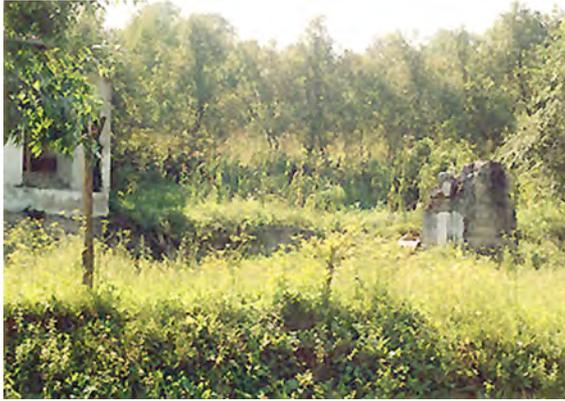
13.2. Pobriježje mosque – photo 1

Photo (1996): Medžlis of the Islamic Community of Sanski Most.

Site of the Pobriježje mosque at the end of the war; stump of minaret at right.

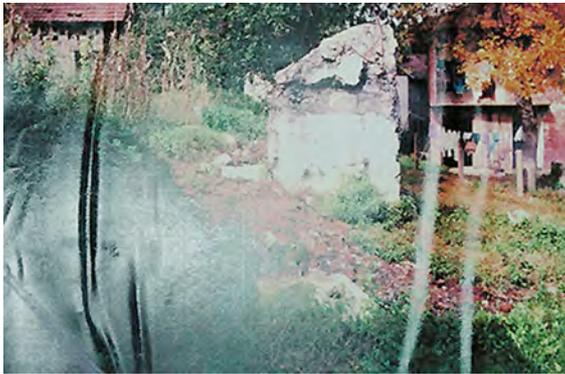
13.2. Pobriježje mosque – photo 2

Photo (1996): Regional Museum Bihać.

Site of the Pobriježje mosque at the end of the war; close-up of the destroyed minaret.

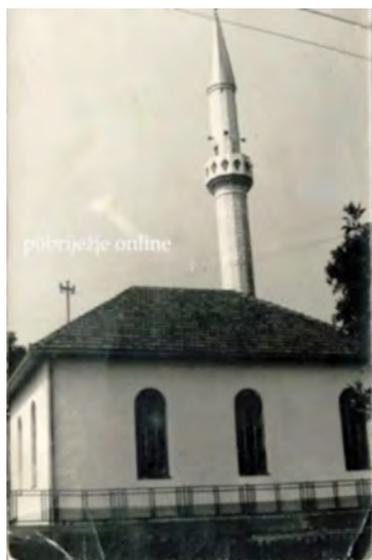
13.2. Pobriježje mosque – photo 4

Pre-war photo: Medžlis of the Islamic Community of Sanski Most.
The Pobriježje mosque before the war, viewed from the east.

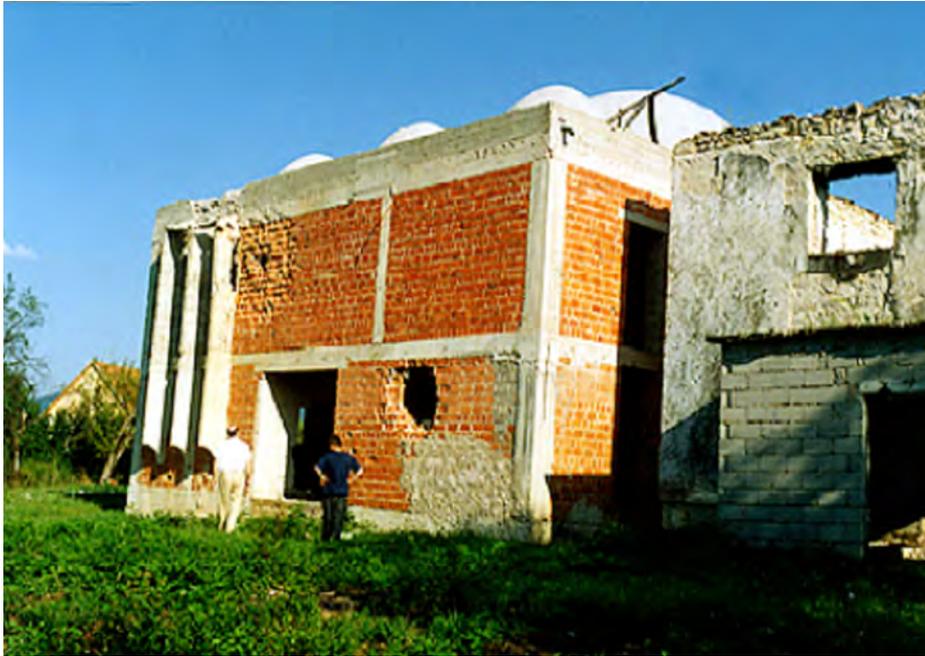
13.3. Hrustovo-Kukavice, New mosque – photo 1

Damage description: Several projectile impacts, two of them penetrating the brick wall of the new mosque can be seen in photos taken at end of war. Otherwise the perimeter walls and the mosque's dome appear intact. Building materials, including copper sheeting from the roof of the new mosque, were reportedly taken during war.

The New mosque in Hrustovo-Kukavice at the end of the war: note projectile impacts; the burned-out Old mosque can be seen at the right.

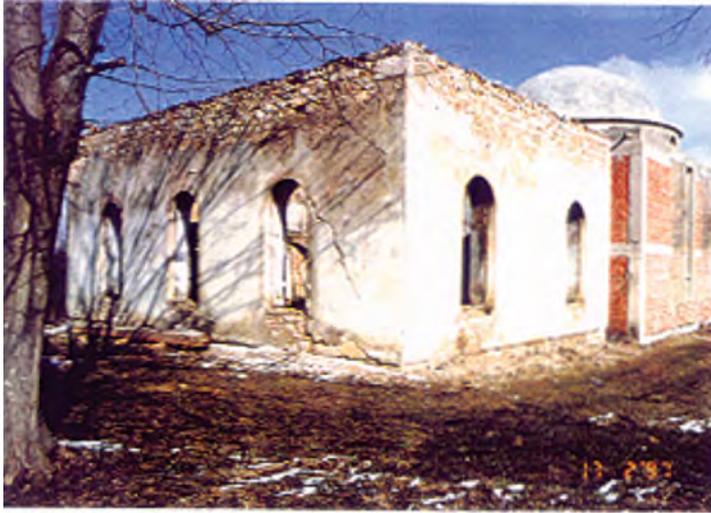
13.4. Hrustovo-Kukavice, Old mosque – photo 1

Damage description: In photos taken after the end of the war, the Old mosque in Hrustovo-Kukavice, immediately adjacent to the New mosque, is completely burned out, its roof and wooden minaret are gone, the mosque's interior is gutted, its perimeter walls are damaged but remain standing up to the roof line.

Old mosque at end of war, viewed from south; the New mosque can be seen at right.

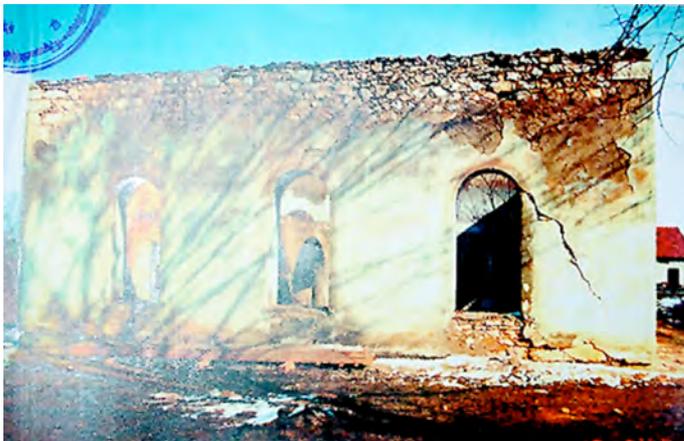
13.4. Hrustovo-Kukavice, Old mosque – photo 2

Old mosque at end of war, viewed from the SW side; note charring, damage to walls.

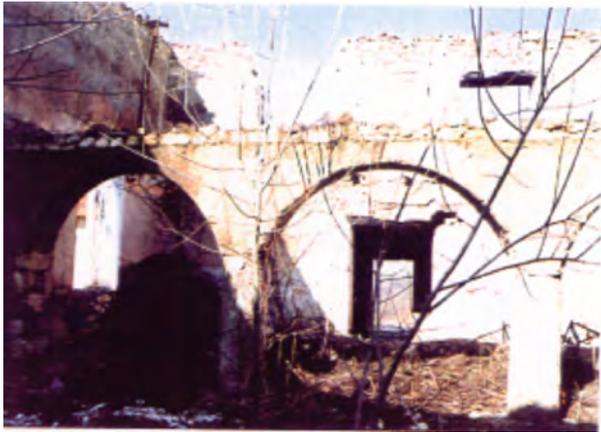
13.4. Hrustovo-Kukavice, Old mosque – photo 3

Old mosque at end of war, view of the interior facing towards the entrance.

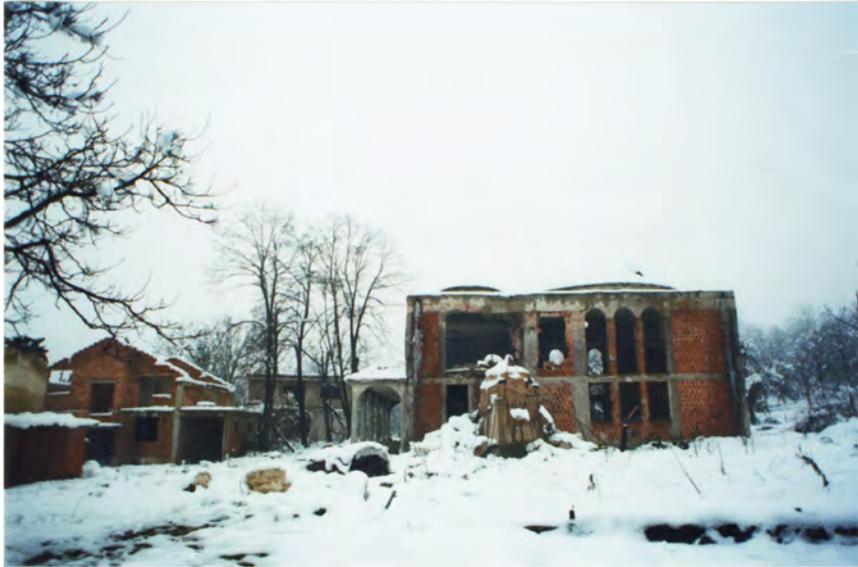
13.5. Vrhpolje mosque – photo 1

Damage description: In photos taken at the end of war, the mosque's minaret has been destroyed by a blast, only its massive stump remains, surrounded by rubble. Parts of the mosque's roof and the western façade of mosque are damaged. There is also damage to interior. Building materials were reportedly removed from the mosque during the war.

The Vrhpolje mosque immediately after the end of the war; distant view from the SW, with the stump of the destroyed minaret at center right.

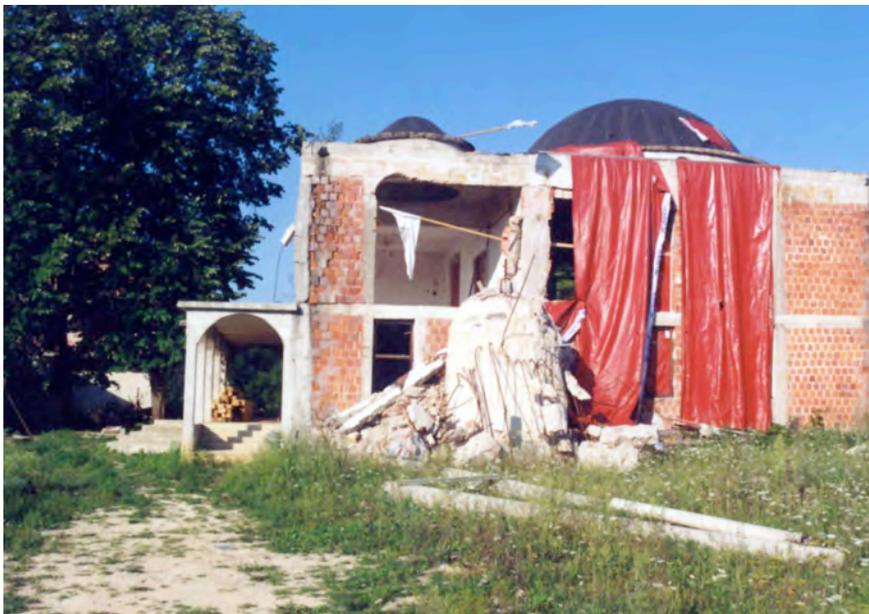
13.5. Vrhpolje mosque – photo 2

The Vrhpolje mosque during the first summer after the war; close-up view from SW, with the stump of the destroyed minaret at center.
