Municipality: 7. Brčko

7.1 Bijela Mosque

Neighborhood:	Kolobara
Town:	Brčko
GPS:	44°52'47.6"N 18°48'13.9" E
Construction:	19 th century (1881, rest. 1893)
Historical period:	Austro-Hungarian
Official status:	listed monument
Building use:	religious
Building type:	Mosque
Building setting:	city
Building condition:	completely destroyed under reconstruction

Damage description: Mosque completely destroyed, ruins razed, building materials removed.

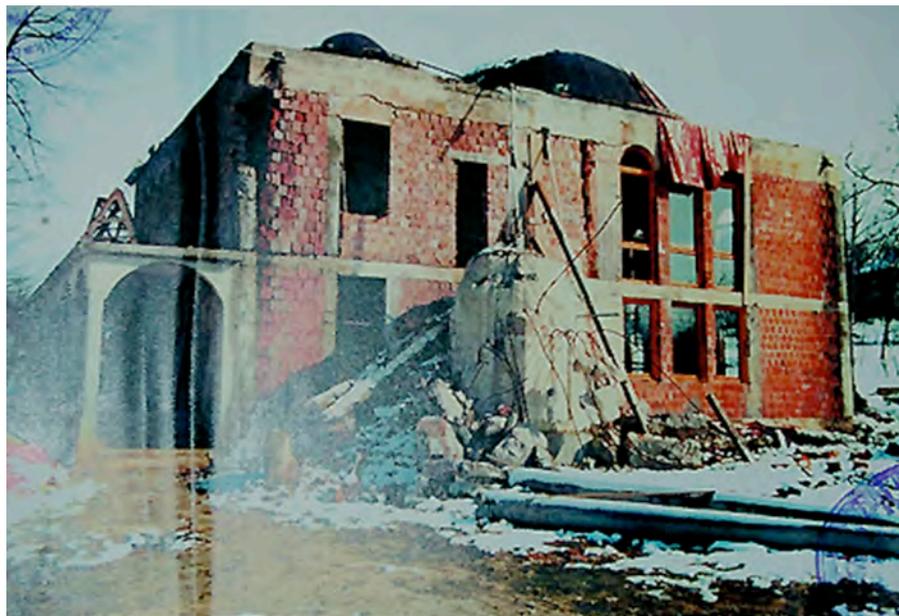
13.5. Vrhpolje mosque – photo 3

View of the mosque after partial repairs, the stump of the blown-up minaret at center.

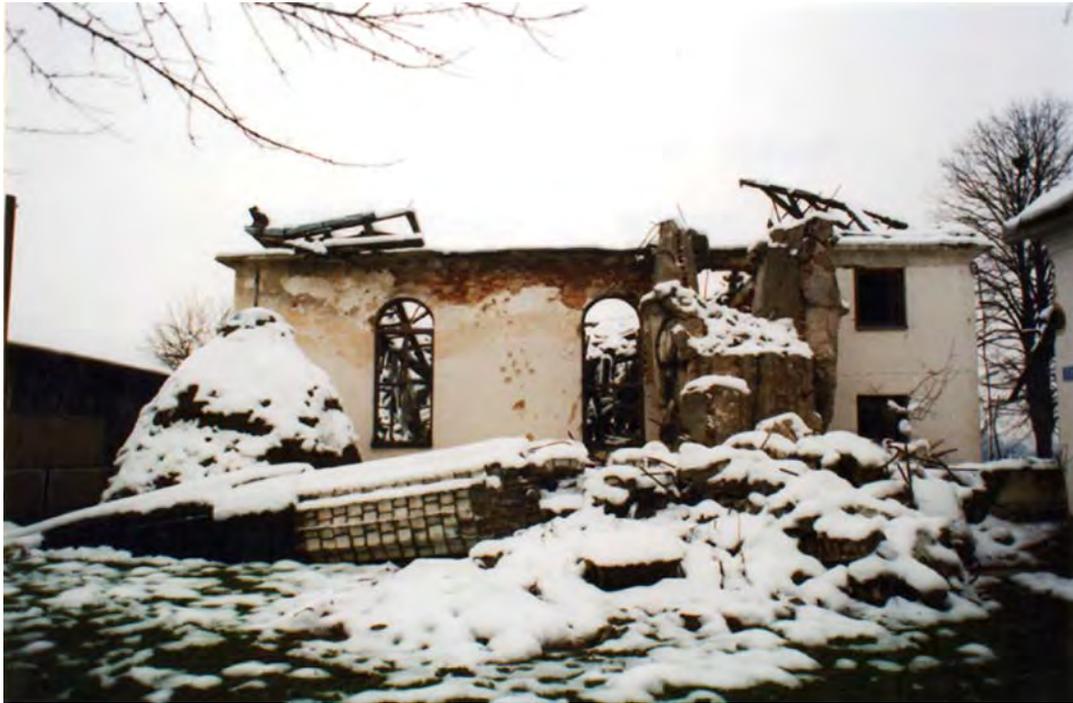
13.6. Šehovci mosque – photo 1

Damage description: The mosque is burned out, its roof collapsed, its interior gutted and open to the sky. The perimeter walls remain standing up to the roofline in photo taken at the end of the war. The minaret was evidently destroyed by a blast. The massive concrete base of the minaret, split apart by the force of the explosion, remains at the site.

The Šehovci mosque at the end of the war, with stump and toppled shaft of minaret.

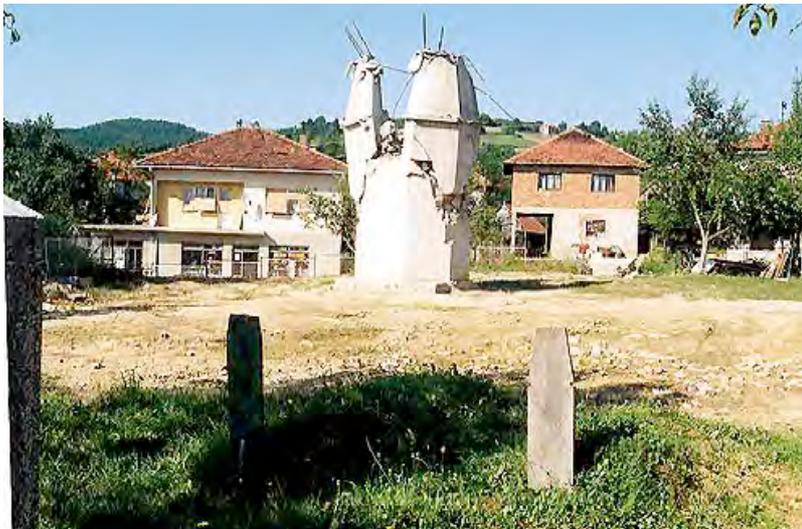
13.6. Šehovci mosque – photo 2

The site of the mosque, after the ruins had been cleared away, with the base of the minaret at the center; viewed from the mosque cemetery.

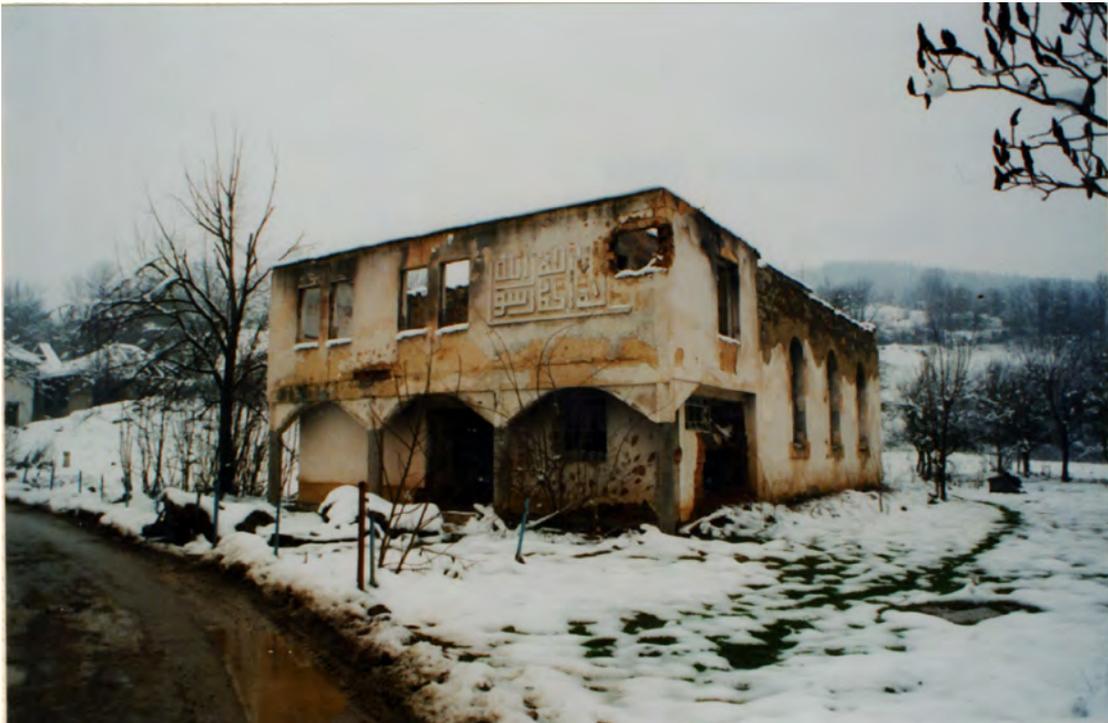
13.7. Trnova mosque – photo 1

Damage description: In photos taken after the end of the war, the Trnova mosque is completely burned out. The mosque's roof and minaret are gone, its interior is gutted and open to the sky. There are projectile impacts in the front façade of the mosque, partly destroying the calligraphic religious inscription.

Photo (12/1995): Kemal Zukić, Islamic Community of Bosnia and Herzegovina.
The Trnova mosque, immediately after the end of the war; viewed from the WNW.
Modern entrance portico at center left, main prayer hall of old mosque at right rear.

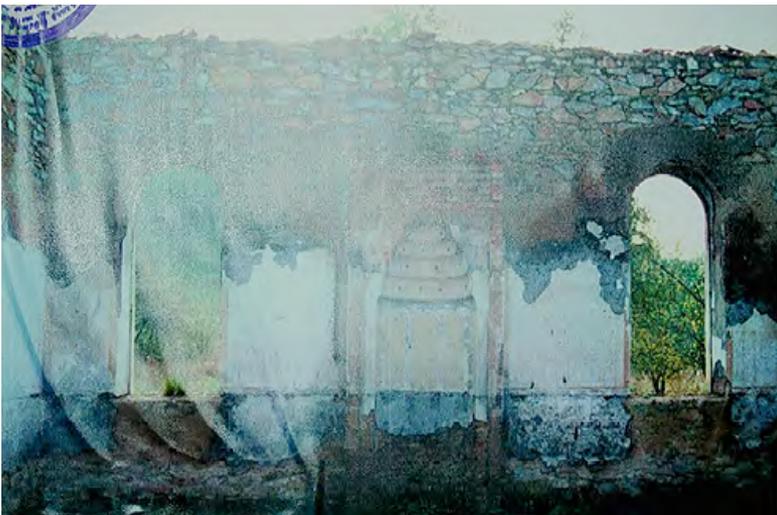
13.7. Trnova mosque – photo 2

Photo (1996): Regional Museum, Bihać.
Trnova mosque at the end of the war; interior view facing the *mihrab* (prayer niche).

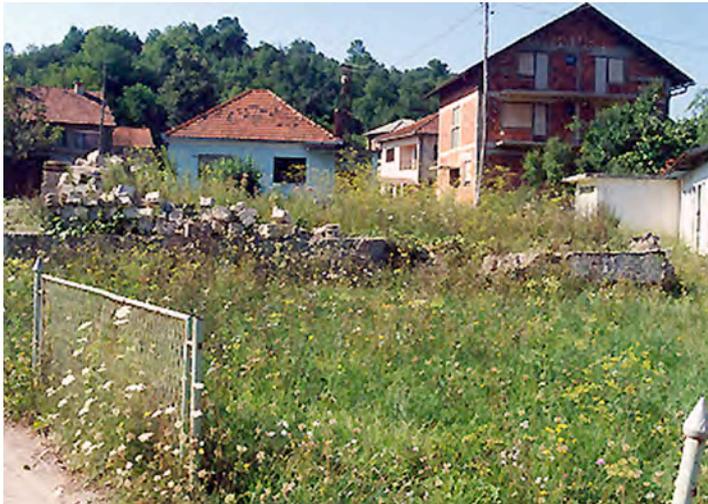
13.8. Stari Majdan. Palanka mosque – photo 1

Damage description: The Palanka mosque was completely destroyed. In photographs taken immediately after the end of the war, only the remains of the mosque's stone foundation walls can be seen still standing to a height of 0.5m to 1m.

Site of destroyed Palanka mosque, viewed from SE – note red house at right rear.

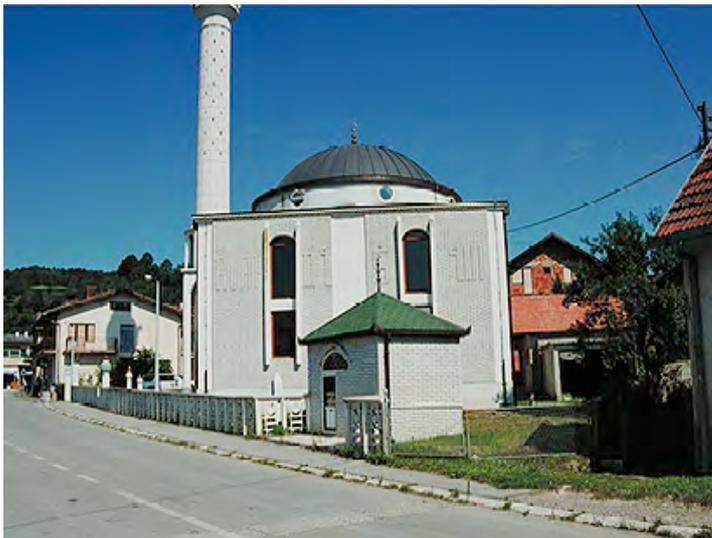
13.8. Stari Majdan. Palanka mosque – photo 2

Palanka mosque, rebuilt after the war, viewed from the SE – note same red house.

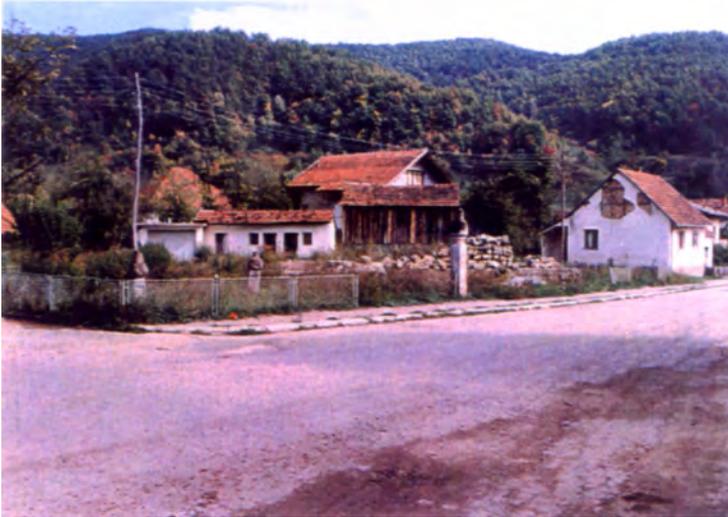
13.8. Stari Majdan. Palanka mosque – photo 3

Empty site of Palanka mosque at the end of the war, viewed from the west; note the hills in the background.

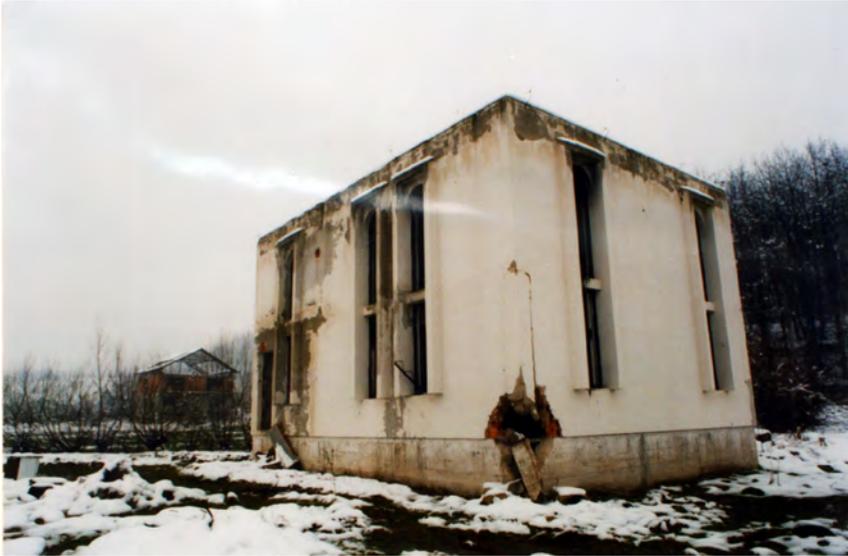
13.10. Dževar mosque – photo 1

Damage description: Photographs taken immediately after the end of the war show the Dževar mosque damaged by multiple projectile impacts. One can see blast damage and soot marks on the perimeter walls, especially around the windows, its roof and minaret are gone, its interior is burned out.

The Dževar mosque at the end of the war, viewed from the south. Note the marks left by projectile impacts.

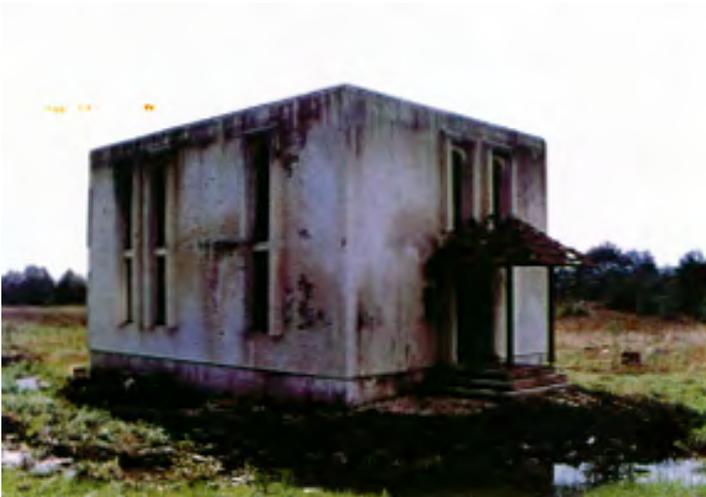
13.10. Dževar mosque – photo 2

The Dževar mosque at the end of the war, viewed from the north.

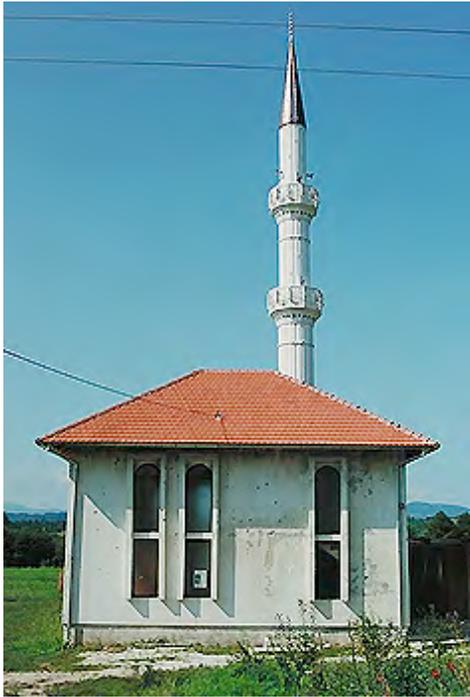
13.10. Dževar mosque – photo 3

The mosque with a new roof and new minaret, repairs to walls, viewed from the NE.

The mosque has been reconstructed since the end of the war. It has a new minaret and a new roof, and visible repairs of the damage from the projectile impacts in its perimeter walls.

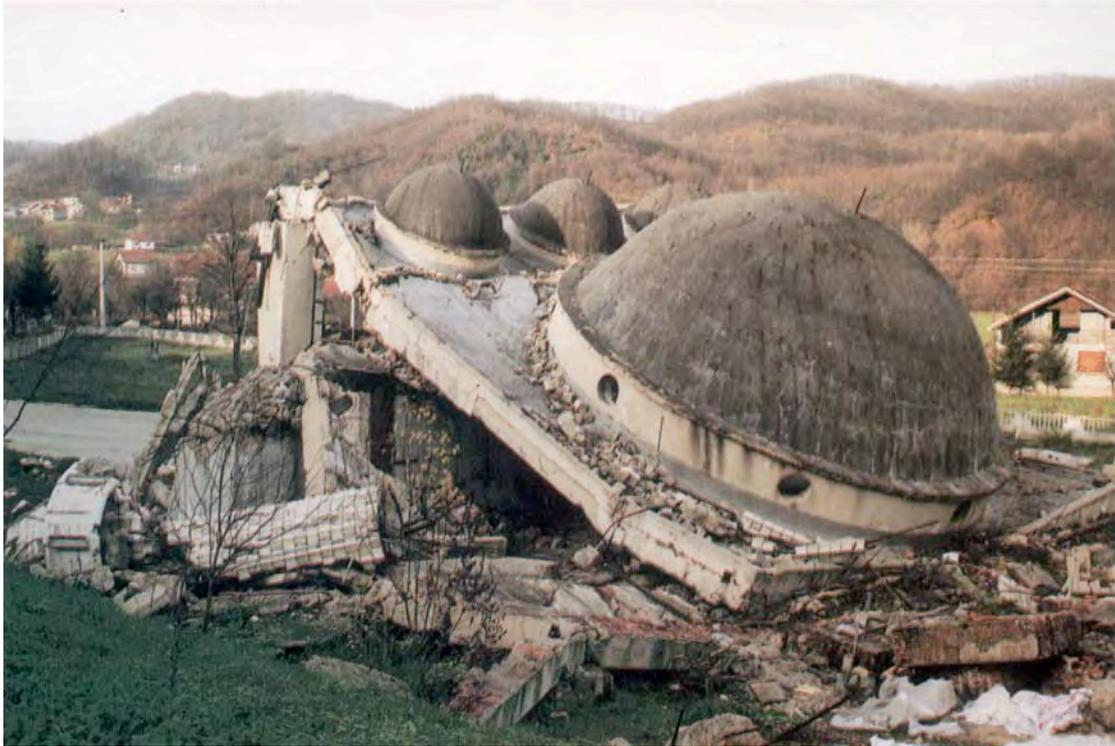
13.12. Donji Kamengrad. New mosque – photo 1

Damage description: Photographs taken immediately after the war show the Donji Kamengrad mosque almost completely destroyed. Its minaret is seen lying in pieces next to the mosque.

The mihrab wall has been destroyed, as have the side walls of the mosque. The only wall left standing, the mosque's entrance façade, is badly fractured. The domes on top of the collapsed, reinforced-concrete roof slab of the mosque are the only major structural elements remaining after the blast,

The New mosque in Donji Kamengrad, built not long before the war, was destroyed with explosives, placed at the supporting columns of the mosque, which caused the entire mosque to collapse towards the *mihrab*. The mosque was wrecked beyond any possibility of repair.

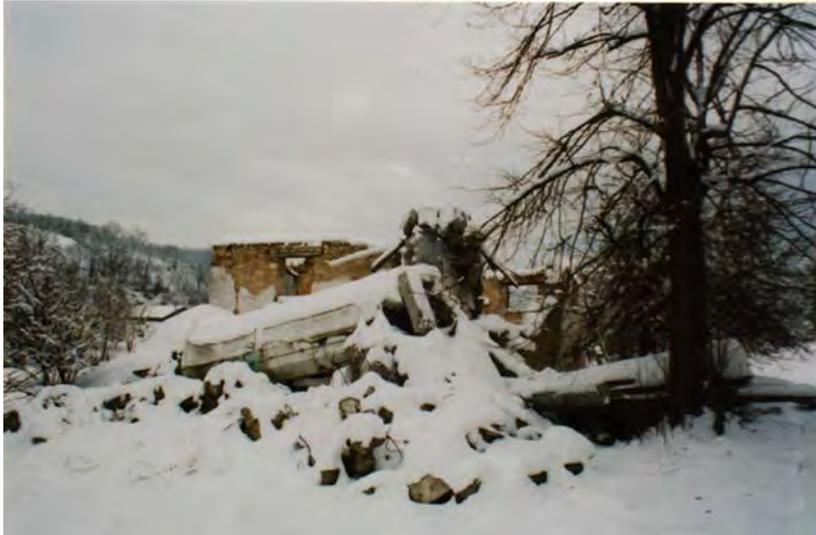
13.13. Skucani Vakuf mosque – photo 1

Damage description: In photos taken after the end of the war, the mosque's minaret has been destroyed by a blast. Only the shattered stump and some fragments of the shaft of the toppled minaret remain. The mosque has lost its roof, its perimeter walls are damaged but some sections remain standing up to the roofline; collapsed roof beams can be seen projecting from the interior.

The Skucani Vakuf mosque at the end of the war, blown-up minaret in foreground.

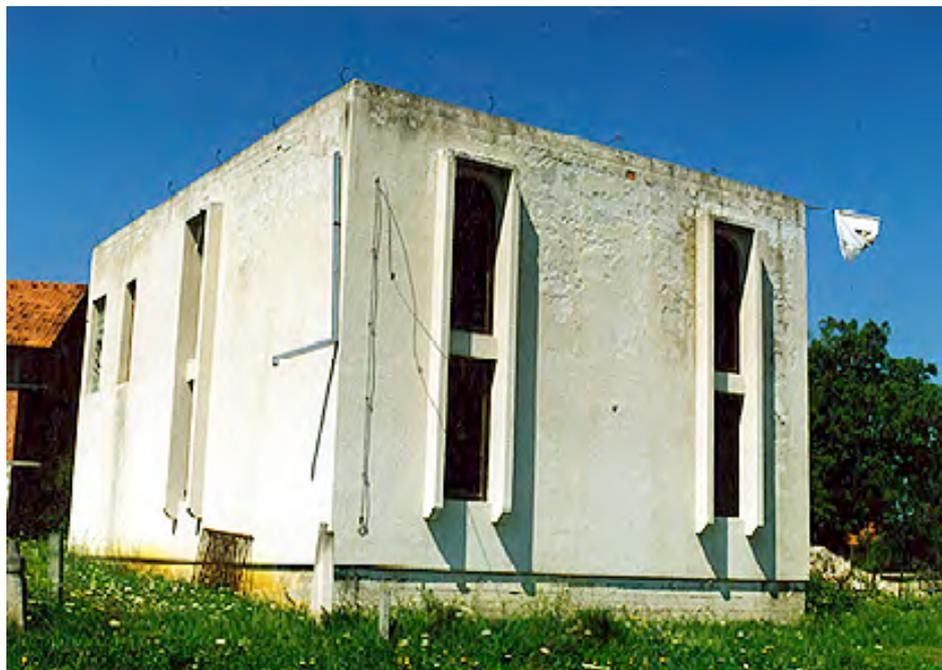
13.14. Lukavice mosque – photo 1

Photo (1996) Medžlis of the Islamic Community of Sanski Most.
The Lukavice mosque at the end of the war.

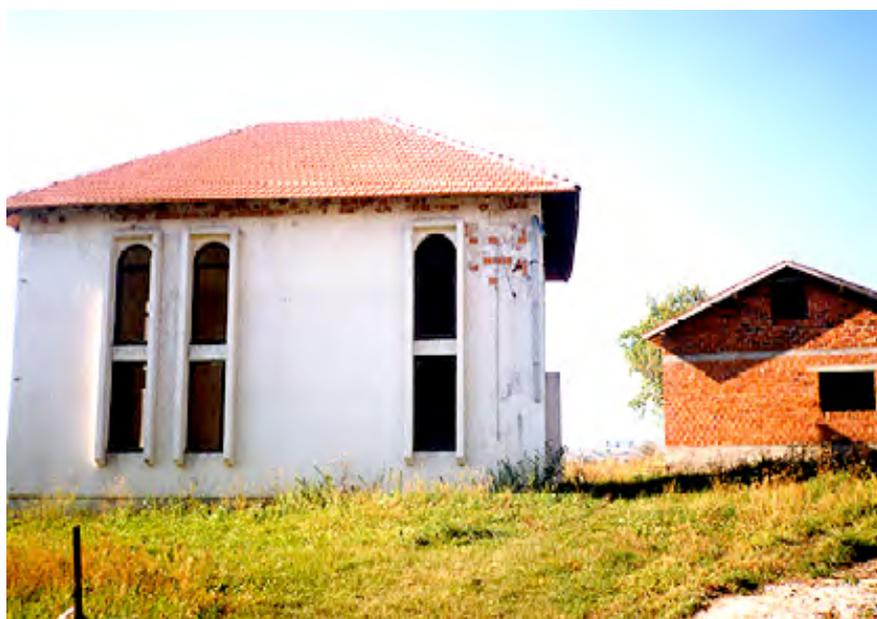
13.14. Lukavice mosque – photo 2

Photo (1998) Medžlis of the Islamic Community of Sanski Most.
The Lukavice mosque undergoing reconstruction after the end of the war. Five years
after this photo was taken, the mosque's minaret was rebuilt..

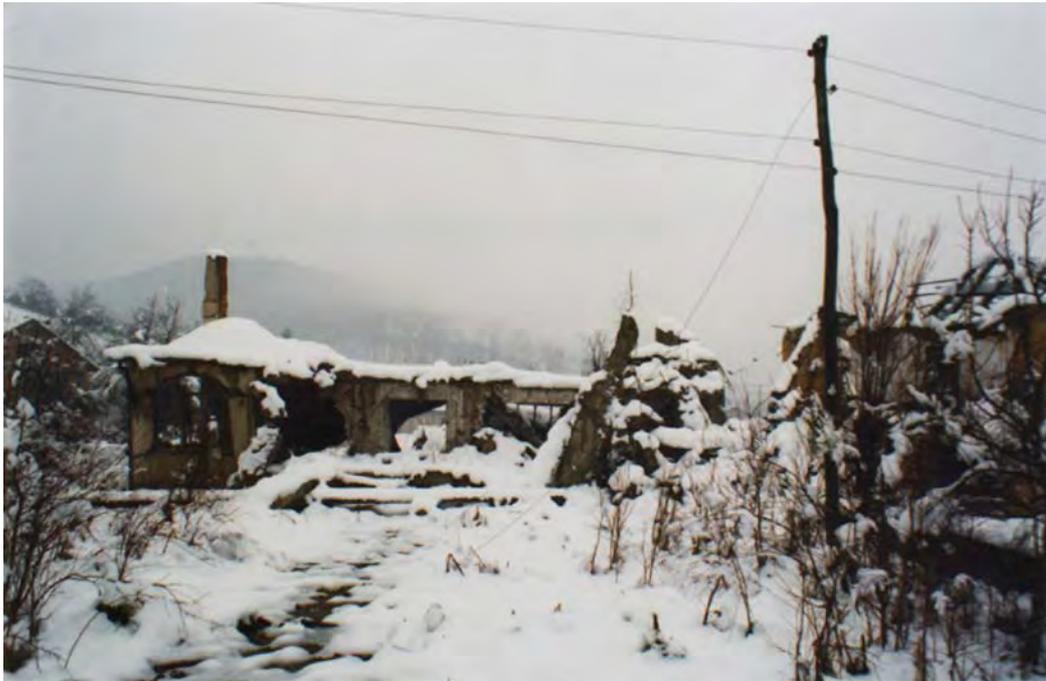
13.15. Tomina mosque – photo 1

Ruins of the Tomina mosque, immediately after the end of the war, viewed from NW.

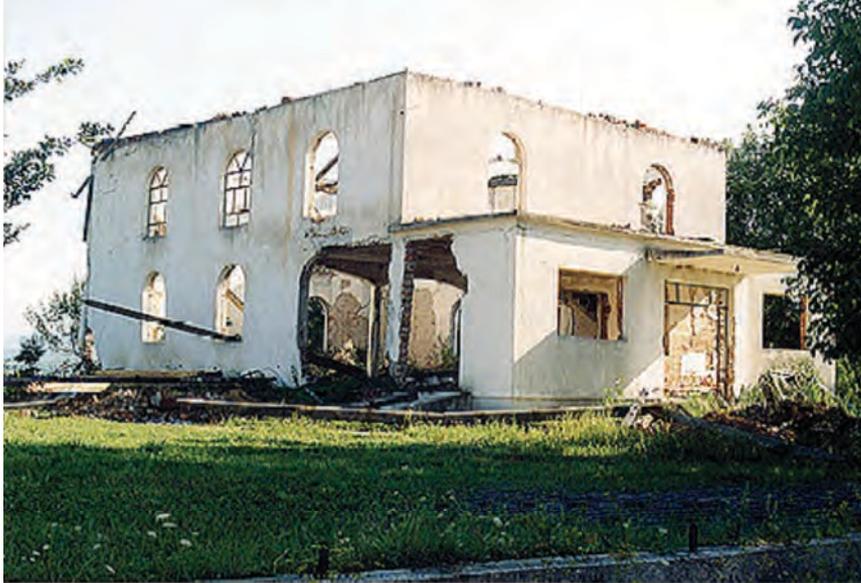
13.16. Čaplje mosque – photo 1

Photo (1996): Medžlis of the Islamic Community of Sanski Most.
The Čaplje mosque at the end of the war, viewed from the NE; entrance at R.
Note the large holes in the perimeter wall and the side of the entrance portico.

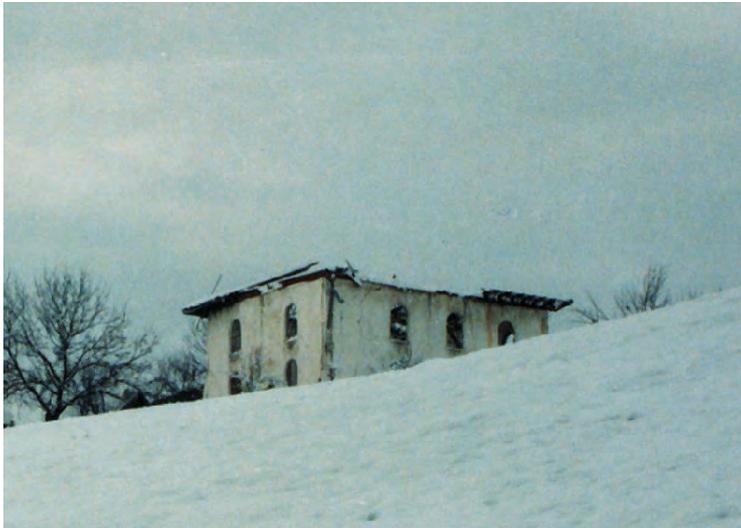
13.16. Čaplje mosque – photo 2

Photo (12/1995) Kemal Zukić, Center for Islamic Architecture, Islamic Community of Bosnia-Herzegovina.
The Čaplje mosque at the end of the war, viewed from the east; *mihrab* wall at L.

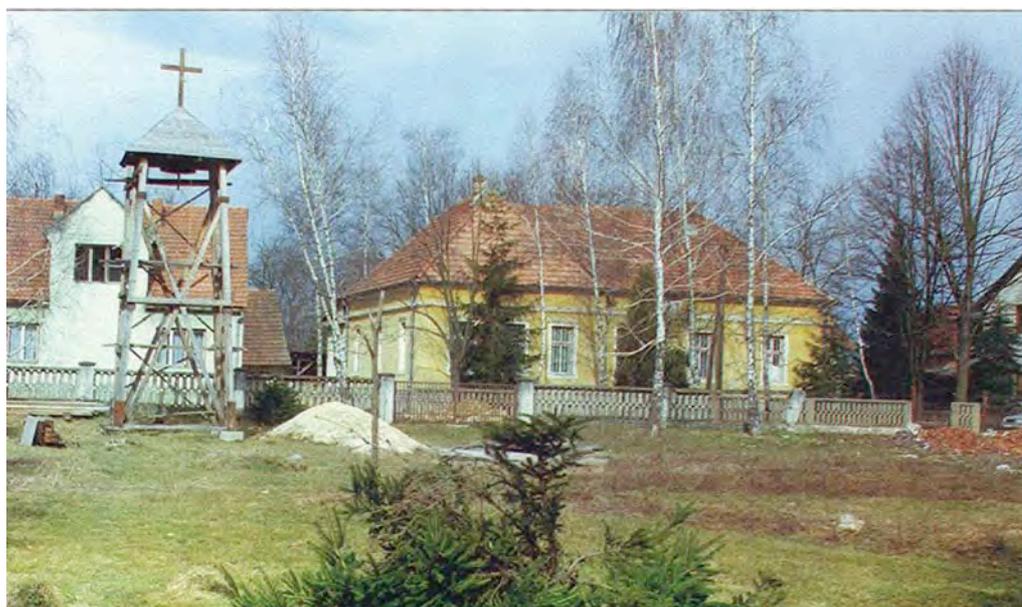
13.17. Town Catholic church in Sanski Most – photo 1

Site of the destroyed church, brown outlines of the foundations in foreground at right; view from the rear of the church site. The entrance of the church faced the street, which runs between the white fence and the parish rectory (the yellow house with the red tile roof). A temporary belfry, erected after the war, can be seen at left.

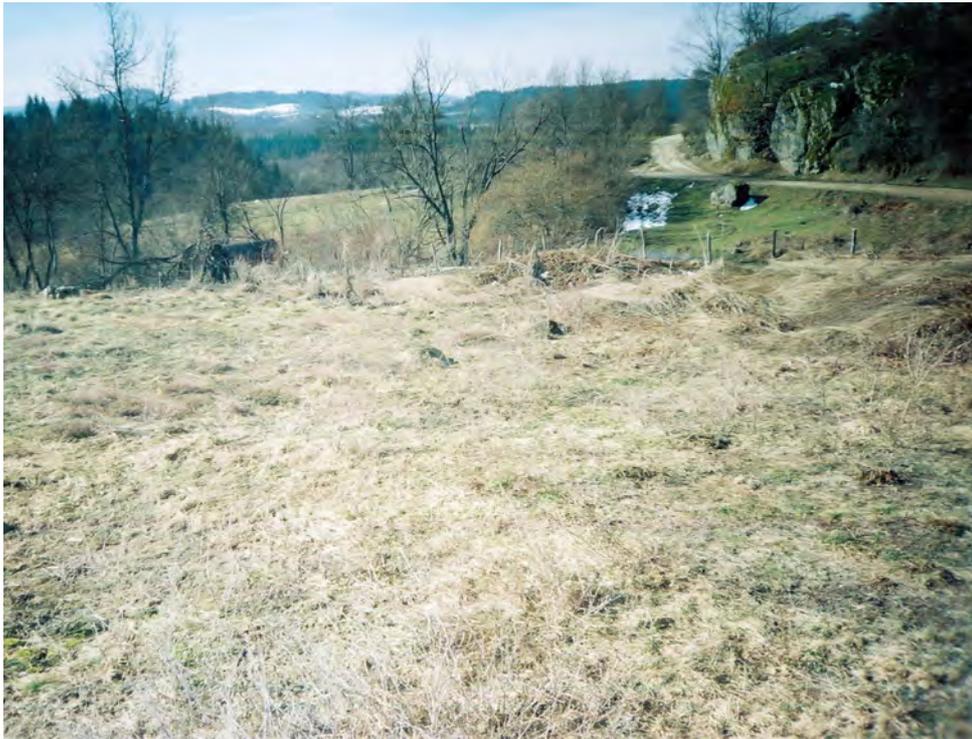
14.1. Kruševci mosque – photo 1

Photo (04/2010): Medžlis of the Islamic Community of Kaljina-Sokolac.
Empty site of the destroyed Kruševci mosque.

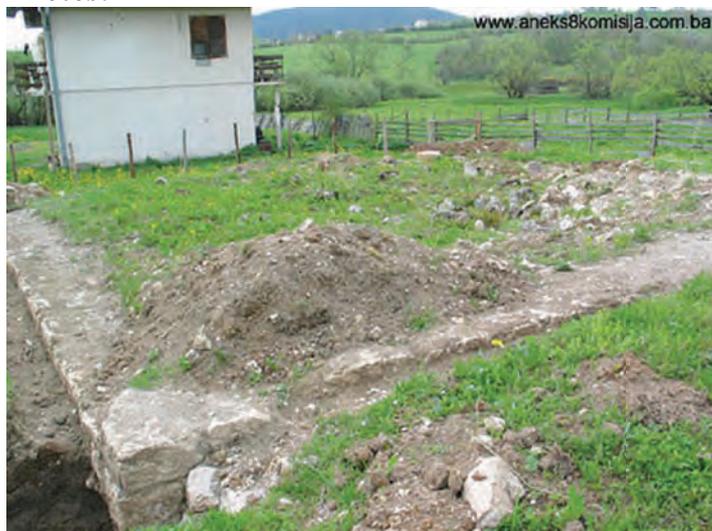
**14.2. Knežina mosque – photo 1**

Photo (2004): Commission to Preserve National Monuments of BiH.
Foundations of the destroyed Knežina mosque.

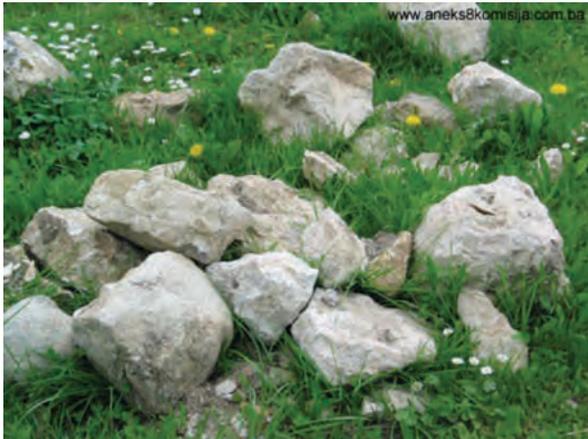
14.2. Knežina mosque – photo 3

Photo (2004) Commission to Preserve National Monuments of BiH.
Fragments of the destroyed Knežina mosque.

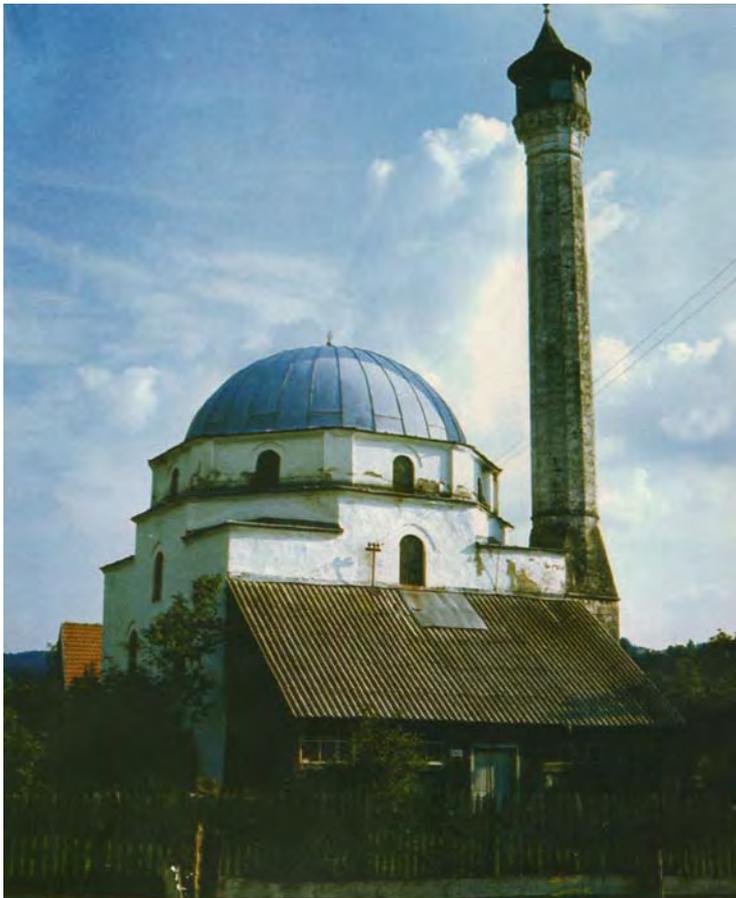
14.2. Knežina mosque – photo 4

Photo: Center for Islamic Architecture, Islamic Community of Bosnia-Herzegovina.
The Mosque of Sultan Selim II in Knežina before the war.

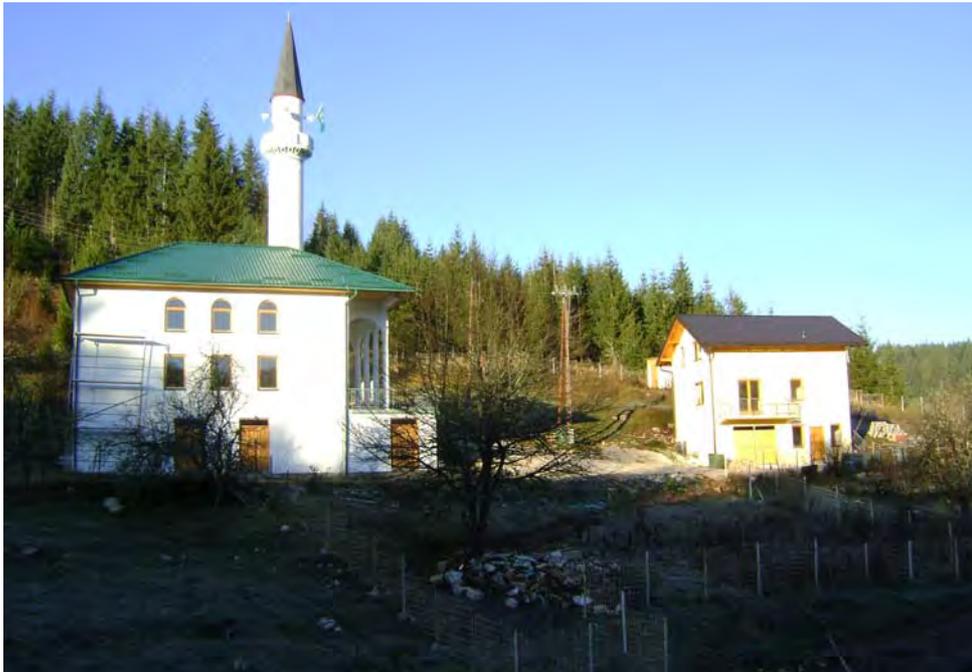
14.3. Kaljina mosque – photo 1

Photo (2008): Medžlis of the Islamic Community of Kaljina-Sokolac.
The Kaljina mosque undergoing postwar reconstruction.

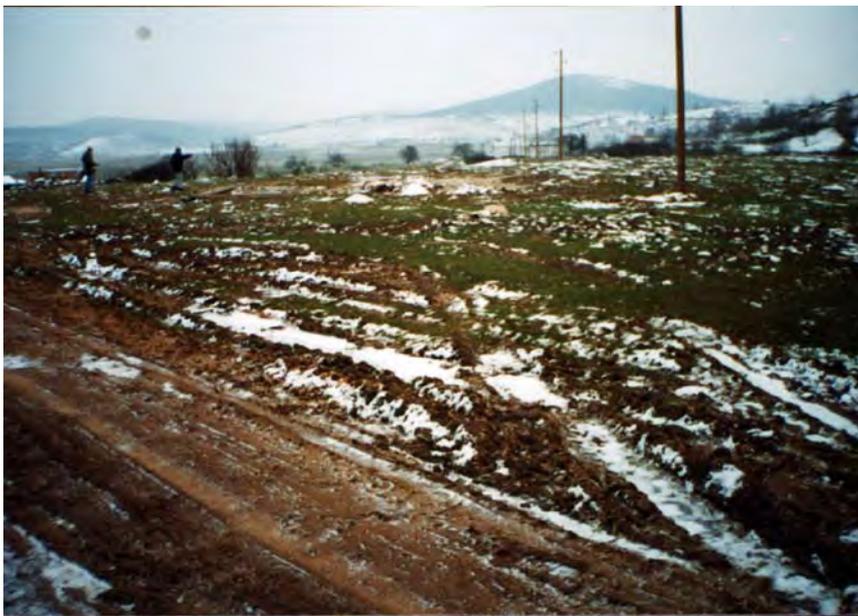
14.4. Novoseoci mosque – photo 2

Empty site of the Novoseoci mosque after the end of the war.

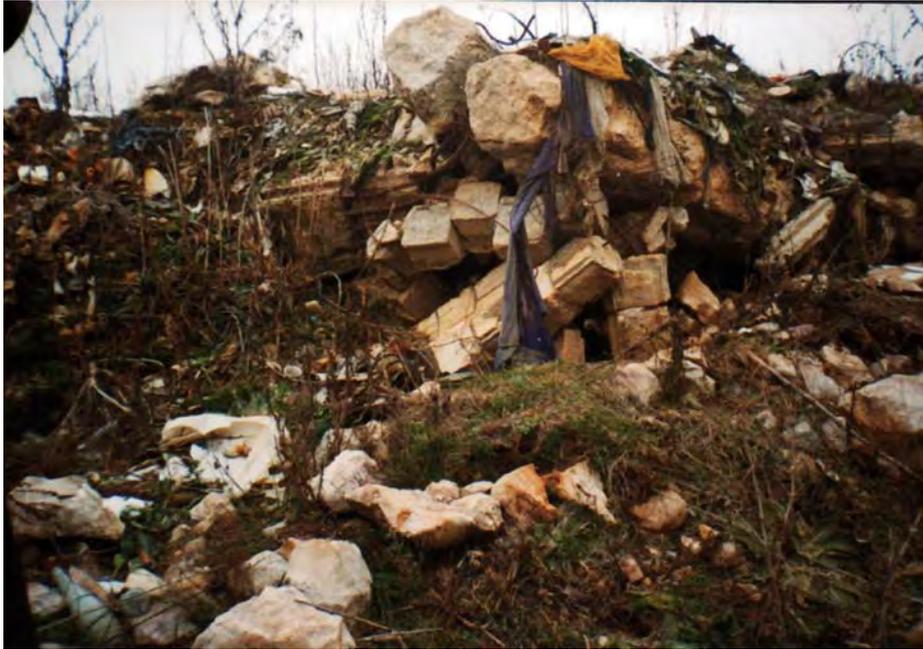
14.4. Novoseoci mosque – photo 3

Rubble from the destroyed Novoseoci mosque and broken Muslim gravestones in the garbage dump at Ivan Polje.

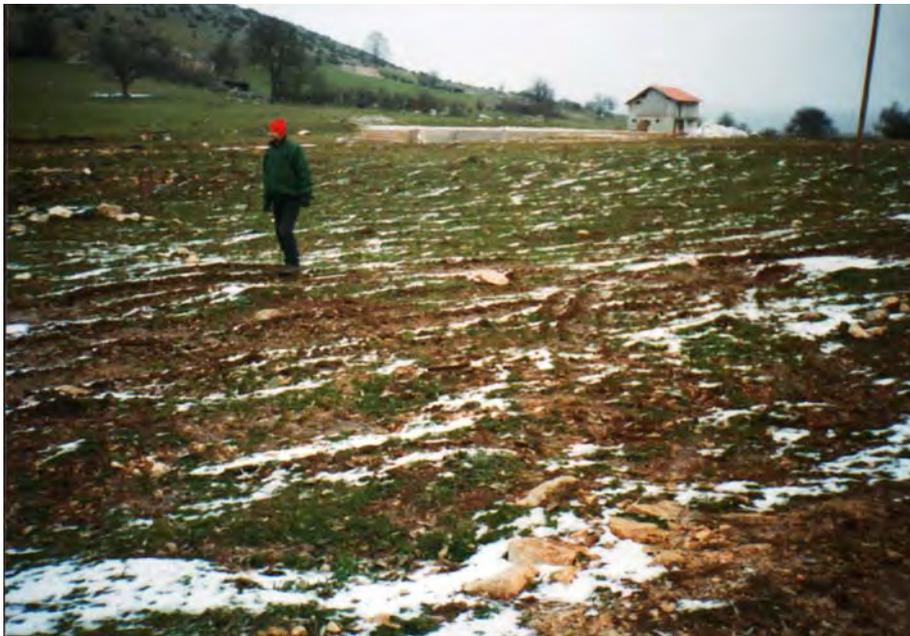
14.4. Novoseoci mosque – photo 4

Mosque site, after the end of the war. In the rear are the concrete foundations of a new Bosnian Serb Army barracks erected in 1998 atop the site of the old Muslim cemetery next to the mosque. The barracks were torn down at the insistence of SFOR.

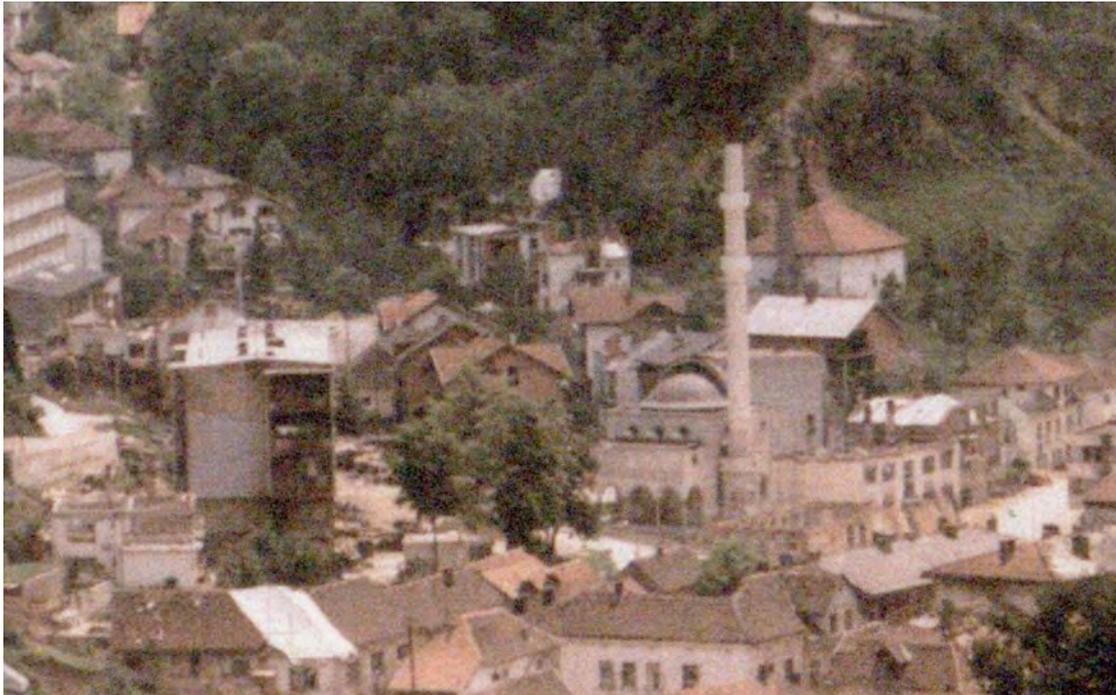
S.1. Čaršijska mosque – photo 2

Photo (1994) by a member of Dutchbat, published in Duijzings (2002). Original photograph in the archive of the Netherlands Institute for Military History (NIMH). The center of Srebrenica during the war, viewed from the WNW: the new Čaršijska mosque is at the center. Several buildings in the town center appear to be burned out or have damaged roofs, but the mosques in the photo appear to be still intact.

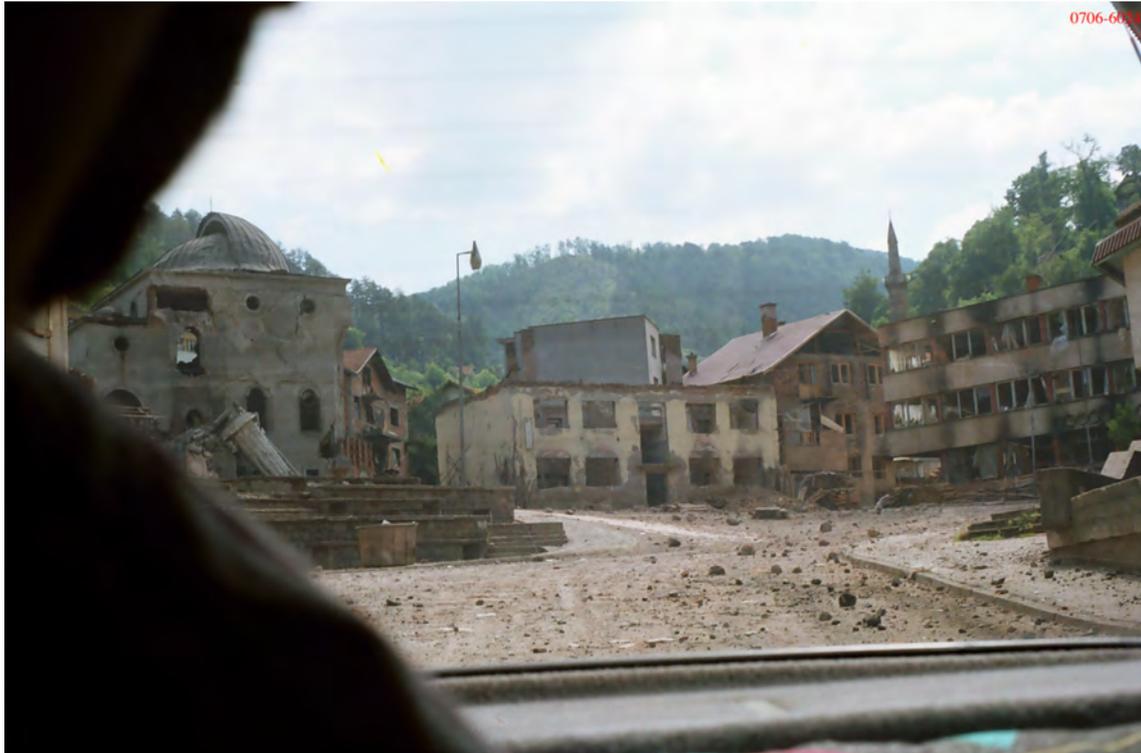
S.1. Čaršijska mosque – photo 5

The Čaršijska mosque, viewed from WSW. In this photo, the main prayer hall of the mosque is still standing, but its minaret has been destroyed by a blast. Part of the shaft of the toppled minaret can be seen at left, leaning against the wall of the mosque.

Chunks of rubble can be seen scattered across the market square. This photo was published in the bi-weekly *Srpska reč*, no. 129 (31/07/1995), p. 9, with the caption: Poslednji snimak srebreničke džamije. Pola sata kasnije pretvorena je u prah i pepeo. (Last photo of the mosque in Srebrenica. Half an hour later it was reduced to rubble): ERN 0706-6050.

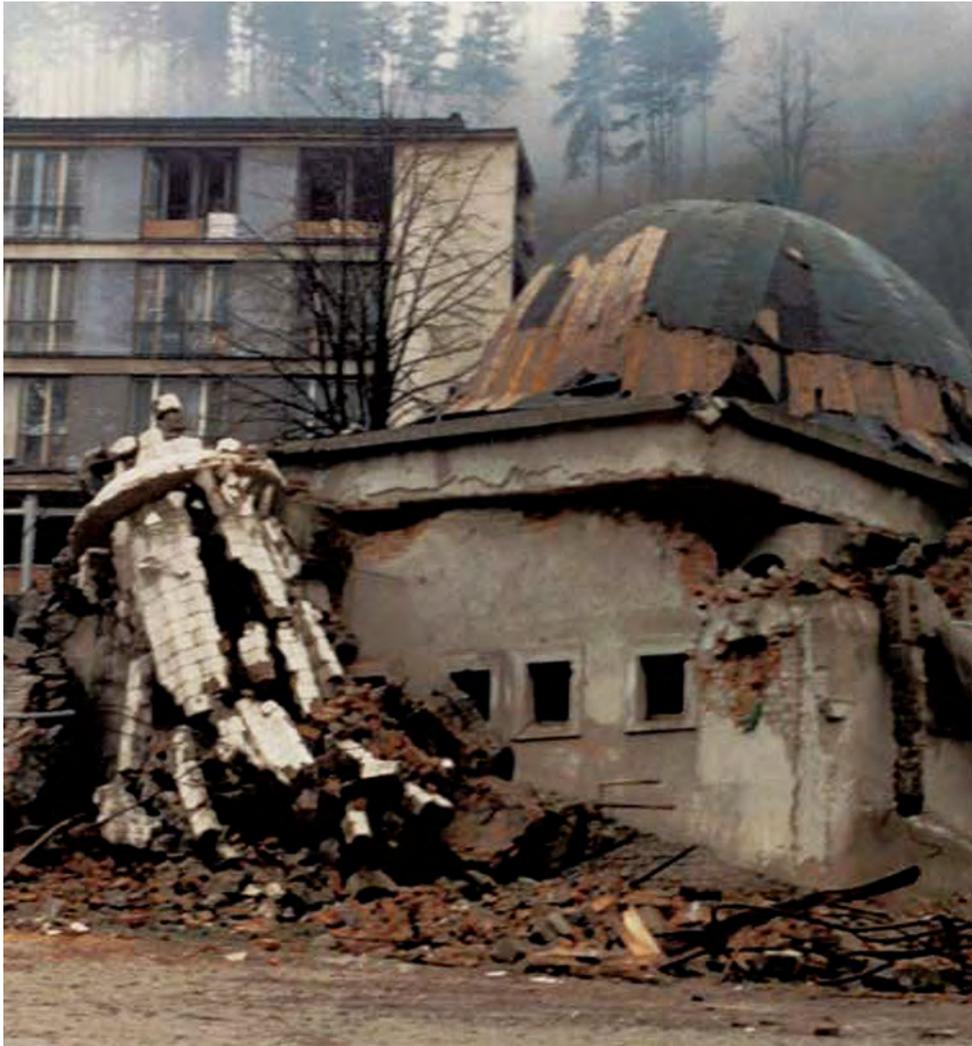
S.1. Čaršijska mosque – photo 6

Photographs taken in early 1996 show the extent of the destruction (Photos 5 and 6 below). The mosque's two-storey tall main prayer hall has been almost completely destroyed. The concrete roof slab supporting the dome over the main prayer hall has dropped from a height of two storeys, coming to rest at a tilt on the remains of the mosque's foundation walls. The mosque's entrance portico, its roof smashed by falling masonry, is seen pushed outwards at a steep angle by the impact of the fallen roof slab.

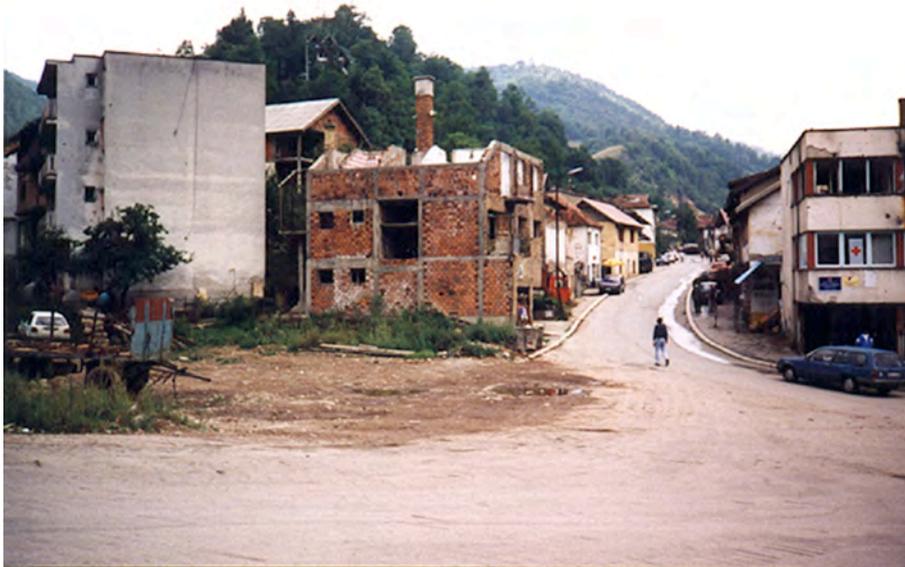
S.1. Čaršijska mosque – photo 8

Empty site of the destroyed Čaršijska mosque, viewed from the WNW.
The site is being used as a parking lot.

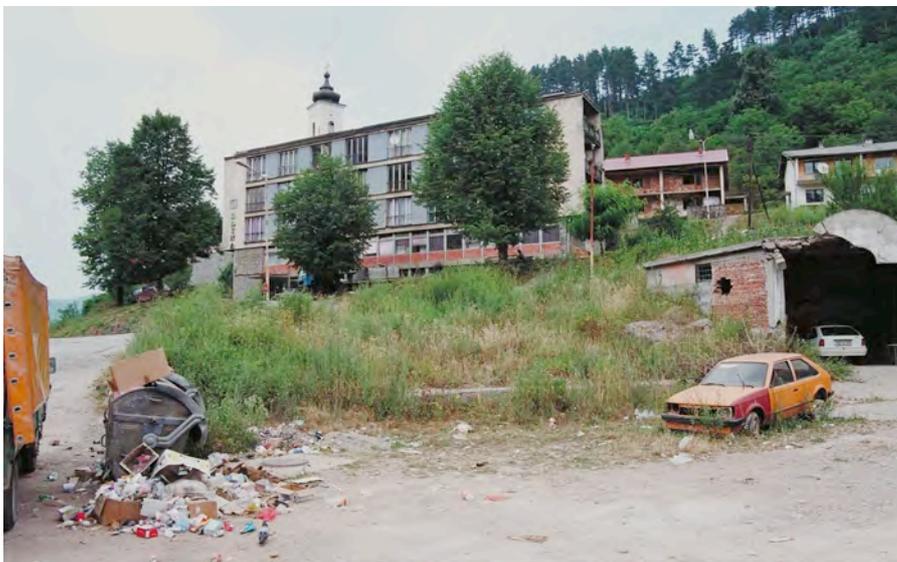
S.1. Čaršijska mosque – photo 9

Site of the destroyed Čaršijska mosque, viewed from the south. For orientation, note the modern building behind the site (cf. photo 6, above). The mosque site is being used for dumping rubbish and as a parking lot.

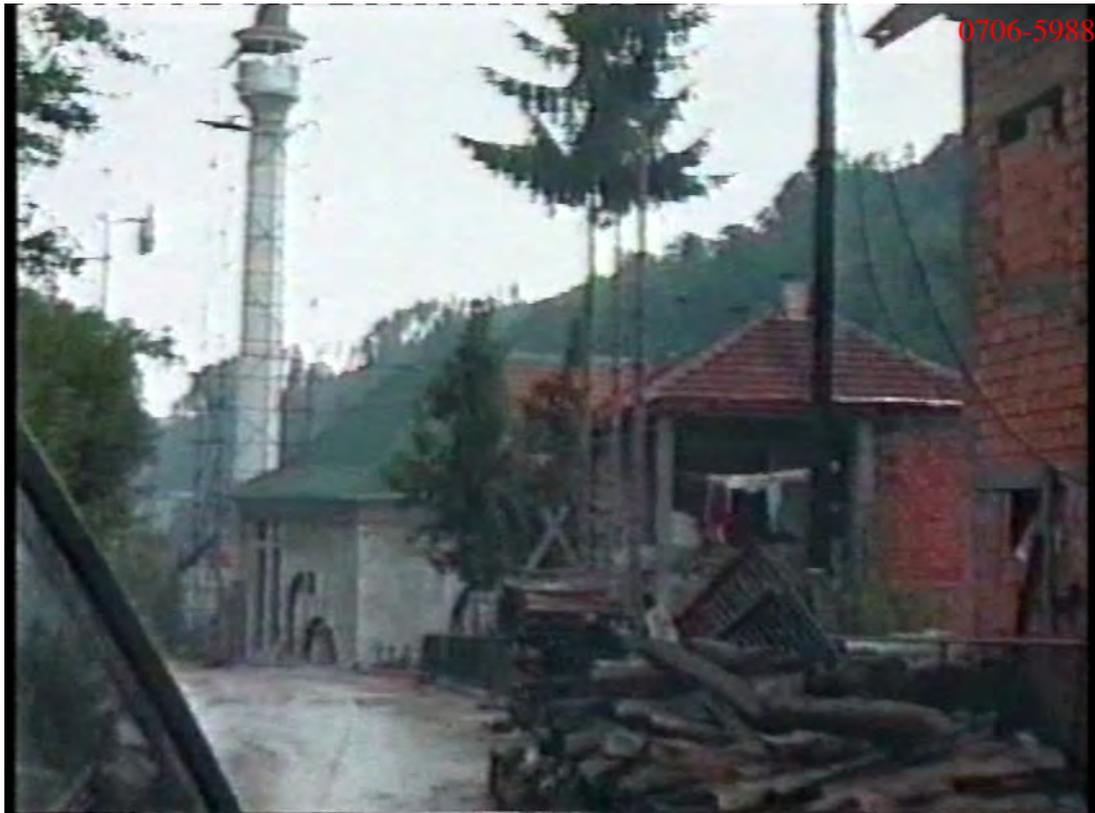
S.2. Petrička mosque – photo 1

The Petrička mosque, view approaching from the south. The mosque's new minaret is seen still standing and surrounded by scaffolding.

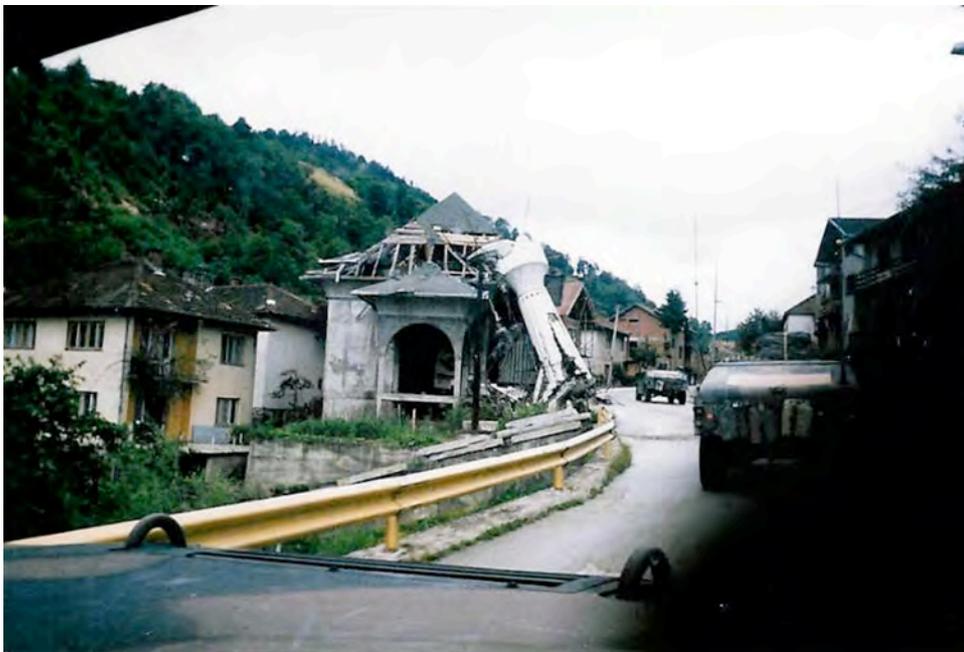
S.2. Petrička mosque – photo 3

An IFOR patrol headed south, out of Srebrenica, passing the ruins of the Petrička mosque. Note the toppled minaret and the smashed roof of the mosque.

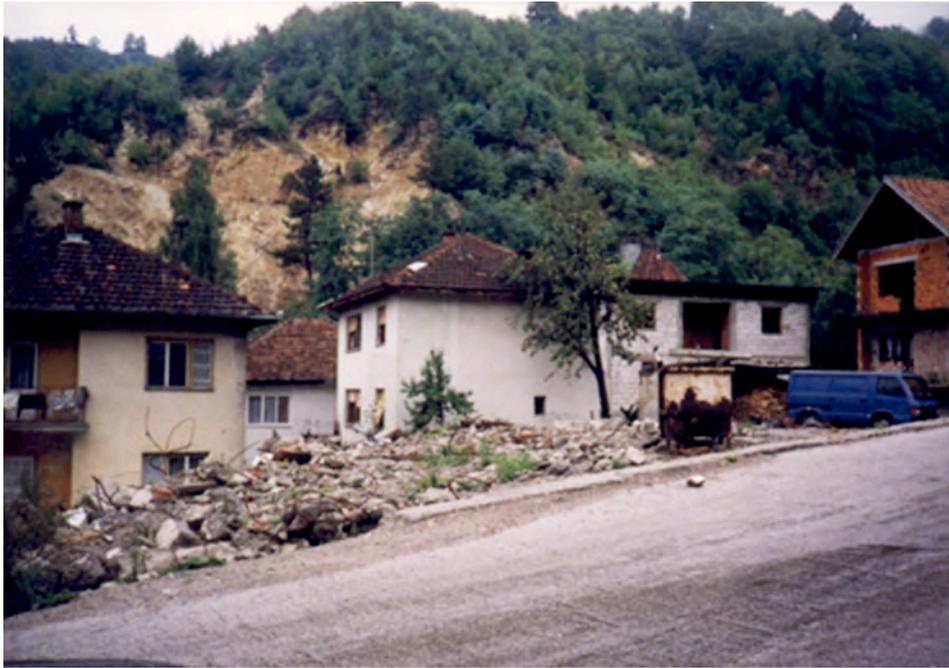
S.2. Petrička mosque – photo 4

Site of the razed Petrička mosque, three years after the war.
