Municipality: 7. Brčko

7.1 Bijela Mosque

Neighborhood:	Kolobara
Town:	Brčko
GPS:	44°52'47.6"N 18°48'13.9" E
Construction:	19 th century (1881, rest. 1893)
Historical period:	Austro-Hungarian
Official status:	listed monument
Building use:	religious
Building type:	Mosque
Building setting:	city
Building condition:	completely destroyed under reconstruction

Damage description: Mosque completely destroyed, ruins razed, building materials removed.

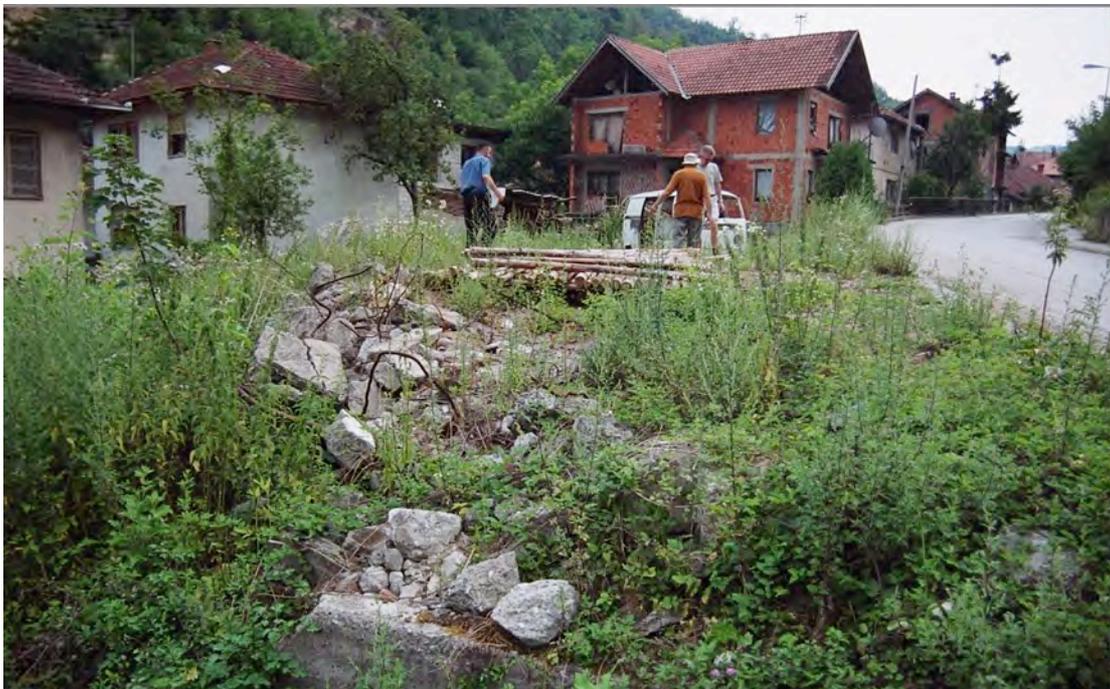
S.2. Petrička mosque – photo 5

Remains of the razed Petrička mosque. The foundations can be seen next to the street, at top center. The round concrete building element at center left is part of the minaret, the base of the muezzin's balcony (*šerefə*).

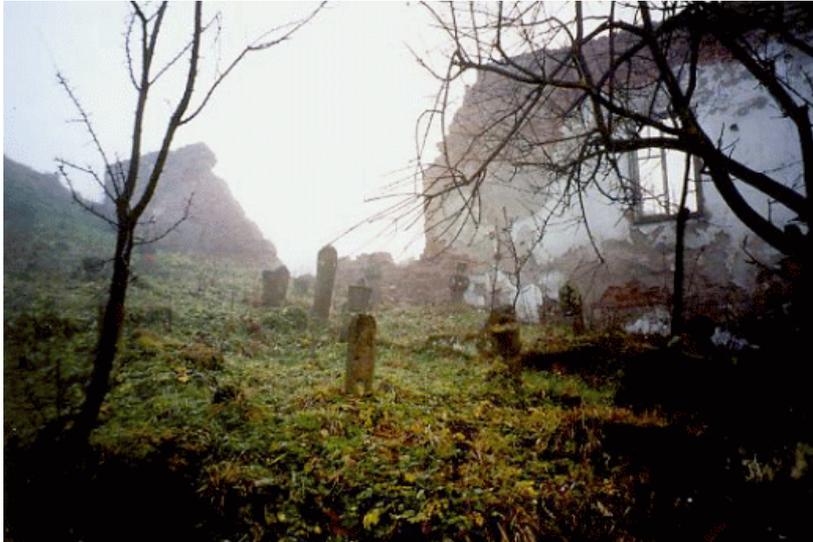
S.3. White mosque – photo 1

Ruins of the White mosque in Srebrenica, viewed from the SE.

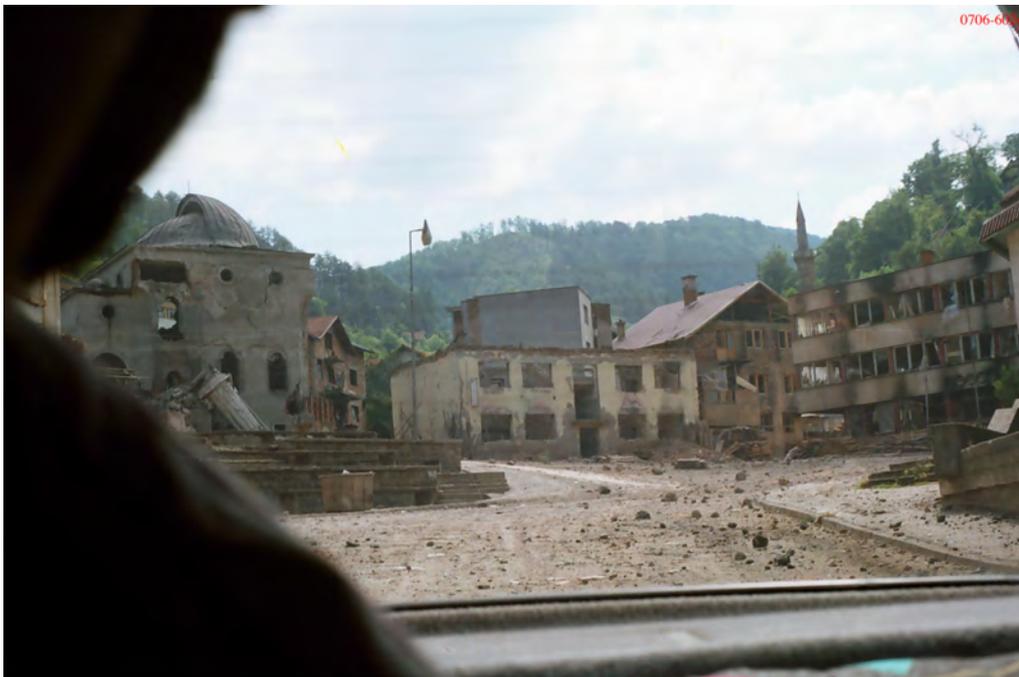
S.3. White mosque – photo 5

The minaret of the White mosque is visible above the rooftops at right. The photo was taken shortly after the minaret of the Čaršijska mosque, at left, had been blown up.

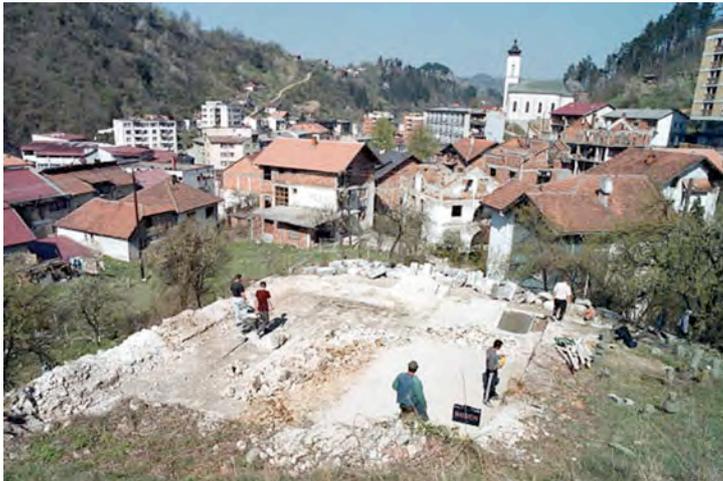
S.3. White mosque – photo 6

The site of the White mosque in Srebrenica, being prepared for reconstruction.

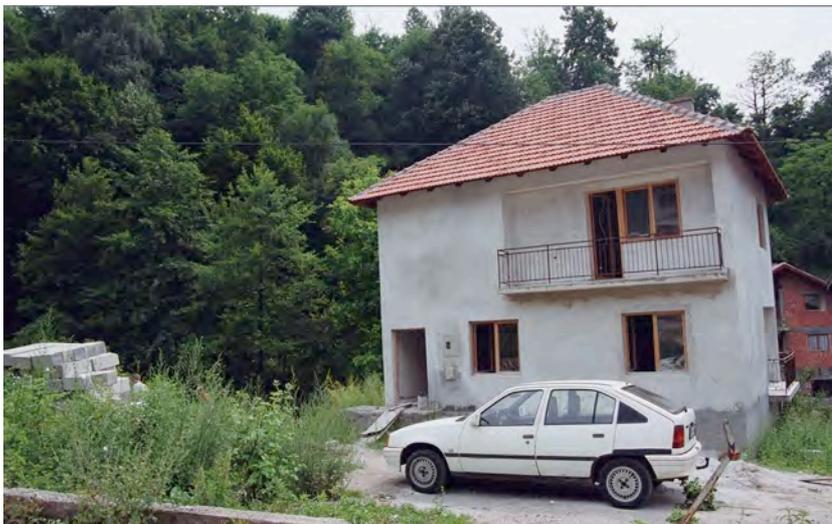
S.4. Crvena Rijeka mosque – photo 2

Post-war photo (07/2002) András Riedlmayer.
Site of the razed mosque at left, the *vakuf* building under reconstruction at right.

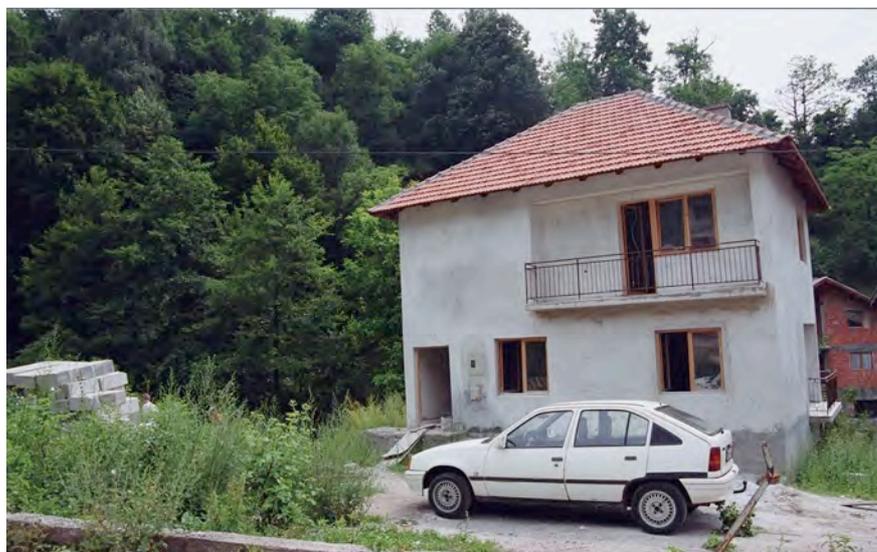
S.5. Archive and library of the Islamic Community of Srebrenica – photo 2
Post-war photo (07/2002) András Riedlmayer.
Site of Crvena Rijeka mosque at left, the *vakuf* building under reconstruction at right.

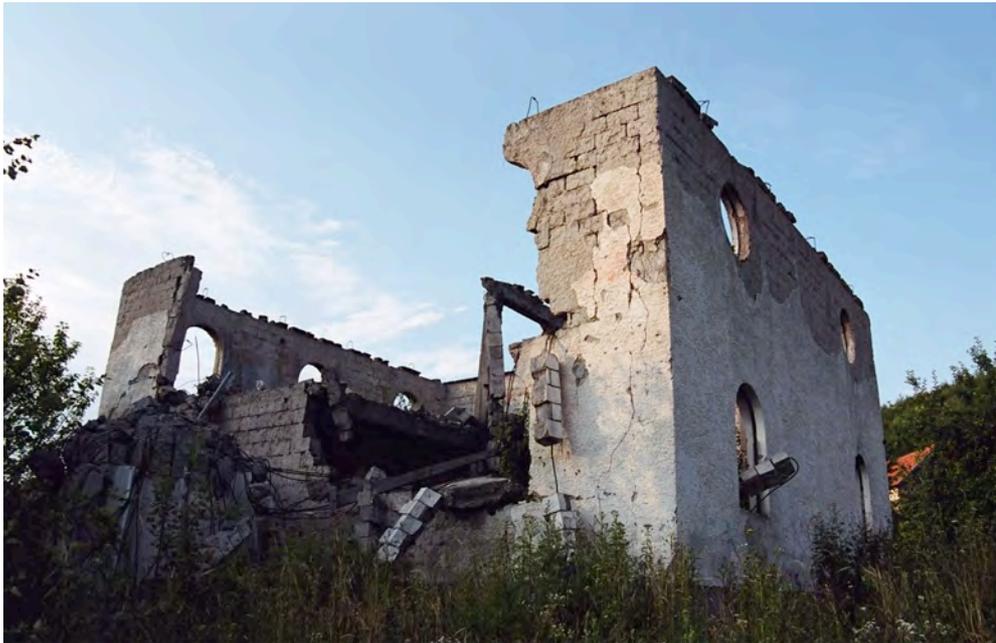
S.6. Vidikovac mosque – photo 1

Ruins of the Vidikovac mosque, viewed from the SSW. The toppled minaret has fallen into the mosque, destroying the SW wall and the interior. The stump of the minaret can be seen at bottom left. The mosque's entrance façade can be seen at far left, the *mihrab* wall at the right. Note shattered roof timbers inside the mosque.

As was observed at the time of the author's site visit and in photos taken after the end of the war, the Vidikovac mosque was heavily damaged. Its tall minaret has been toppled by a blast at its base. The shaft of the minaret had fallen into the mosque, destroying the entire SW façade of the mosque and most of the interior. Three of the four perimeter walls of the mosque remained standing up to the roofline. The interior of the mosque was filled with rubble and broken roof timbers. Scorched wooden elements and soot marks on interior walls of the mosque were an indication of fire.

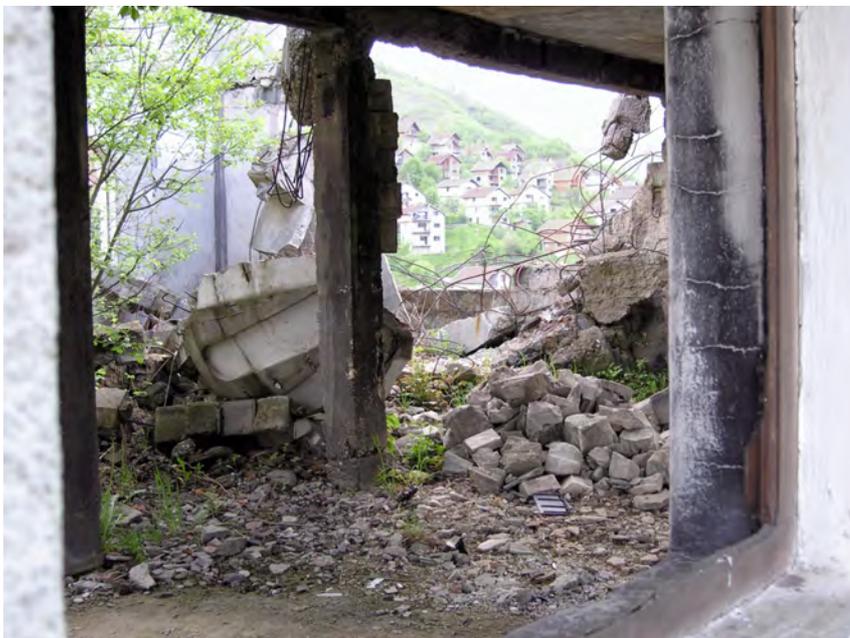
S.6. Vidikovac mosque – photo 2

View of the mosque's interior, looking out towards the south, through the gap in the destroyed perimeter wall. Note scorch marks on the walls (at right) and a large chunk of the blown-up minaret (at center left) that has landed inside the mosque.

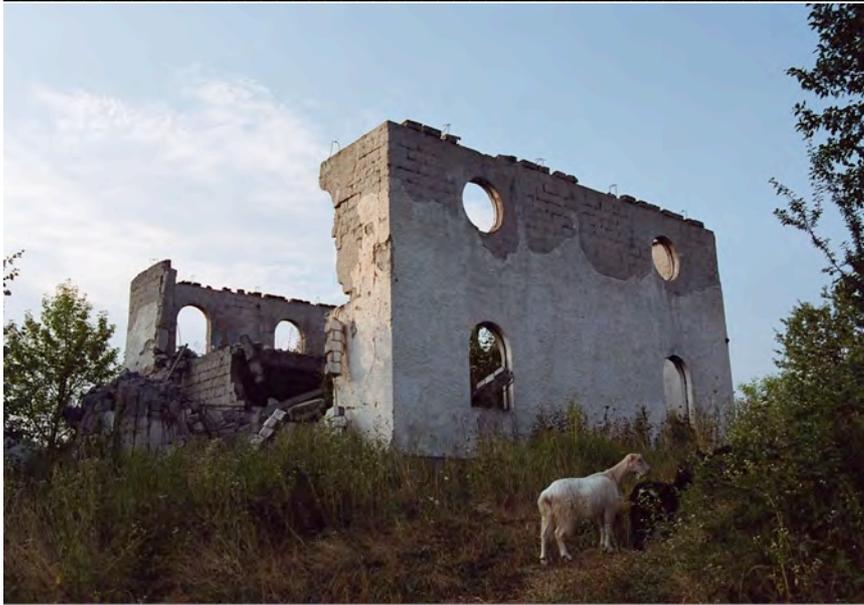
S.6. Vidikovac mosque – photo 3

Ruins of the Vidikovac mosque, viewed from the south; stump of the minaret at L.

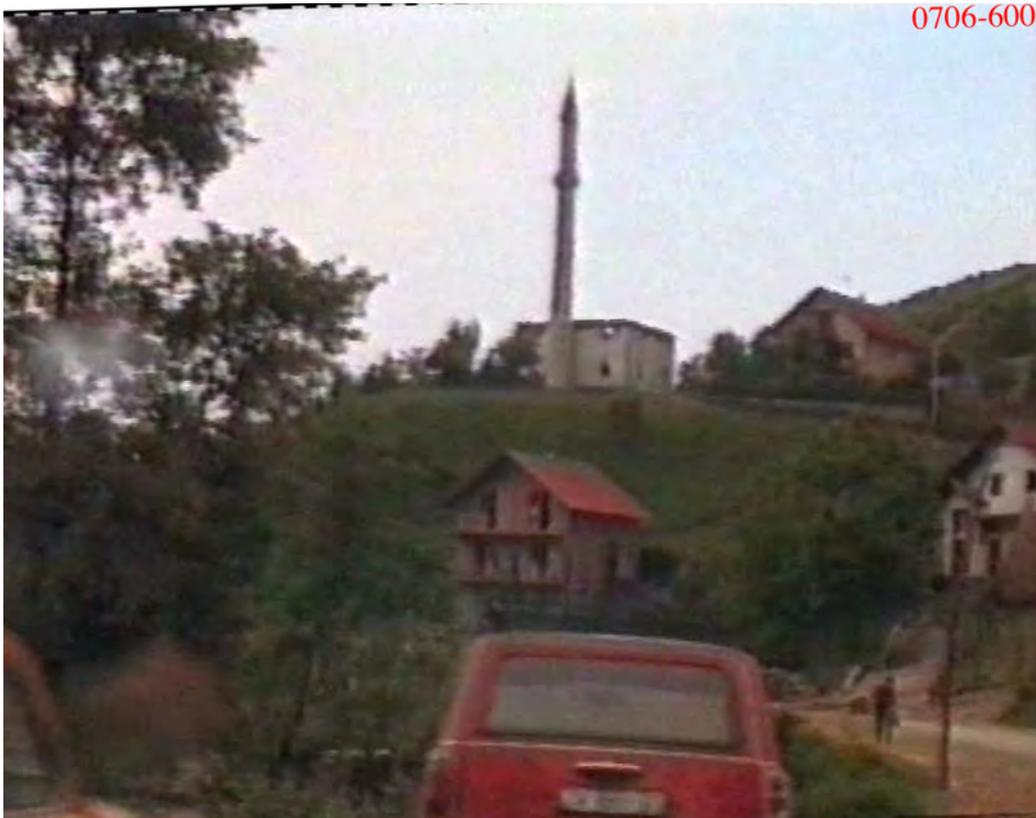
S.6. Vidikovac mosque – photo 4

The Vidikovac mosque, viewed from the SSW. The mosque is roofless, possibly burned out, but the minaret and the mosque's four perimeter walls are still standing.

The roof of the mosque was reportedly damaged by shelling during the war, but the mosque and its minaret were still standing when Srebrenica fell on 11 July 1995. This account is consistent with video footage recorded on 14 July 1995, which shows the mosque roofless, but with its perimeter walls and minaret still intact (see Photo 4, below). At some point thereafter the minaret and the mosque were destroyed.

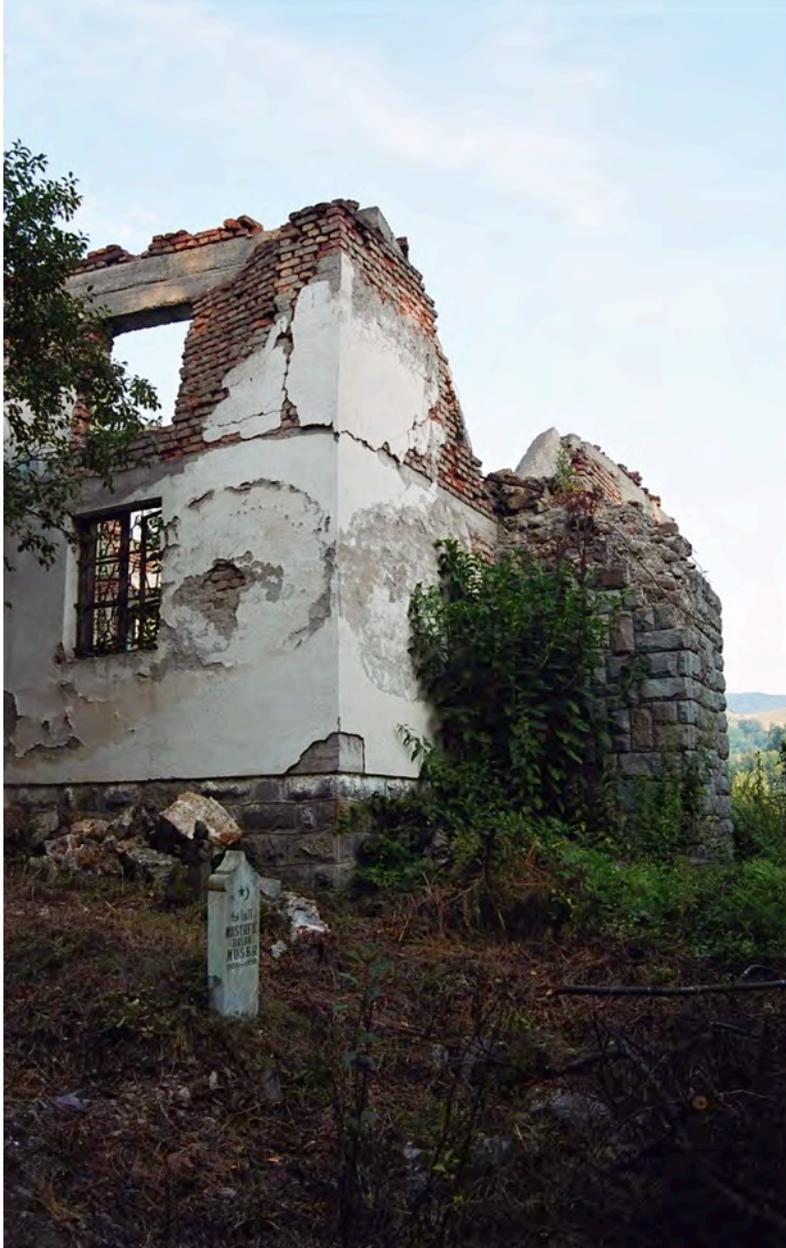
S.8. Gornji Potočari mosque – photo 1

NW corner of the mosque; note projectile impacts, stump of destroyed minaret at R.

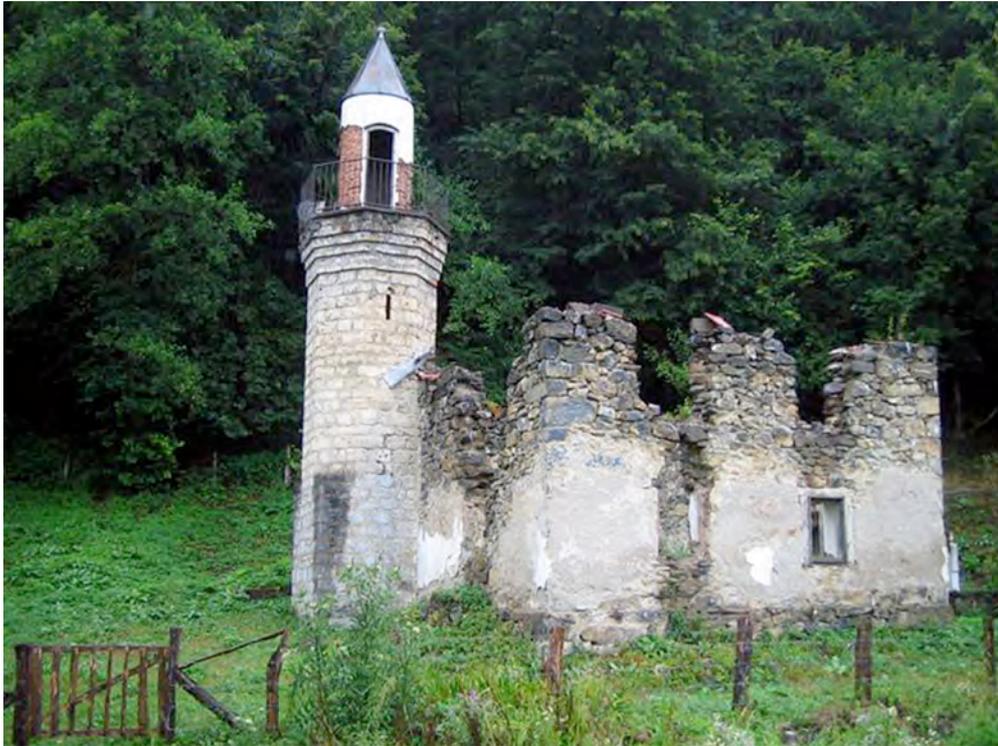
S.9. Slapovići mosque – photo 1

Post-war photo: Center for Islamic Architecture of the Islamic Community of BiH.
The burned-out Slapovići mosque, viewed from the SW.

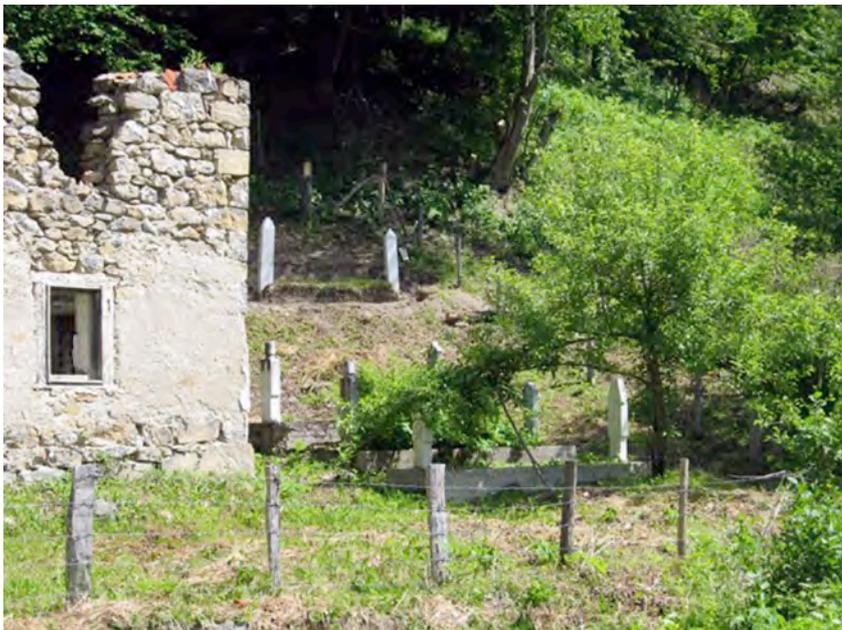
S.9. Slapovići mosque – photo 2

Post-war photo: Center for Islamic Architecture of the Islamic Community of BiH.
Close-up view of the SE corner of the mosque and the mosque graveyard.

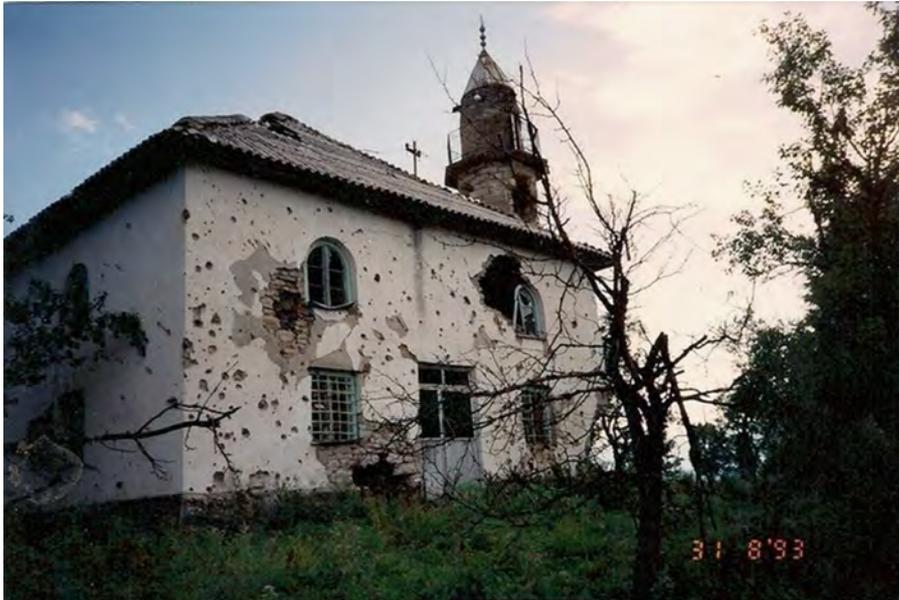
S.10. Sućeska mosque – photo 1

Damage description: In a photograph taken during the war (31/08/1993), the Sućeska mosque is seen heavily damaged by multiple projectile impacts, with holes in the mosque's roof, in the shaft of its wooden minaret, and in its entrance façade and other perimeter walls.

Wartime photo (31/08/1993) in the archive of the Center for Islamic Architecture, Islamic Community of Bosnia and Herzegovina.
View of NW façade of the Sućeska mosque, showing damage from projectile impacts.

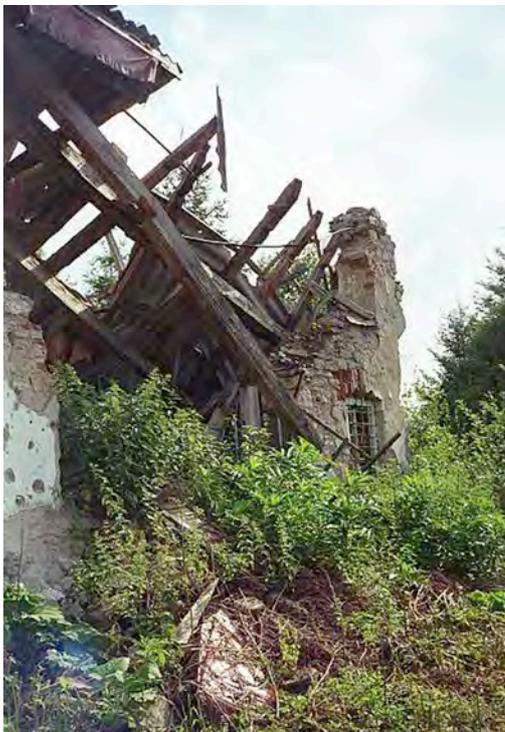
S.10. Sućeska mosque – photo 2

In photographs taken after the end of the war, the Sućeska mosque is almost completely destroyed. The mosque's roof and minaret and three of its four perimeter walls have collapsed. The interior is left exposed and open to the sky and is covered with smashed roof timbers and rubble. The mosque's northeastern perimeter wall is damaged, but remains standing up to the roofline.

Photo (06/2000): Jonathan Morgenstein.
View of NW façade of the Sućeska mosque, with roof timbers collapsed into interior.
For orientation, note pattern of impact holes in plaster at **L**, also visible in 1993 photo.

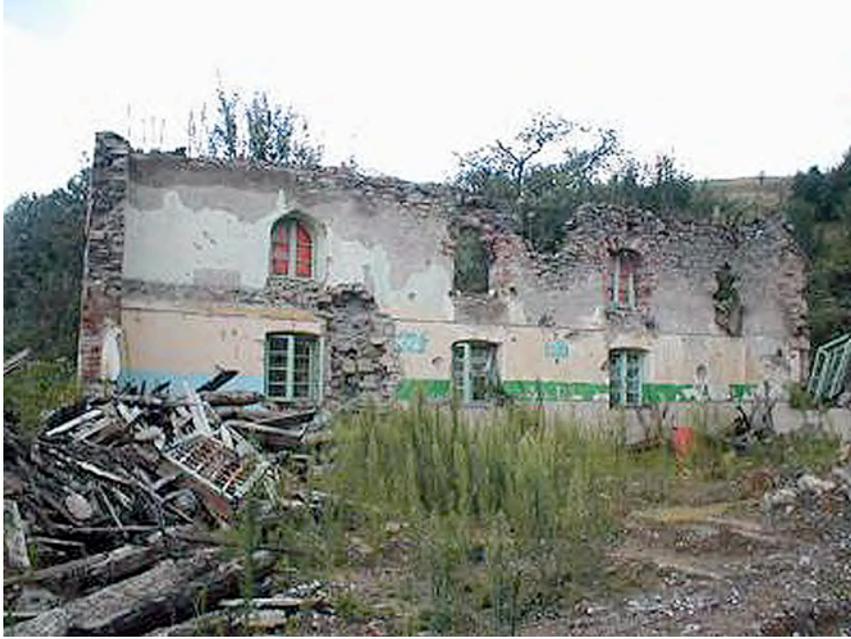
S.10. Sućeska mosque – photo 3

Interior view of the mosque, following initial cleanup; remains of ruined entrance façade demolished, roof timbers collected in a pile at left. The NE perimeter wall is damaged but still standing.

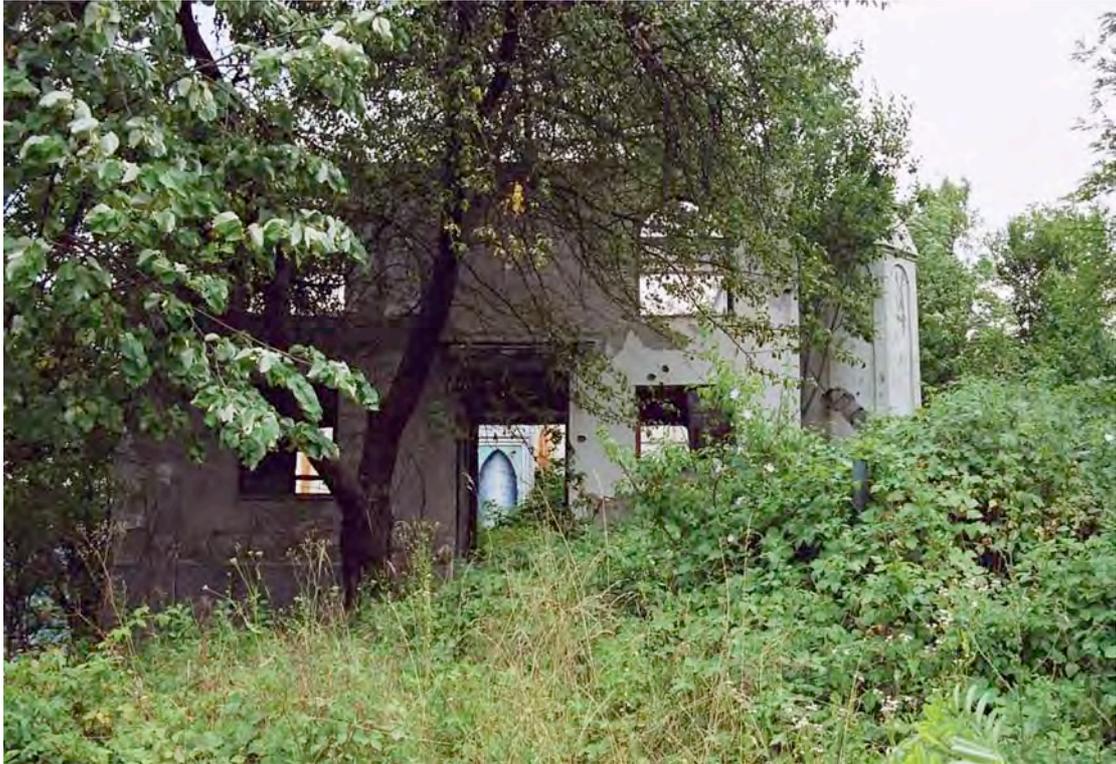
S.11. Liješće mosque – photo 1

Damage description: The Liješće mosque has lost its roof, its interior is gutted and left open to the sky. The perimeter walls remain standing up to the roofline. Charred roof timbers seen inside the mosque indicate destruction by fire. The tall, concrete minaret of the mosque has been destroyed above its base by a blast. Shattered pieces of the shaft of the toppled minaret were seen lying on the ground next to the mosque.

Entrance façade of the Liješće mosque. The base of the minaret is at right. The colorful *mihrab* of the mosque can be seen through the missing door.

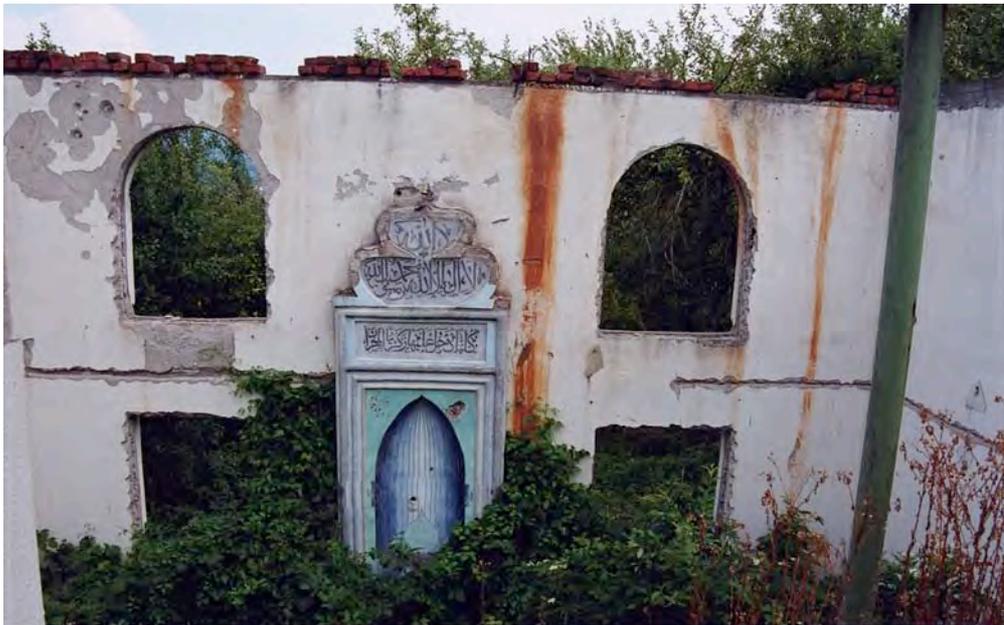
S.11. Liješće mosque – photo 2

Interior of the burned-out Liješće mosque, looking down from the women's balcony towards the *mihrab*.

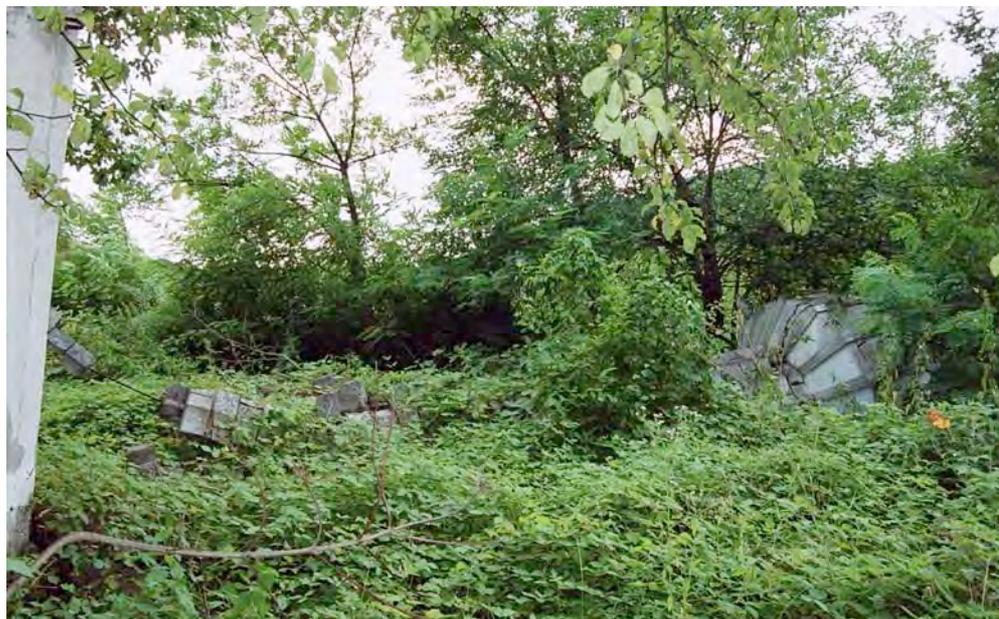
S.11. Liješće mosque – photo 3

The toppled minaret of the Liješće mosque; base of minaret at L, muezzin's balcony (*šerefe*) at R; broken pieces of the shaft in between, partly covered by vegetation.

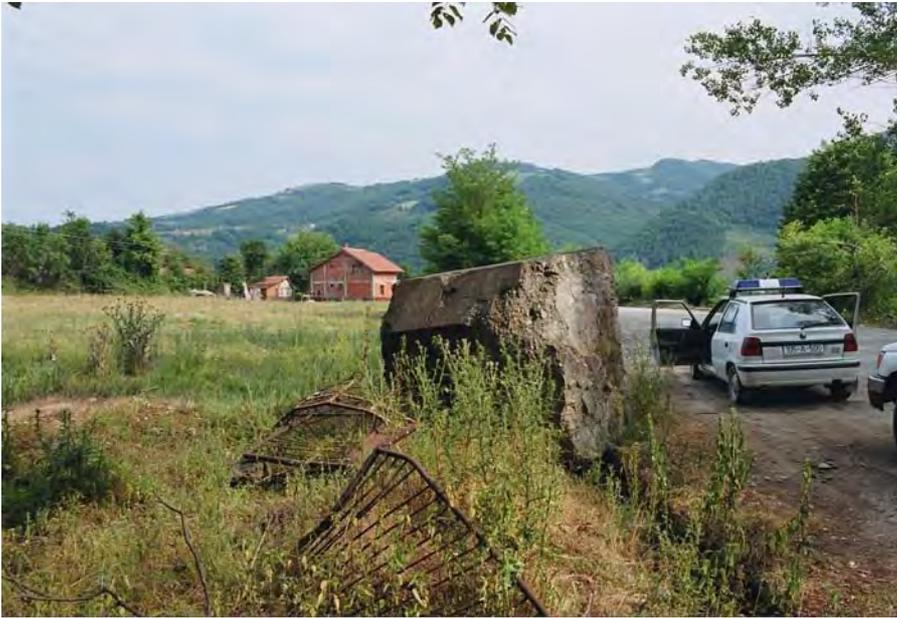
S.12. Dobrak mosque – photo 1

Damage description: The Dobrak mosque has been completely destroyed, its ruins razed, its building materials removed and the site leveled. The only surviving element of the mosque left at the site at the time of the author's survey visit was a very large piece of concrete, possibly part of the base of the mosque's minaret, and some rusted iron railings. Patches of disturbed ground trace the outlines of the foundations of the destroyed mosque.

Site of the destroyed mosque (at L) and its last remains (R); view looking south, towards the Drina.

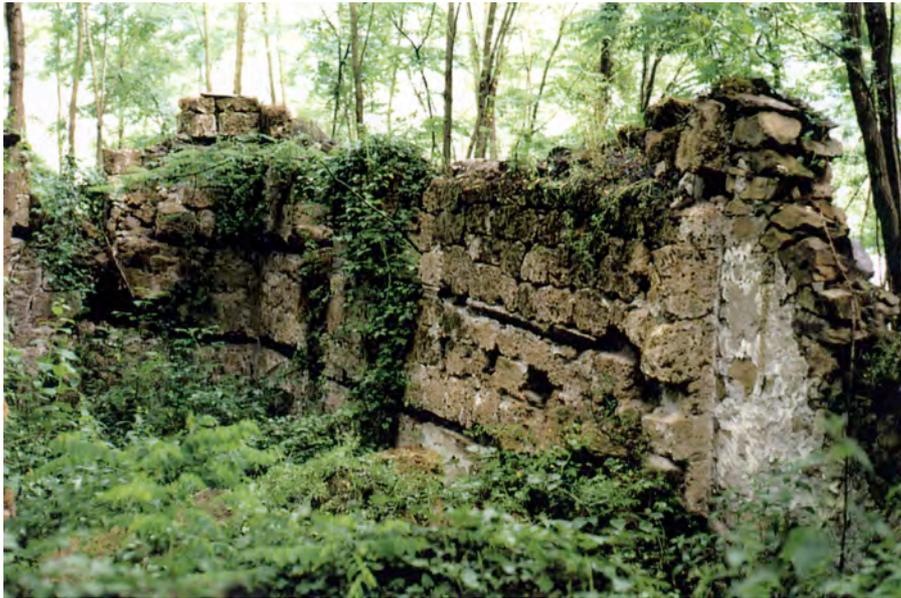
S.13. Old mosque in Peći – photo 1

Damage description: In photographs taken after the end of the war, the Old mosque is very heavily damaged. The mosque's roof and minaret are completely destroyed, its interior is gutted and filled with rubble, open to the sky, with sapling trees and other vegetation growing inside. Only some damaged sections of the Old mosque's stone perimeter walls remain standing.

Old mosque in Peći, view of the interior with part of damaged perimeter wall.

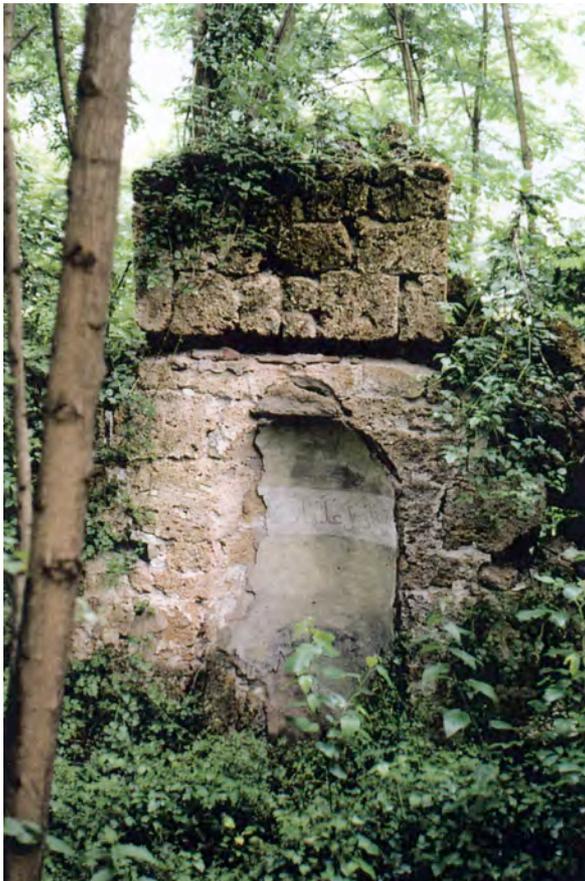
S.13. Old mosque in Peći – photo 2

Remains of the *mihrab* (prayer niche) inside the Old mosque in Peći.

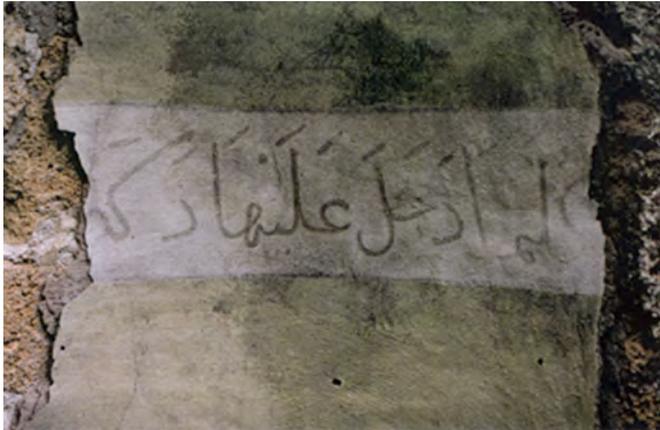
S.13. Old mosque in Peći – photo 3

Damaged inscription from the Qur'an (Surah Al Imran 3:37) inside the *mihrab* (prayer niche) of the Old mosque in Peći.

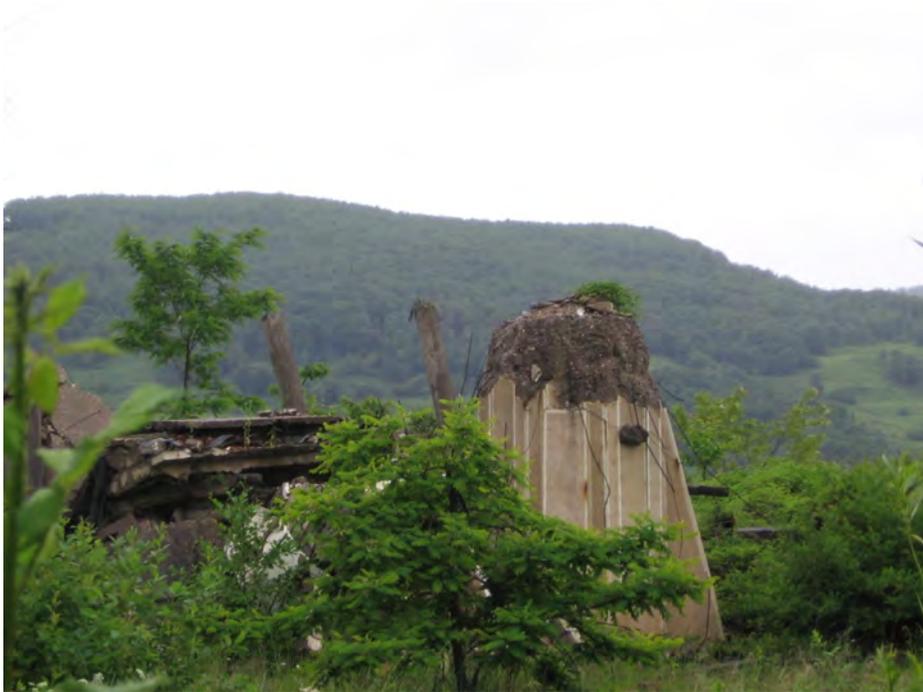
S.14. Osat mosque – photo 1

Damage description: In photographs taken after the end of the war, the Osat mosque is almost completely destroyed, a pile of concrete rubble shattered by a blast. The remains of the fallen muezzin's balcony can be seen lying on the ground, next to the base of the minaret, which is the only element of the mosque left standing.

Ruins of the Osat mosque: the stump of the minaret is at right, the white remains of the muezzin's balcony (*šerefe*) can be seen on the ground, behind the tree at center.

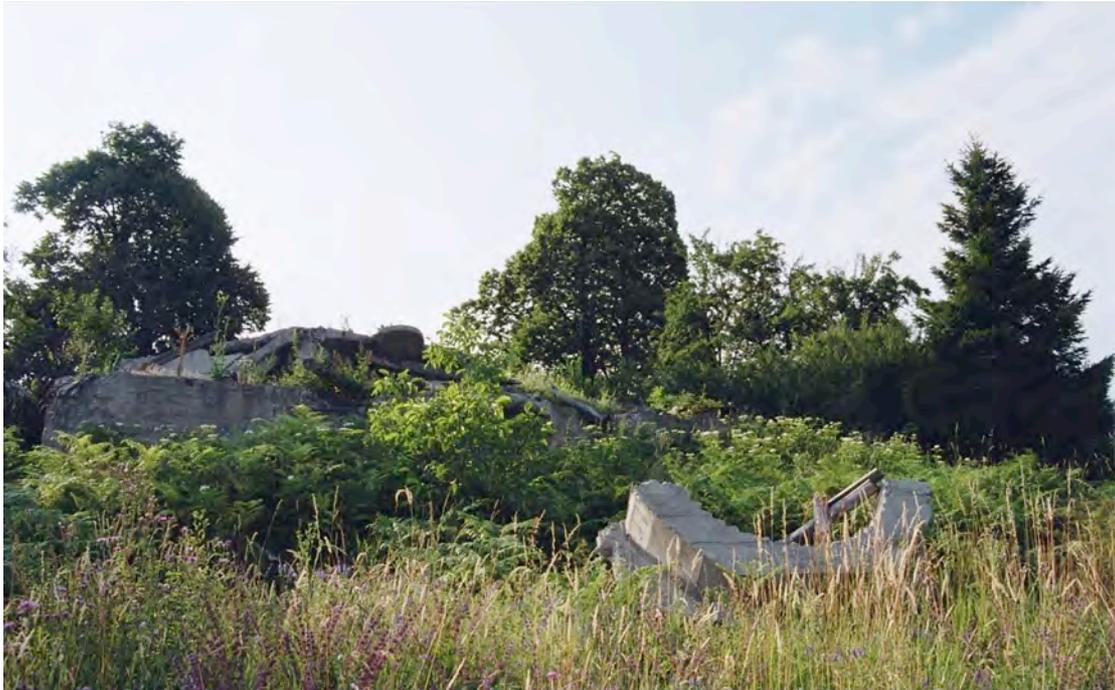
S.15. Osmače mosque – photo 1

Damage description: The mosque in Osmače was completely destroyed. Only a massive pile of concrete rubble, shattered by blast, could still be seen at the site of the mosque at the time of the author's site visit. The only identifiable element in the rubble was a broken, semi-circular fragment of the muezzin's balcony (*šerefe*).

Rubble of the Osmače mosque; fragment of muezzin's balcony (*šerefe*) at center R.

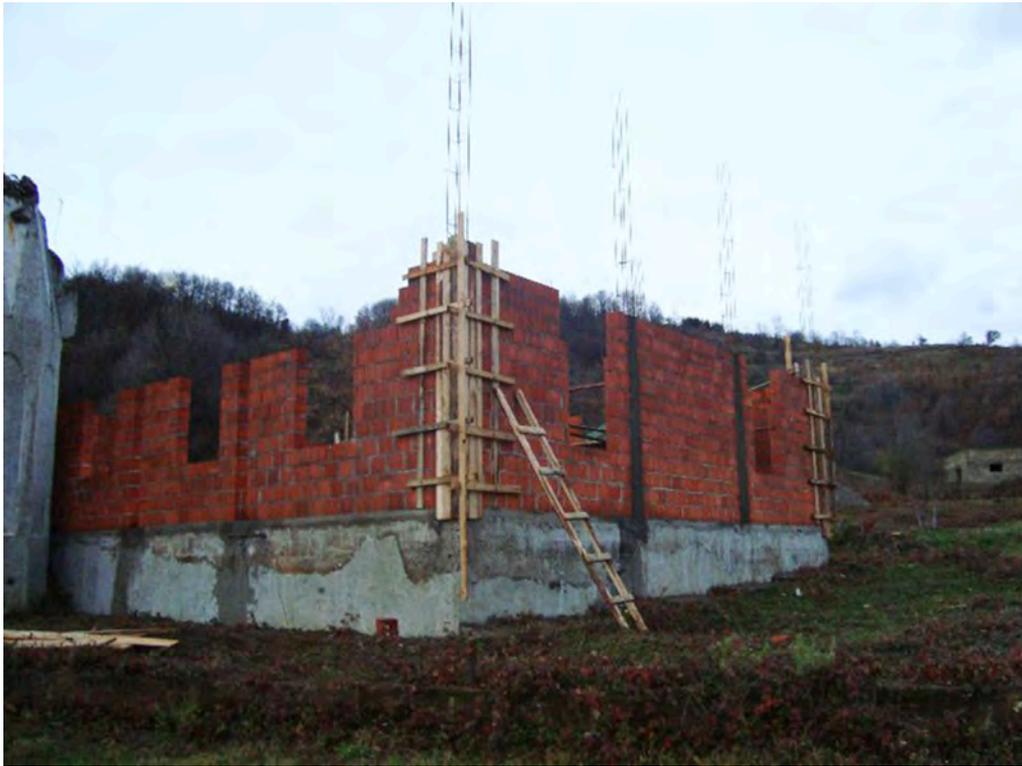
S.16. Tokoljaci mosque – photo 3

Damage description: In a post-war photo of the mosque site, the only element of the Tokoljaci mosque left standing is the massive stump of the minaret, truncated unevenly at the top of its base and showing signs of blast damage. It appears that the concrete foundation of the destroyed mosque, which itself shows signs of wartime damage, is being repaired and re-utilized as a foundation base for the post-war reconstruction of the mosque.

The mosque in Tokoljaci, undergoing post-war reconstruction, viewed from the south. Note the damaged foundation, with parts of the original plaster coating still in place and signs of recent repairs; the stump of the destroyed minaret can be seen at left.

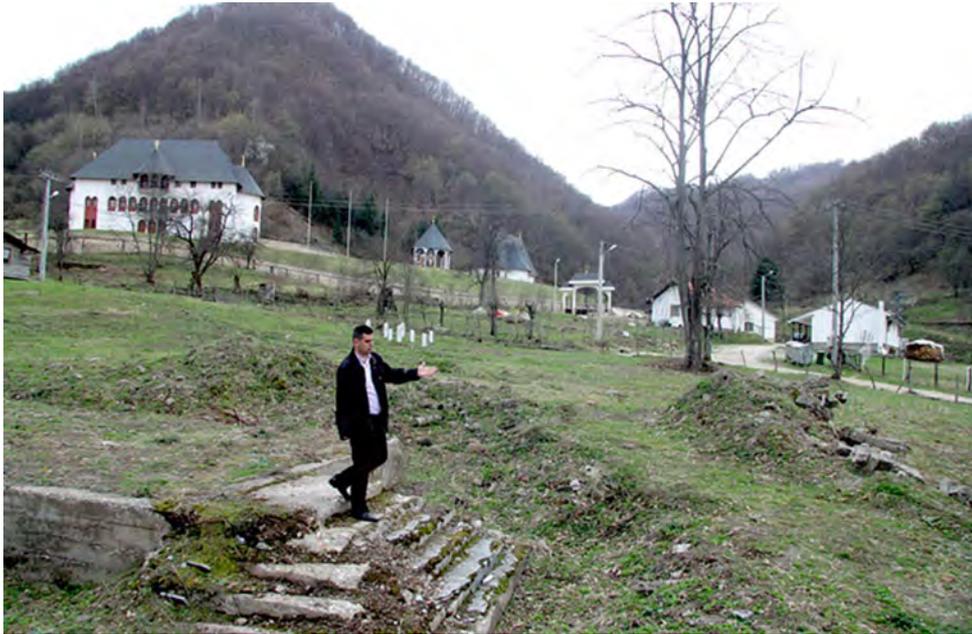
S.17. Sase mosque – photo 1

Post-war photo (2011) Center for Islamic Architecture, Islamic Community of BiH. Site of the destroyed mosque in Sase in the foreground, new buildings and access road of the Serb Orthodox monastery in the background. The Muslim gravestones seen in the rear of the site, behind the mosque's foundations, mark recent (post-2005) burials.

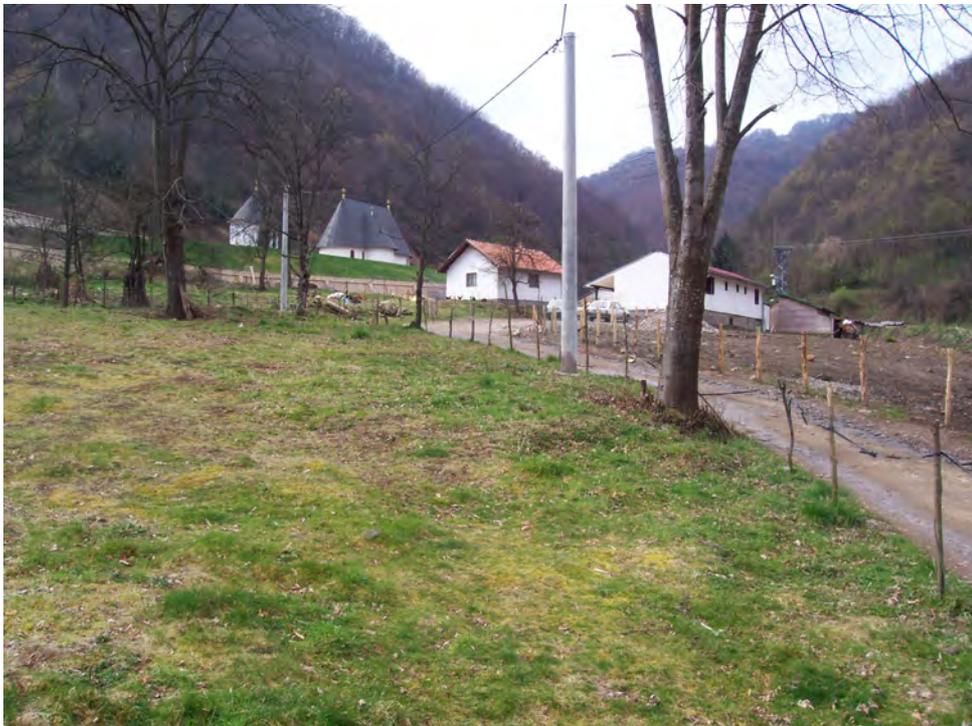
S.17. Sase mosque – photo 3

Post-war photo (2005) Center for Islamic Architecture, Islamic Community of BiH. Site of the razed mosque and Muslim cemetery in Sase. The new buildings and access road of the Serb Orthodox monastery can be seen at the right and rear of the photo.

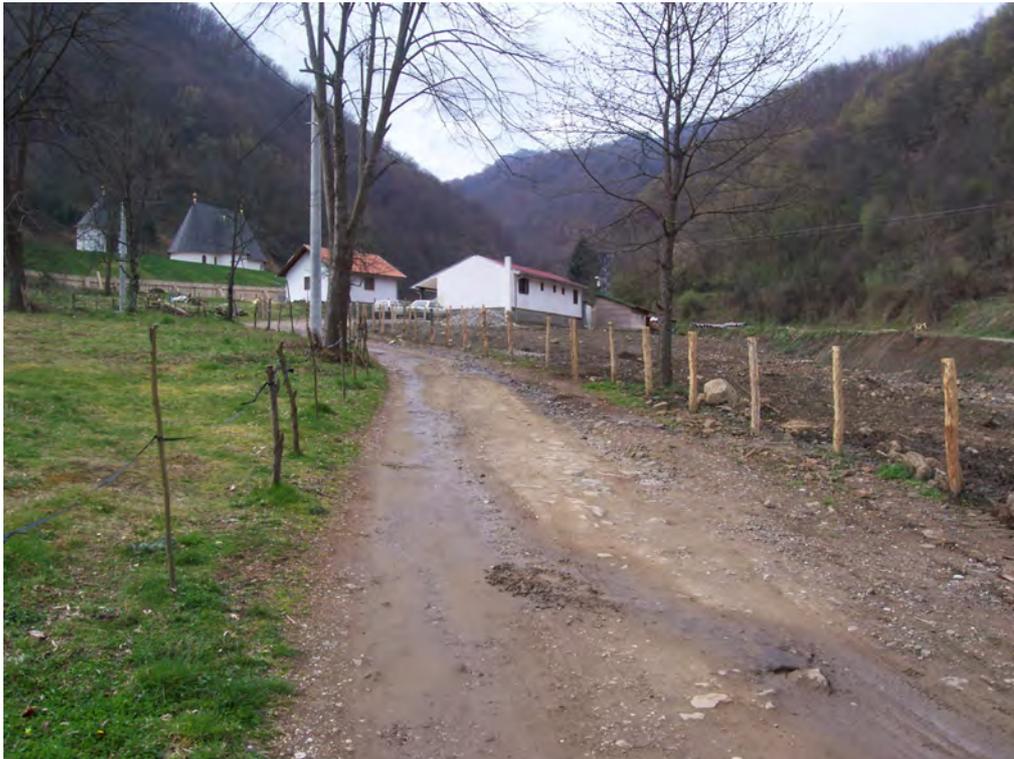
S.17. Sase mosque – photo 4

Post-war photo (2005) Center for Islamic Architecture, Islamic Community of BiH.. Site of the mosque and Muslim cemetery in Sase, with new Serb Orthodox monastery buildings and access road.
